Causes of Damage of Rural Road in Coastal Areas of Bangladesh

Md. Jahangir Alam¹, Mohammed Emdadul Karim², and Md. Shamsul Hoque¹

This paper focuses on the causes of rural road damage in coastal areas of Bangladesh.

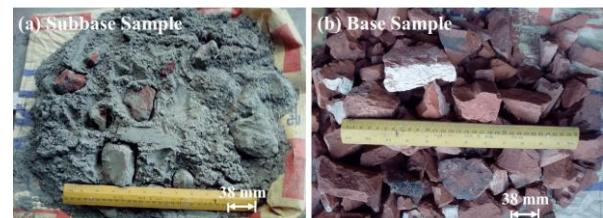
Recommended size of the burned clay brick chips for subbase and base is 38mm down well graded brick chips (Road Design Standards of LGED, 2005). In many cases, it was found that 70% (by weight) of the total brick chips are larger than 38mm (see Figure 5). As per LGED specification, the ratio of the brick chips and sand should be 1:1 in subbase. In such a mixture, the brick chips become isolated and suspended in the fine sand matrix where property of sand dominates in stress-strain behaviour of the mixture. This ratio need to be revised based on experimental study using different mix ratios. In the field, more than 65% fine sand was found in sand-brick chips mixture. In the base, used brick chips are made from 2nd class clay bricks which are not properly burned in many cases. This type of brick chips are easily break-down during vehicle movement resulting rutting at wheel position of the road. These sub-base and base are responsible for rural roads with rutting, a lot of pot holes and damage.

Figure 5 (a) Sub-base and (b) Base samples collected from Kaliganj, Satkhira

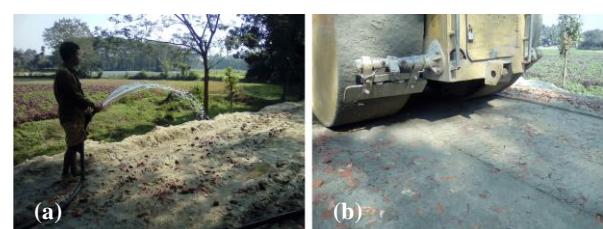
One site was visited while the subbase construction was ongoing. There, brick chips and fine sand are mixed at a ratio of 1:1 to use as sub-base. After mixing, the samples were watered by the labours. The labours did not have any moisture meter to measure the immediate moisture content of the sample while rolling. They do not have any training or knowledge about optimum moisture content. They just water until the sample gets wet (see Figure 6(a)). Thereafter, the rolling is done (Figure 6(b)). It is possible to get better CBR value by maintaining the moisture content and proper compaction. So, better performance of road can be achieved by supplying the portable moisture meter and giving training to the workers, how to measure the moisture content and do better compaction.

Figure 6 (a) Mixed brick chips and sand (1:1) in Sub-base and watering before rolling and (b) after rolling.

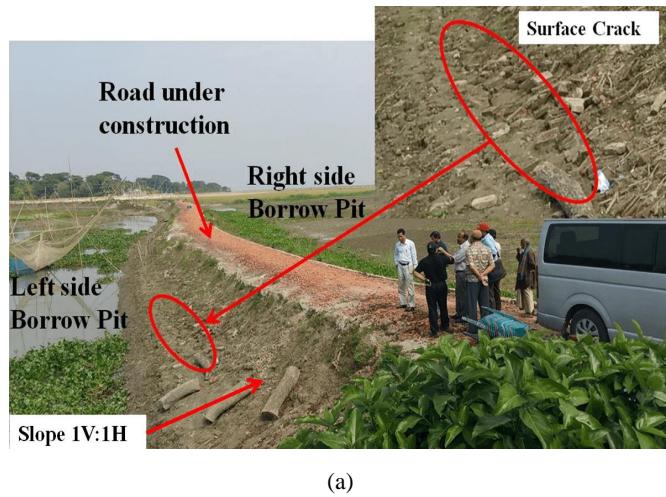
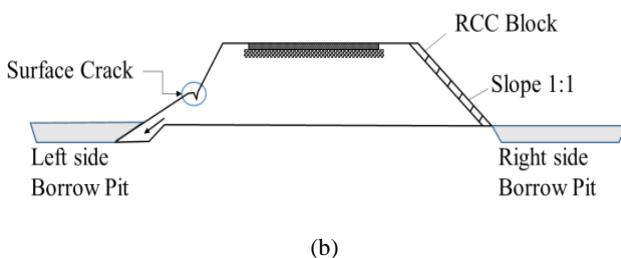
In most of the sites, side slopes of roads were found steeper (1V:1H) than the design value. Side slope of embankment mentioned in the Road Design Standards of LGED (2005) is 1V:1.5H for clayey soil, 1:2 clayey sand and 1:3 for sand or silty sand. Figure 7(a) shows a road at Bilaspur, Kaziarchar, Shariatpur. As the slope is steeper and the height of the road is more than 3.66 m, a surface crack was observed on the slope. To make it clear a real figure and schematic diagram is shown in Figure 7(b). Due to the steeper side slope and poor compaction, the crack also appeared on the shoulder of the road at Uttarpura, Uzirpara, Barisal (see Figure 8). Here, the Reinforced Cement Concrete posts were tilted. To make the steeper slope soil improvement need to be done or some protection system need to be followed. In some instances, farmers cut the embankment at toe making vertical cliff. This is another reason of steep slope of road embankment.

Figure 7 Failure line is observed in a road of Bilashpur, Kaziarchar, Shariatpur: (a) Photograph, (b) schematic diagram.

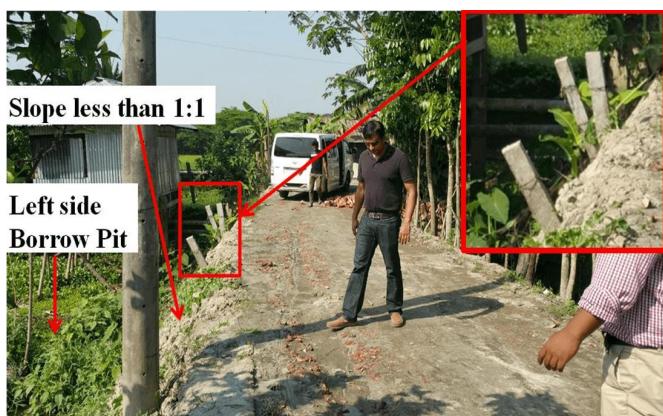
Figure 8 Steep side slope of rural roads in the study area (Location: Uttarpura, Uzirpar, Barishal).

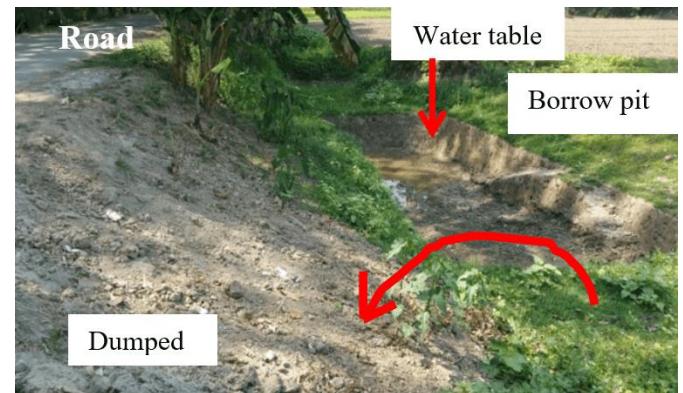
Borrow pit locations were found at very near to the road in most of the cases. Borrow pit location should be at least 3 m or 1.5 times of road height (which one is bigger) away from toe line (Road Design Standards of LGED, 2005). But in Figure 9, it is observed that the location of the borrow pit is at the toe of embankment. This is another reason of surface crack shown in Figure 9. This kind of mistake is very common in the rural areas.

Figure 9 Borrow pit was at the toe of the road. (Location: Babubazar, Barishal).

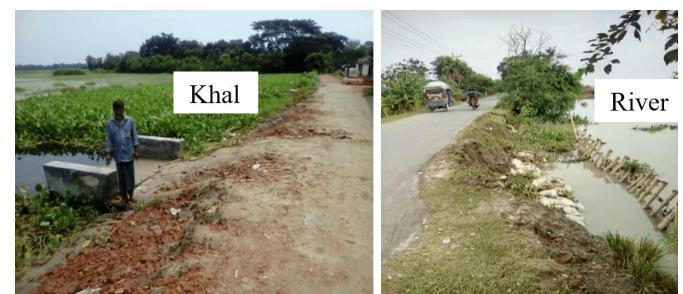
Some rural roads run along the bank of river or khal (Figure 10). This kind of road needs slope protection works for sustainable road construction. Sometimes, slope protection work is done using CC block revetment as shown in Figure 12. This is a typical design which is followed everywhere without any slope stability analysis. That is why sometimes slope failures are observed as shown in Figure 10(b) and Figure 12. Limited fund of rural road construction is a reason of not doing any proper slope protection design. If the slope protection is designed properly, construction cost of project will be more than the estimated budget.

Figure 10 Road along (a) khal and (b) river.

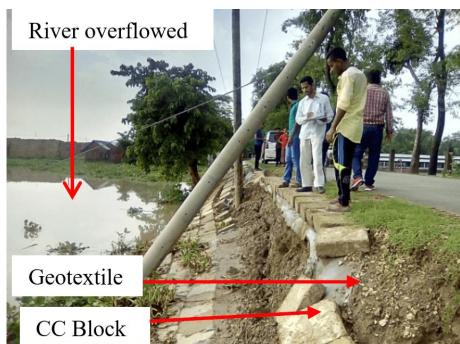
Figure 12 Embankment slope failed.

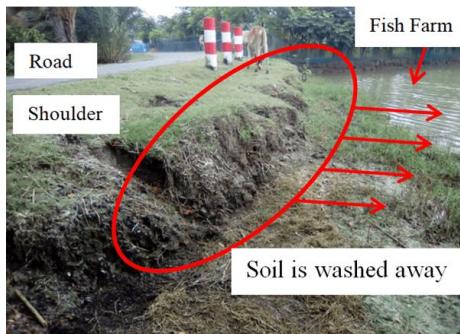
Figure 13 Side slope of rural road washed away by wave action.

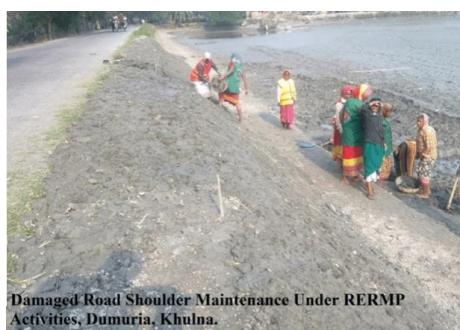
Figure 14 Mud is dumped for repairing side slopes and shoulder (source: LGED website).

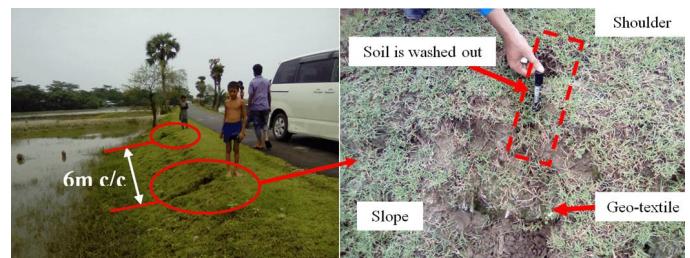
Authors observed a subsurface drainage path is installed in some recently completed rural roads. In the both sides of subgrade layer aggregate and sand wrapped with geo-textile are installed. The cross section of this modified road is shown in Figure 15 (a). This wrapped aggregate and sand mixture would work as a drain line through subgrade of the road. Here, the water inlet and outlet are placed in a zigzag pattern that is illustrated in Figure 15(b). Subgrade drain is 450 mm wide and 300 mm thick (Figure 15(a)). The center to center distance of subgrade drain is 6 m. However, in the rainy season it was found that the soils above the subgrade drains were washed away (the dashed oval marked portions in Figure 16). In Figure 16 (a) two photographs are exhibited where this type of erosion observed.

Figure 16 Effect of sub-surface drain.

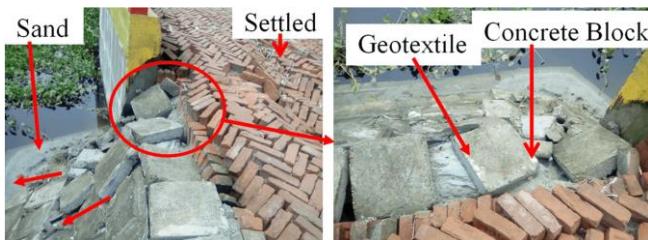
Approach road on the two side of bridge need extra attention in construction methodology and design. Removal of mud from the base of approach road and proper compaction of fill is necessary. More importantly, alternative design is needed to avoid differential settlement between abutment and approach road. In Figure 17, some photographs are added to show the settlement of approach road. Geotextile and CC blocks were used for slope protection at approach embankment. Consolidation settlement of underlying soft soil, lack of compaction of approach embankment and inadequate wing wall

are the major reasons of approach road damages. Sand compaction pile or PVD with preloading may be adopted to improve soft soil.

Figure 17 Damages of an approach road of a bridge.

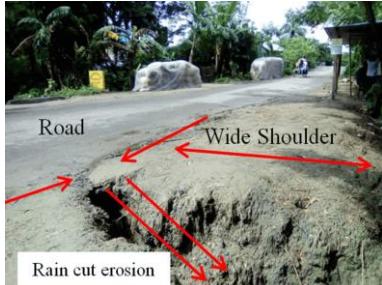
Lean clay or silt from nearby borrow pits are dumped at shoulder and side slopes. As the water table is high in the coastal region, so the collected borrow pit soils are highly moist and difficult to compact. In most of the cases, side slopes and shoulders are washed away during torrential rain in the next monsoon after construction (Figure 18) or the rain water makes her own path by eroding the shoulder.

Figure 18 Rain cut erosion in shoulder without vegetation

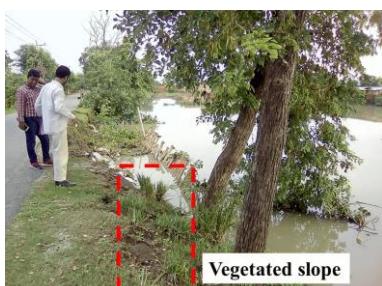
Vegetation is eco-friendly and has a very beneficial effect on the side slope protection. In many cases, it helps to make a sustainable slope. But, due to lack of maintenance and inadequate sunlight, it does not grow properly to protect the slope (Figure 19). Sometimes, deep seated slope circle failure occur which cannot be protected by vegetation only. At the side slopes, trees are planted to protect slopes. Sometimes, trees are uprooted (Figure 19) during storm and shoulder and road are damaged. This uprooted trees should be removed immediately and road should be repaired.

Figure 19 Slope failed in a vegetated slope.

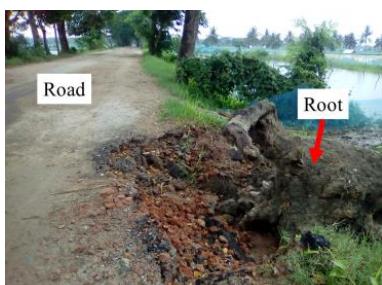
Figure 20 Uplifted tree damaged the road.

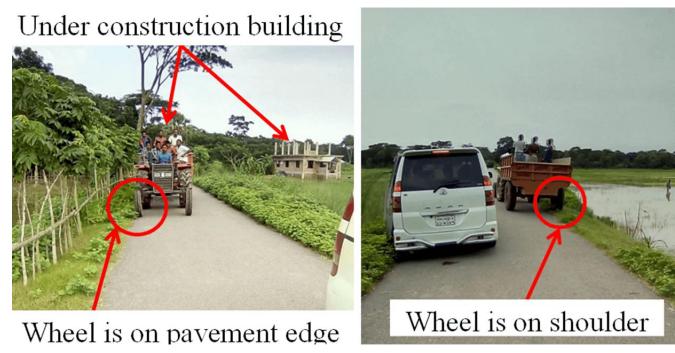
When a road network is developed in rural area, economic activity increases. Some people build multi-storied buildings beside road. So, loaded trucks enter into rural roads for which the road is not designed. During passing other vehicle, wheels of truck go on soft shoulder causing initiation of damage at pavement edge and shoulder (Figure 21). Because of frequent movement of loaded truck the small damage becomes bigger.

Figure 21 Truck is on (a) the edge of pavement and (b) shoulder.

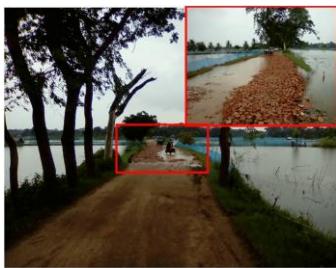
When roads are constructed on this subsoil, consolidation and squeeze out of soft clay cause subsidence, cracking and rutting of constructed road. Subsoil investigation should be mandatory for road project in coastal areas. Special attention should be given in the planning and design phase of road projects. Geotechnical Engineers should be involved in the design phase. Figure 23 shows the settlement of road on soft soil. In the both sides of the road fish farm is full of water.

Figure 23 A portion of road settled.

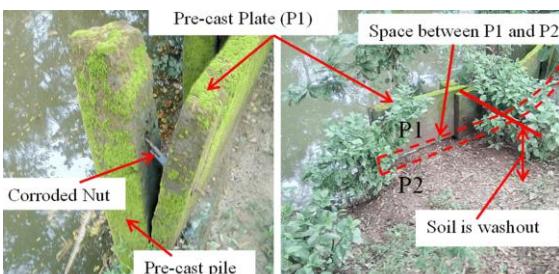
Palisading is done to stabilize the slope of the road along the pond, khal and river. In most of the cases palisading does not work properly. Figure 24 shows the design of palisading followed by LGED. Firstly the precast piles of 3 m length are driven into the existing soft soil at a c/c distance of 0.90 m. Thereafter the RCC precast plates are hooked using nuts and bolts. After one or two years of construction the nuts and bolts become corroded and slipped from hooked piles (see Figure 25(a)). Besides, in between two vertical RCC plates small gap exist through which the soil washed away day by day and erode the slope (Figure 25(b)). Later this design is modified by LGED. They used cast in place plates instead of precast plates. However, this system is not stable in many soil conditions of coastal districts. The posts are inserted within the soft soil layer. Failure of palisading is observed in Kajiarchor, Shariatpur (Figure 26). Existing typical design and construction methodology of palisading need to be revised. Palisading design need to be modified with proper stability analysis by Geotechnical Expert.

Figure 25 (a) Nut corroded and (b) Soil washed out in between the plates.

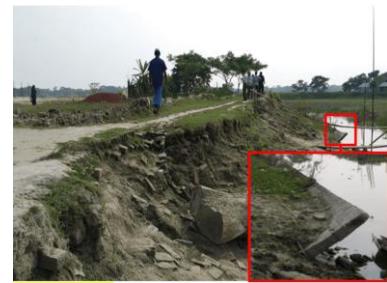
Figure 26 Palisading failed.

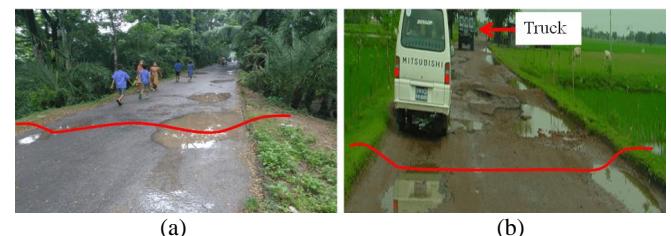
When roads are constructed, crown and 3% lateral slope is maintained (Road Design Standards of LGED, 2005). After one year of construction, rutting and subsidence of pavement create water logging on the road pavement. This water logging damages the bituminous carpeting and subsequently base layer. Two photographs of Khulna region are exhibited in Figure 27 (a) and (b). Figure 27 (a) is the photo of rural road constructed in 2015 and the water logging is started in 2016 though the pavement is not damaged yet whereas Figure 27 (b) represents the photograph of another road (more than one year) where due to water logging as well as vehicle movement the pavement and base were damaged.

Figure 27 Water logging on the new pavement road. (a) Initial settlement and (b) settlement and wide spread pot holes.

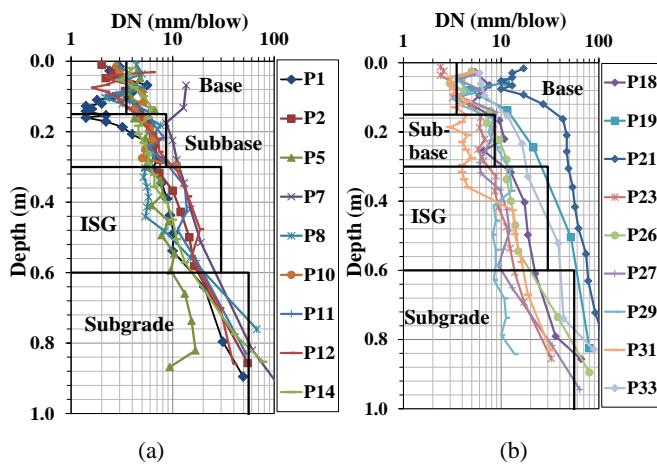
The recommended CBR value versus DCP penetration per blow for rural road construction was collected from LGED as shown in Figure 28. To compare the LGED recommended DCP values with field DCP values, total 34 DCP (Dynamic Cone Penetration) tests were conducted in rainy season on some village roads in Khulna district, Bangladesh. Test locations are listed in Table 1. Results of DCP tests done on road pavement are shown in Figure 29 (a) and (b) whereas results of DCP tests done on shoulders are shown in Figure 30 (a) and (b). In Figure 29 and Figure 30, the black lines are the LGED recommended maximum DCP penetration per blow (denoted as DN in mm/blow) for various layers of pavement. Where DN exceeded black line indicates not meeting the requirement set by LGED.

Figure 29 DCP test results conducted on the village road.

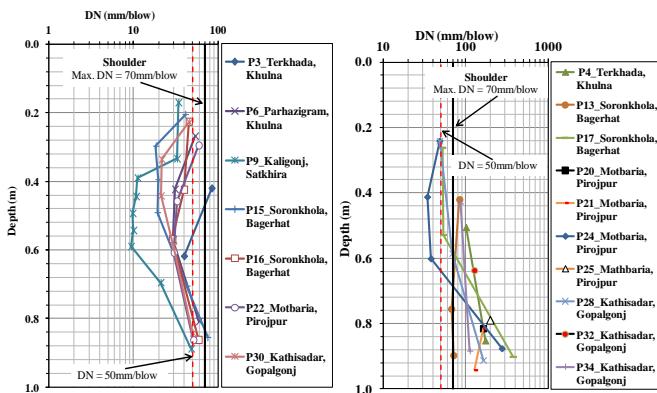
Figure 30 DCP tests conducted on the shoulder of the rural road.

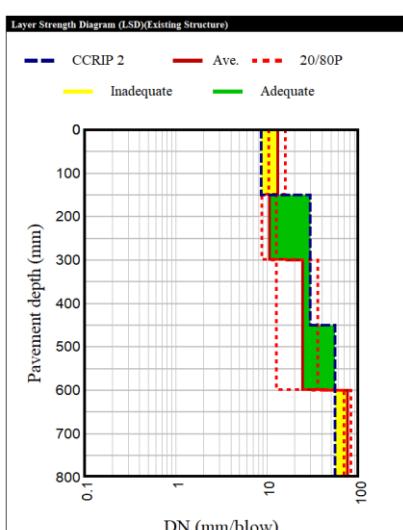
Figure 32 Analysed DCP test result (P7_Modhupur, Khulna): Layer strength diagram.

Rutting on road pavement may be attributed to inadequate base layer. Initiation of damage at the edge of pavement may be attributed to inadequate shoulder. Shoulder and widened part of road acts as confinement to existing road. Soft shoulder is not capable of giving confinement to pavement layers. That is why authors think that shoulder should be hard type with herring bone brick under which there should be a sub-base layer. Dumping of mud at shoulder and side slope must be avoided to make sustainable rural road.
