Anchors of Anchored Slopes in Taiwan

ABSTRACT: A catastrophic failure of an anchored cut slope at the national expressway in 2010 uncovered the status quo of tie-back anchors in Taiwan. Serious corrosion of anchor components due to poor corrosion protection was found to be the most obvious factor contributing to this landslide among other factors. After an extensive island-wide investigation on the existing anchored slopes, similar corrosion problem was found in many other anchored slopes. After the investigation, the construction and maintenance practice of anchored slopes had been fundamentally changed in Taiwan. This paper covers the inspection results on anchored slopes and also the measures taken to improve the corrosion protection of existing anchors and new anchors. Based on the problems found from the existing anchored slopes, some modifications on anchor tendon assembly and cement grouting practice had been developed to upgrade the corrosion protection of the new anchors and to monitor the long-term anchor load change as well.

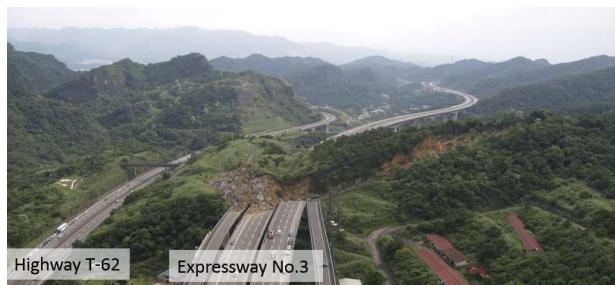
A catastrophic dip slope failure occurred suddenly at an anchored cut slope of Taiwan national expressway No. 3 in 2010 after 13 years in service (Figure 1). Originally, this slope was supported with a 20 m high retaining structure with precast RC crosses on slope face and 10 levels of tie-back anchors. Totally, 572 ground anchors were installed with a pre-stressed load of 60 tons each. From the remains of anchors on site, it was found that a large portion of anchors were seriously corroded (Figure 2) due to improper corrosion protection under the anchor head. Since ground anchors with the similar construction practice have been widely used to support the roadside slopes in Taiwan, they are likely to suffer similar corrosion problem (Lee et al., 2013 and Liao et al., 2013). The Ministry of Transportation and Communication (MOTC) of Taiwan government launched an extensive island-wide inspection program on the status quo of existing anchored slopes along the highways, railways and public roads (TGS, 2011 and Liao et al., 2014). Totally, more than 30,000 anchors were inspected and it had been concluded that anchor corrosion was a systematic problem island-wide for anchored slopes. After the investigation, immediate measure was taken to protect the existing anchors from further corrosion. In the meantime, the stability of existing anchored slopes was checked and additional measures were taken to make up the loss of anchor capacity due to corrosion and other causes. For the new anchors being installed to compensate the loss of tie-back capacity of corroded anchors, some modification on anchor tendon assembly and cement grouting process are suggested to upgrade the corrosion protection of the new anchors and to reliably monitor the long-term anchor load change.

Figure 1 Landslide on National Expressway No. 3 in Taiwan
(photo taken on April 25, 2010)

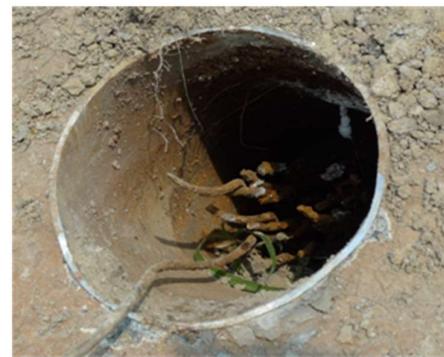
Figure 2 Seriously corroded and broken steel strands found from at the landslide site

During the process of slope sliding, a large number of ground anchors were ripped off by the massive forces generated from the sliding mass. Serious corrosion observed on the ground anchor components indicated the abundance of groundwater in the slope. Figure 3 summarizes the field inspection results of ground anchors. By measuring the length of remained steel strands on the sliding surface, three types of steel strands breakage can be categorized. The “Red” category stands for the anchors of which strand breakage was closely under the anchor head. The “Yellow” category stands for the strand breakage in between anchor head and sliding surface. The “Green” category stands for the strand breakage near the sliding surface. The “Blue” category stands for the anchors remained on the slope face. Since the “Blue” anchors located on the not moving portion of the slope, they had no direct link to the causes of this landslide.

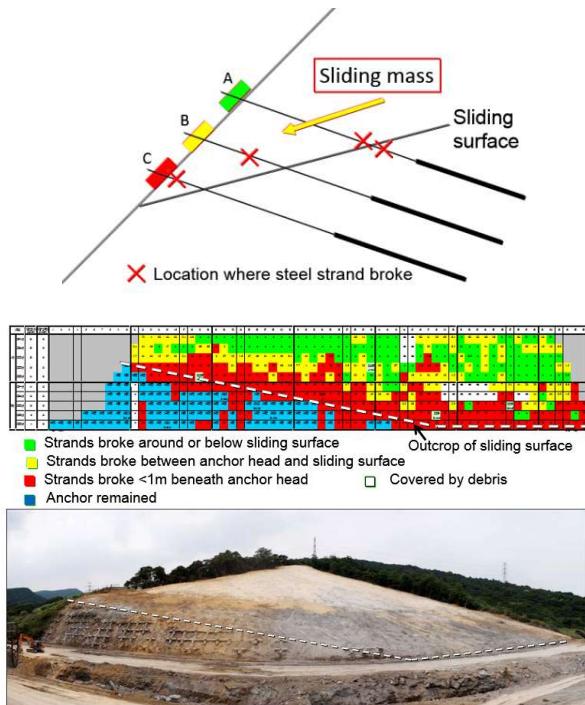
If neglecting the number of anchors still remained on the face slope (Blue category), approximate 40 percent of the broken ground anchors were in Red category. They were all located in the range between 5 - 7m above and 1-3 m below the outcrop line of sliding surface on the face slope. For anchors located within this range, some showed white stain under the RC cap of anchor from the photos taken prior to the landslide. It is the deposit of calcium carbonate and is the sign of long time groundwater effluent from the anchor hole. As indicated by the distribution of Red marked anchors

in Figure 3, the groundwater level could rise to 5 - 7m above the outcrop line on the face slope. When the slope mass slid down, the steel strands of anchors in Red category broke at a location very close to the anchor head. It implies that steel strands were corroded under the anchor head for anchors in the Red category. Above the Red zone was the Yellow zone where steel strands were broken in the free length section and the breakage location was at some distance away from the anchor head. Since no anchor was actually pulled out from its fixed end, it can be concluded that all the failed anchors were resulted by the breaking of steel strands at different locations in free length.

Figure 3 Exposed sliding surface and distribution of anchors with different strands breakage locations on the free anchor end
(Liao et al, 2013)

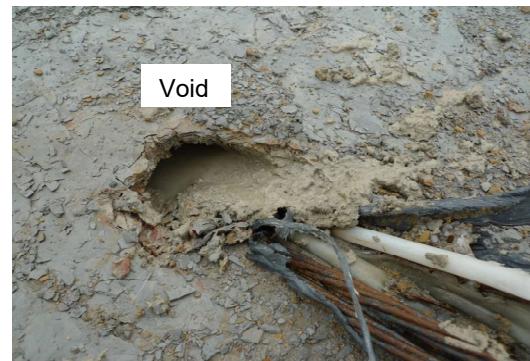
During anchor construction, it was the standard operation procedure to inject the entire anchor hole with cement grout first and then inserted the tendon assembly to the hole later. In theory, the annular space between anchor hole and plastic sheath of the free anchor end should be fully filled and sealed with cement grout. However, the remains of anchors left on the sliding surface did not show that way (Figure 4). There was ungrouted void both inside and outside of the plastic sheath in free anchor end. Obviously, some cement grout might have leaked out through the cracks and joints inside the slope or it might simply be a result of mal-practiced anchor construction. Not surprisingly, steel strands with improper corrosion protection corroded due to exposure to humid underground environment or being submerged by groundwater.

Figure 4 Ungrouted void in free anchor end (inside and outside of plastic sheath) found from anchors left on the sliding surface

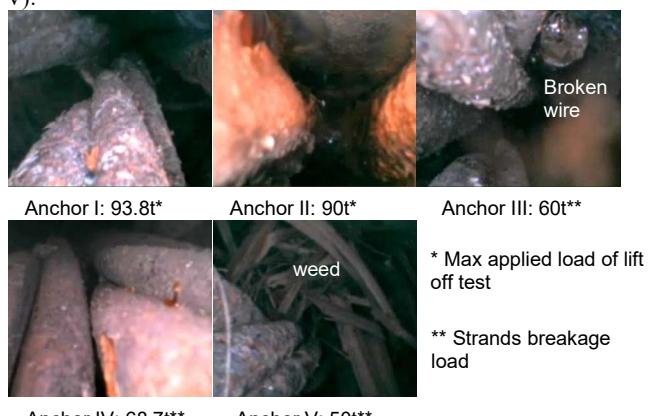
Figure 6 shows the endoscopic images taken from the anchors remained on the face slope of the Expressway landslide. In general, all anchors inspected suffered serious strands corrosion problem and should be classified as unacceptable condition according to the BSI standards for ground anchorages (BSI, 1989). Interestingly, the endoscopic images showed some wires of the strand had already broken at the time of endoscope inspection (Anchor III) and some strands were surrounded by weeds inside the anchor hole (Anchor V).

Figure 6 Images of endoscope inspection taken under the anchor head before carrying out the anchor lift off test

Lift off test was carried out on these anchors and the test results, such as lift off load and maximum applied load, are listed in Table 1. Obviously, there is no clear correlation between breakage load and the extent of surficial corrosion of steel strands. For example, the

surficial corrosion condition of steel strands of Anchors I & II is no better than Anchors III, IV, and V. But Anchors I & II could sustain the maximum pull-out load about 50% higher than the other three anchors. Anchors I & II showed no strand breakage up to maximum applied load; Anchors III, IV, and V showed strand breakage during stressing and the maximum load applied was lower. For those anchors failed by strands breakage, some wires in the strands (i.e., the strands which are subjected to most serious corrosion or most stressed) broke first during stressing. After that, the load was redistributed to other wires and caused a chain-reaction type of breakage. In other words, strands may be broken in a wire-by-wire pattern; anchors may be broken in a strand-by-strand pattern and then a brittle type of failure occurs on anchor.

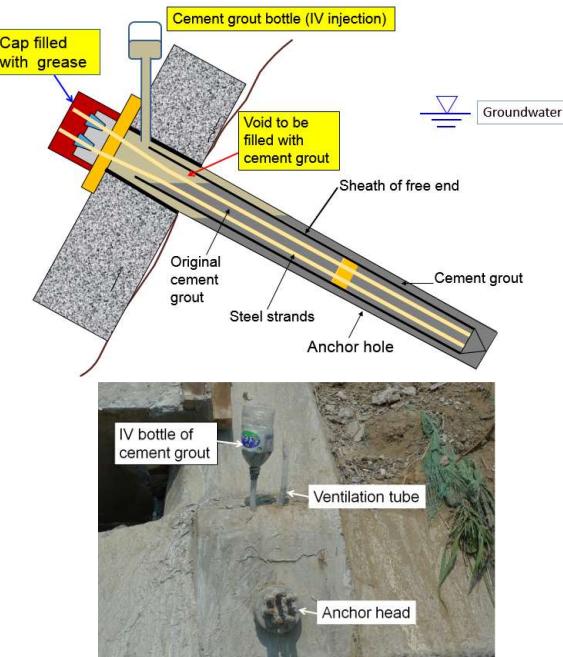
Figure 11 Fill up the voids under anchor head with cement grout for the existing anchors

Although many inspected anchored slopes show no sign of instability in Taiwan, a large number of anchors are suffering steel strand corrosion problem. There is an urgent need to prevent the rusting condition of existing ground anchors from getting worse. To do so, cement grout, which was low cost and commonly used, was injected to fill up the voids below the anchor head of the existing anchors to stop further corrosion on steel strands. This work could be carried out by drilling two holes from outside of the anchor to reach the void under the anchor head first (Figure 11). One hole was for cement grout injection; the other was for air ventilation. Cement grout (water/cement ratio = 0.5) was injected to the void with grouting pump. Since cement grout may settle or leak out from the anchor hole, pumping process may have to repeat several times and it could be time consuming. To make sure cement grout had filled up the anchor hole, an intravenous (IV) injection method is adopted as the final step of this remedial treatment. When the cement grout was effluent from the ventilation hole and was in balance with the grout supply bottle, then it could be certain that the void underneath the anchor head was filled with cement grout and the steel strands were safely covered with cement grout.
