Forensic Investigation of A Subway Tunnel Construction Failure

ABSTRACT: In this paper, the forensic evidences and investigation of a subway tunnel construction failure occurred in Kaohsiung, Taiwan are presented. The studied construction failure occurred during a cross passage excavation of a shield tunnel construction work of the Kaohsiung Mass Rapid Transit System, and resulted in severe tunnel collapse and extensive ground failure that even reached to ground surface 30m above the tunnel depth. Valuable photo images obtained during and post event, as well as results of special geophysical testing methods were presented and compared to verify proposed failure scenario. Information presented in this paper is hoped to be helpful to improve engineers' knowledge for preventing similar construction risks.

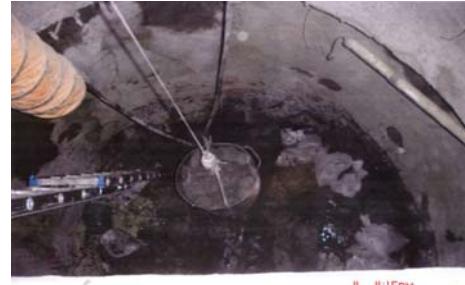
In the afternoon of December 4th 2005, when the sump excavation reached a level 4.95m from the floor of the crosspassage, a chunk of wet soil tumbled out from the southern wall of the sump at the bottom around 3:30pm. The small collapse was followed by steadily increased outflow of mud water as shown in Figure 6. At the beginning of the seepage, sand bags and shotcrete were adopted in an effort to stop the flow. However, the amount of water increased with time despite more dry cement and coagulating agents were dumped into the sump. At 4:50pm, water inside the sump started to whirl turbulently showing the signs of collapse of the side wall of the sump. The top cap of the sump was then sealed with anchor bolts, more sand bags, and vertical posts as shown in Figure 7. At 6:00pm, collapse of the sump led to the undermining of the already completed shield tunnels. Water started to spit out between ring lining segments, and chunks of concrete were found to be detached from the edge of ring segments of the shield tunnels (Figure 8). At 6:30pm dislocation of the ring lining segments was clearly identified (Figure 9) and all engineers and workers were forced to evacuate. At 9:30pm nearly 6 hours after the occurrence of the incident, ground above the up-track (south side) tunnel started to settle by 200mm to 250mm. The settlement area soon developed into a big sinkhole within a very short time as depicted in Figure 10, and ruptured several lifeline pipes including two tap water mains of 300mm and 600mm in diameters (Figure 11). By the morning of December 5th, the sinkhole developed to a size of 80m in length and 20m in width (Figure 12). In the meantime, another ground collapse in a size of 20m long and 10m wide was quickly developed on the north side where the down-track tunnel sit below (Figure 13). These two huge cave-ins on the ground surface led to the threat of large scale collapses of the shield tunnels and the crosspassage. These ground cave-ins were finally backfilled and stabilized near the midnight on December 5th, over 30 hours efforts. In addition to the ground failures, the existing vehicle underpass above the failed tunnels was also found to have been seriously damaged by the accident (Figure 14).

Figure 6 Muddy water started to flow into the bottom of the sump (4:15pm, December 4th, 2005)

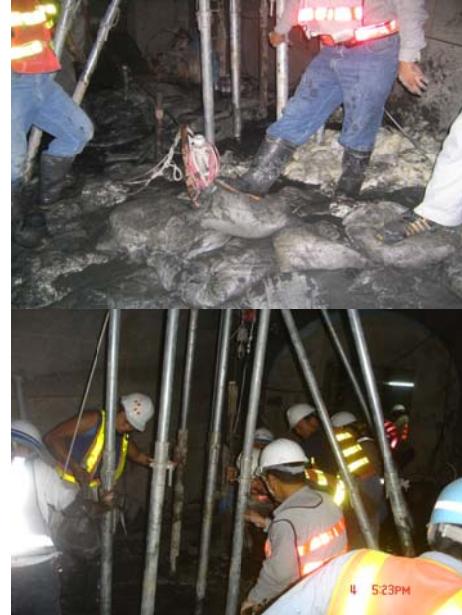
Figure 7 Effort made to seal the top of the sump (5:23pm, December 4th, 2005)

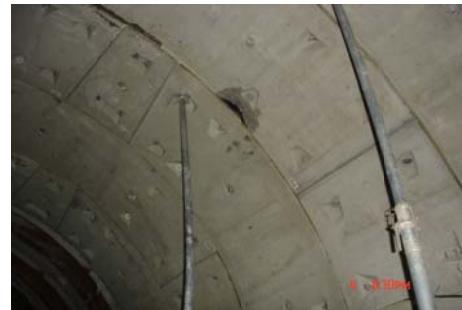
Figure 8 Concrete chunks detached from the ring segments of the up-track tunnel (6:30pm, December 4th, 2005)

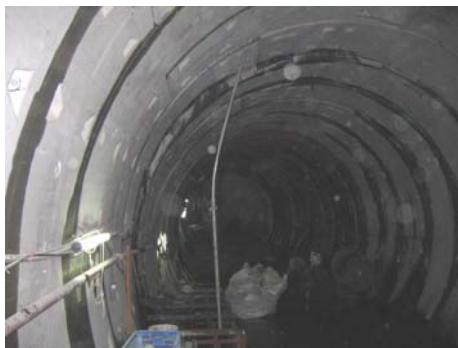
Figure 9 Serious water inflow and dislocation of lining segments inside the up-track tunnel (6:50pm, December 4th, 2005)

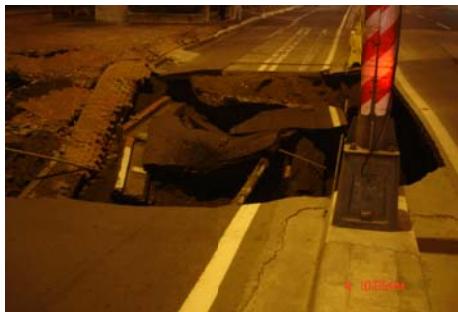
Figure 10 Sinkhole appeared on the ground above the up-track tunnel (10:05pm, December 4th, 2005)

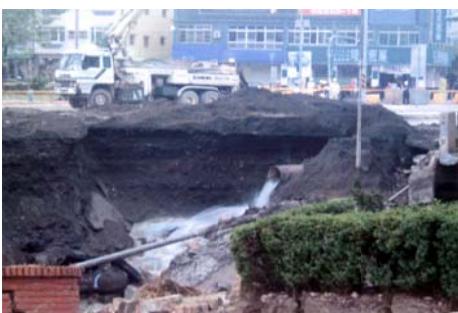
Figure 11 Rupture of the water main (morning of December 5th, 2005)

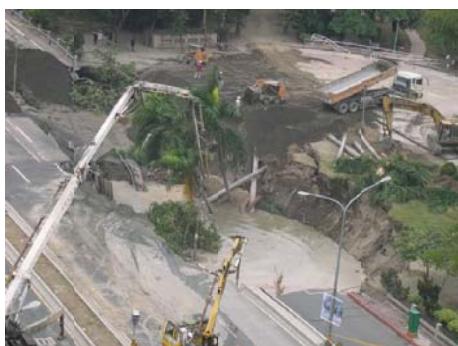
Figure 12 The large sinkhole on the south side and emergency backfill works in progress (daytime of December 5th, 2005)

The first stage of immediate retrofit work mainly focused on backfilling the sinkholes. A total volume of $12,000\text{m}^3$ sand and aggregates, $2,326\text{m}^3$ concrete, as well as 1,150 bags of dry cement,

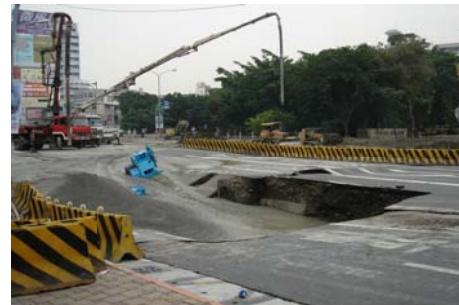
Figure 13 the sinkhole development on the north side above the down track tunnel (4:30pm, December 5th, 2005)

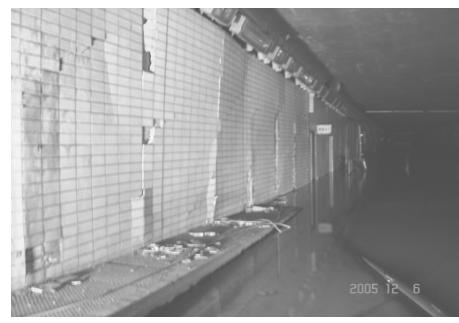
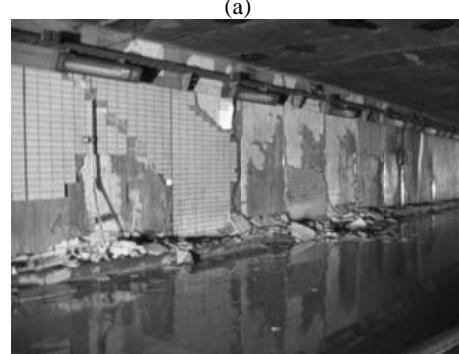
Figure 14 Damaged vehicle underpass

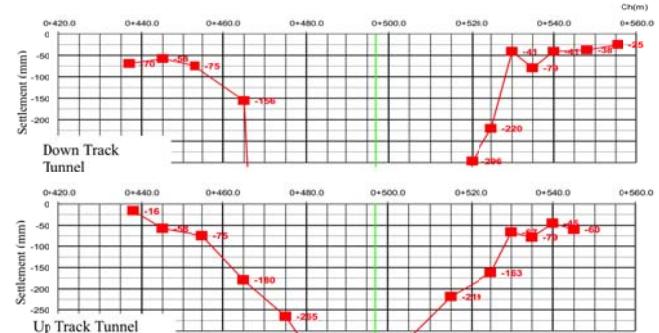
Failure investigation was first conducted by drilling boreholes along the original tunnel alignments. The drilling rod was lowered down to the failed ground in an attempt to reach the pre-casted ring segments of the shield tunnel lining. This borehole probing method was used as a direct inspection measure to assess the damaged condition of the shield tunnels and to estimate the length of collapsed and distorted tunnel portions. Borehole probing results of both the up-track and the down-track tunnels are shown in Figure 17 (Lee and Ishihara, 2008b). The cross passage where the incident occurred was located between mileages of 0+495m to 0+500m. As shown in the figure, the section between mileages 0+465m to 0+520m of the up-track tunnel had collapsed due to the failure and could not be located by the probing rod. Near 120 meters of the up-track tunnel was seriously dislocated. For the down-track tunnel at

the south of the failed cross passage, the section between mileages 0+475m to 0+515m had collapsed and was out of reach by the probing rod. Similar to the up-track tunnel, near 100 meters of down-track tunnel was seriously disrupted. The result of this borehole probing revealed that ground failure might have destroyed the crosspassage and have destructed nearly 120 meters long up-track and down-track shield tunnels.

Figure 17 Borehole probing results of the up-track and down-track tunnels

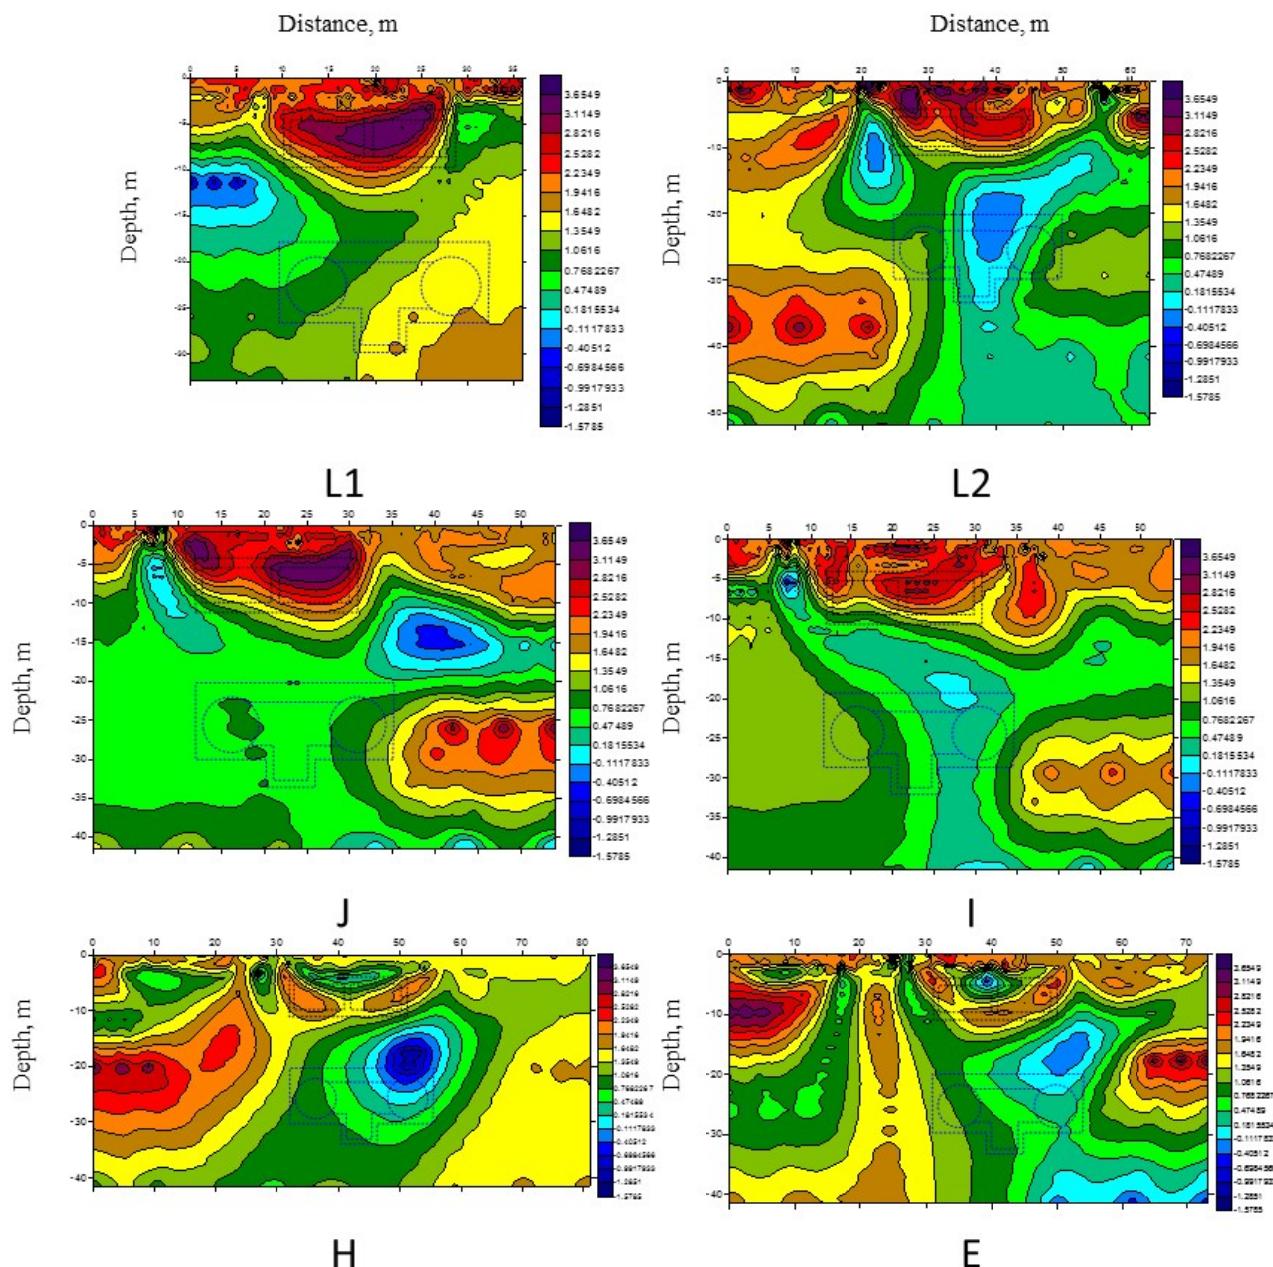
Figure 23 shows the results of 2D RIP test along the selected survey lines marked in Figure 21(b). In these figures, Calibrated values of resistivity are scaled on the right to each profile. As shown in the image profiles, cold colours, from green to deep blue, represent material with relative low resistivity such as disturbed ground with high ground water content or voids. On the contrary, warm colours, from yellow, orange, to red and brown, represent material with relative high resistivity such as dense soil, injected grouts or concrete. In this case, images obtained by the 2D RIP test tend to be slightly distorted upward because only ground surface probing posts were installed to record response resistivity (Lee and Ishihara, 2008a). However, resistivity profiles shown in Figure 23 still clearly indicate that the area in between the vehicle underpass and the cross passage were in serious distressed condition. Profiles L2, H, and E, identify that ground in between the vehicle underpass and the cross passage in south contained high water content and in a loose state at the time of testing. Similar ground condition was also observed in the ground under the sinkhole on the north as shown in Profiles L1, L2, I, and J. In addition, ground failure area on the south where the up-track tunnel was located was found to be more serious than that on the north where the down-track tunnel is.

Figure 23 Results of 2D RIP tests

The 2D RIP results also indicated that damaged areas were larger than two sinkholes appearing at ground surface, and further verified the results of borehole probing that near 120m long tunnels in both directions were destroyed by the piping ground. At the locations of profiles L2, H, and E, which were the east and the west boundaries of the soil improvement work for the damaged cross passage, soil beneath the subway tunnels was also found to be severely agitated by possible soil piping or boiling failures. As shown in these image profiles, the shapes of the agitated soil layers are in funnel shapes. This observation indicates that ground failure was initiated at bottom of water sump and then spread upward through the up-track tunnel first to cause large sinkhole on ground surface. Ground failure then migrated to the soil surrounding the down-track tunnel to cause another sinkhole on December 5th, the second day of the accident. Moreover, no clear image of the cross passage or soil improvement block installed before tunnel construction was found in 2D RIP results; this indicates that the cross passage and the shield tunnels attached to it should have been all broken by the huge soil piping pressure. The 2D RIP results also show that immediate remediation and grout treatments had effectively reached the perimeter of the ground failure to possibly stabilize the ground, as the warm colour areas shown in profiles L2, J, I, H, and E.

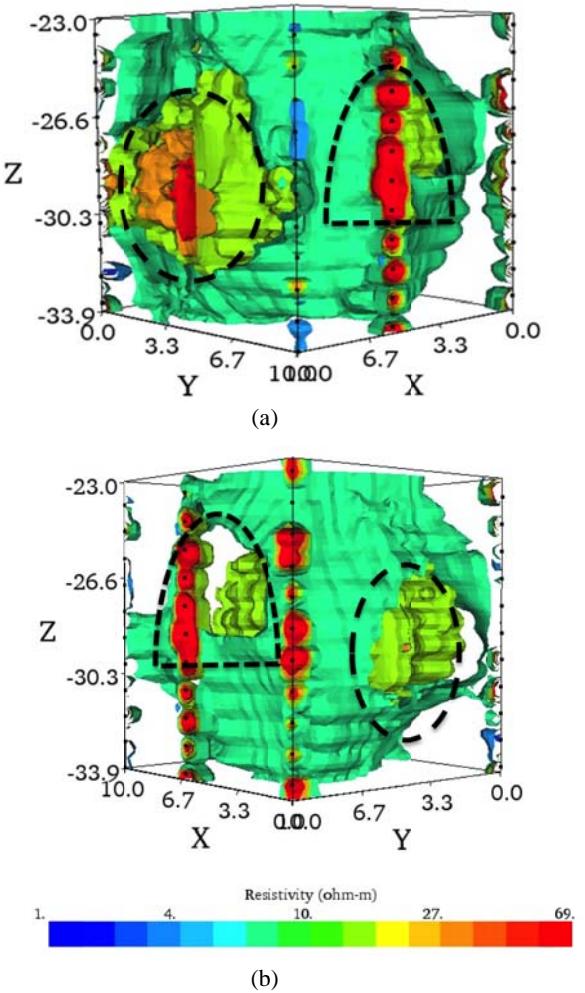
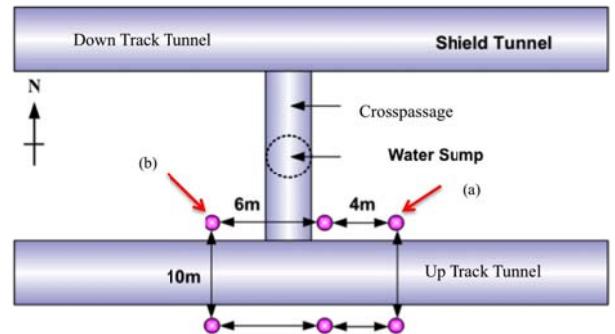
Figure 24 shows the results of the 3D RIP test. As the results of 3D investigation contained fairly complicated stereo information, images shown in the figure have been processed by carefully differentiating assorted materials underground. The light green or blue portion shown in the figure indicates the most of jet grout material applied prior to the construction of the cross passage and the shield tunnels. Reinforced concrete portions of shield tunnels and the cross passage are probably in bright green to yellowish colour. The exposed steel truss and rebar of the cross passage are in orange to red colours with least electrical resistivity. As shown in Figure 24, the integrity of the shield tunnel and the crosspassage was barely observed. The east portion of the shield tunnel was found to have an offset of at least 1m from the cross passage, and the west portion of the shield tunnel was found to be out of shape with an offset over 2m. There was very low resistivity response in both images indicating that the cross passage might have been seriously damaged to expose steel truss components. The results of 3D RIP test denote that piping failure induced from the water sump had probably destroyed the connections of the shield tunnel to the cross passage. The results of both 2D and 3D RIP tests have further verified the results of borehole probing shown in Figure 17. Moreover, it has provided visualization images describing the failure extent and the actual ground condition. This information is valuable for both forensic investigation as well as retrofit design.

Figure 24 Results of 3D RIP tests

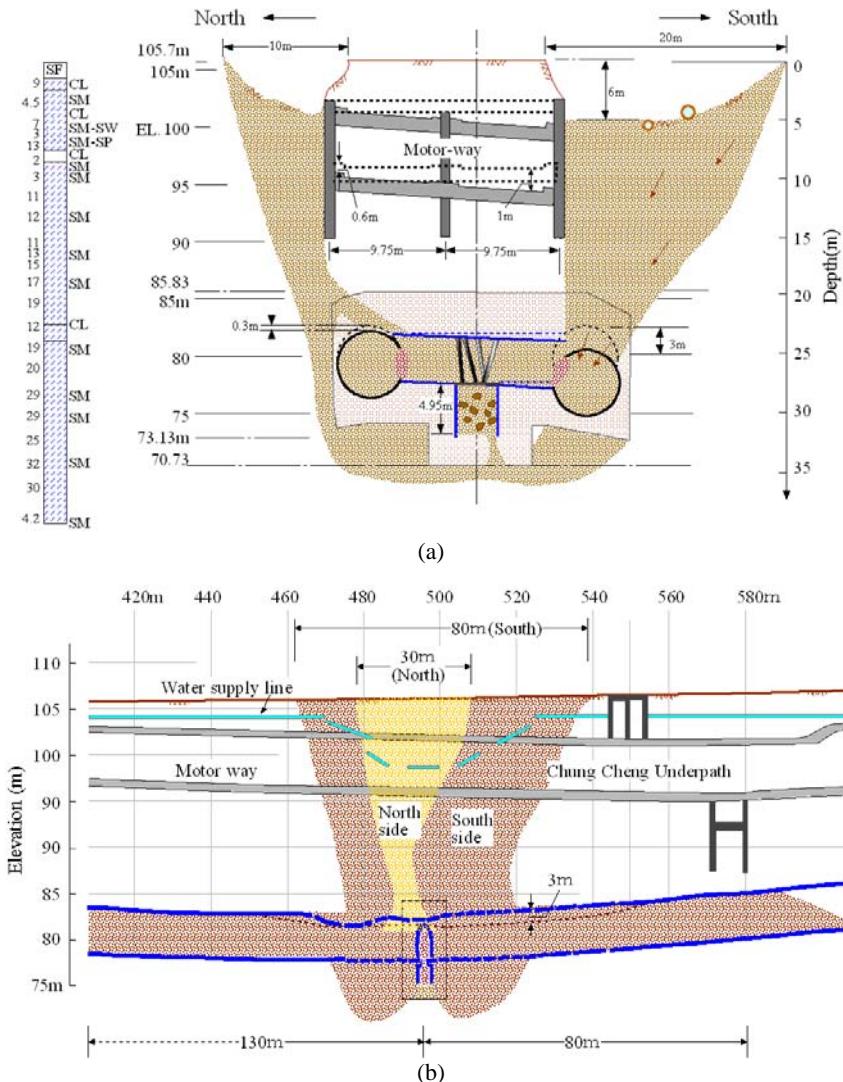
Ishihara and Lee (2008b) first proposed the failure hypothesis of the studied incident (Figure 25) based on the investigation data including workmen testimonies, emergency retrofit work records, as well as the forensic testing results presented in this paper. They described that the failure started from the bottom of the water sump highly likely via a vertical piping crack (Ishihara and Lee, 2008). The invasive hydraulic pressure near 300kPa caused by such a piping failure forced debris to flow into the crosspassage from the collapsed water sump. In the early stage of failure, the jet-grouting block installed for crosspassage construction was fairly strong; it was not broken until the hydraulic pressure caused by piping and flown-in debris had ripped off the ring lining segments of the shield tunnels outside such a jet-grouting block. Ground failure was enlarged when the debris flowed into the tunnels and created large voids underground. The failed ground was in a state near liquefaction due to the high hydraulic pressure and strong downward seepage. The shattered ground soon expanded upward to ground surface forming a huge sinkhole above the up-track tunnel on the south and widely spread to the down-track tunnel on the north

Figure 25 Failure scenario proposed, (a) cross sectional view, (b) longitudinal view (after Ishihara and Lee, 2008)

A forensic investigation committee was formed to study the possible causes of failure. Comprehensive investigation and analysis were conducted including information presented in this paper. The reasons why such dreadful vertical cracks occurred at the bottom of the water sump were probably a combination of design layout, constructability, unique features of local soil, as well as quality control of ground improvement (TCRI, 2006). There were also some facts found that contributed to such massive ground failure. However, piping created by high hydraulic pressure and internal erosion prone local soil are believed to be the major causes of failure. Near 300kPa pressure difference between the constructed tunnel and the confining soil caused the collapse of water sump and led to even severe failure. The estimated seepage hydraulic gradient exceeded 12.5 (TCRI 2006; Ishihara and Lee, 2008).

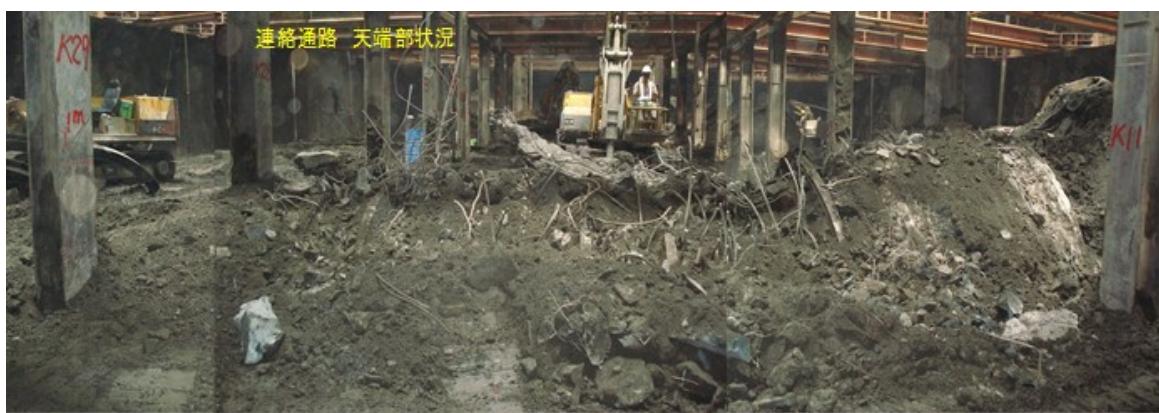
creating similar failure. The vehicle underpass sitting above was thus damaged by distressed ground underneath and all ground as depicted in Figure 25 (Ishihara and Lee, 2008). Moreover, Figures 26 and 27 show the wreckages of the cross passage and the shield tunnel excavated during the retrofit works. As shown in Figure 26, the cross passage inclined to the south and sunk over 2m at the edge connecting to the shield tunnels. The shotcrete lining and the inner truss of the cross passage was found to have been severely broken by the debris flown in. Figure 27 shows clearly that the ring lining segments of the shield tunnel had been ripped off and sunk as revealed in the investigation using borehole drilling and RIP tests. Where the cross passage connecting to the two shield tunnels had the most serious settlement and thus damages included dislocation and collapse to lining segments of the shield tunnel as shown in Figure 27. The proposed failure scenario was further verified by such forensic recovery work.

Figure 26 Wreckages of the crosspassage.

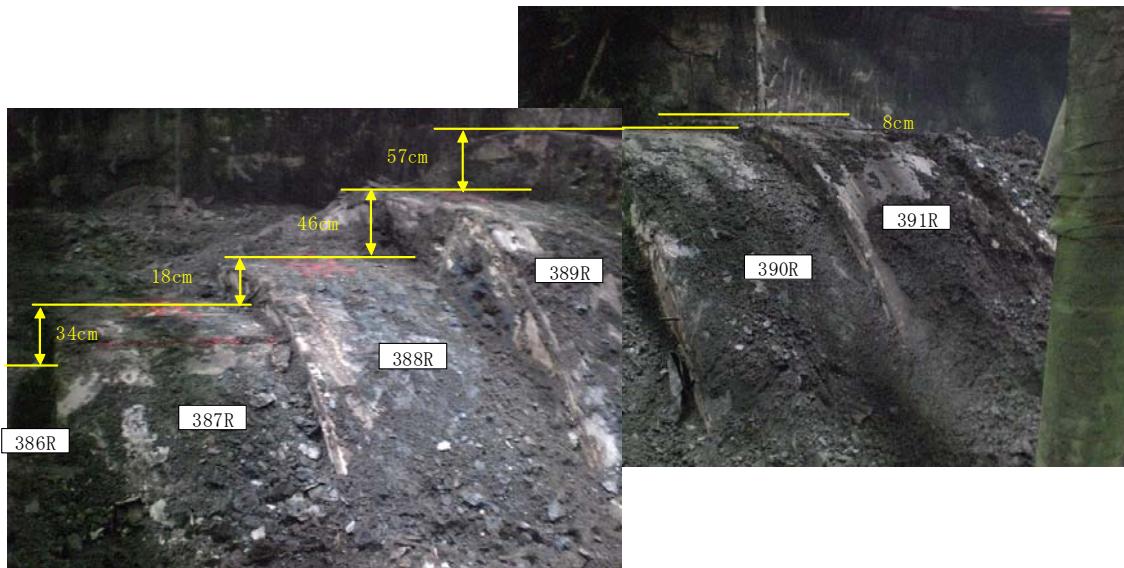
Figure 27 Damaged shield tunnel excavated during the retrofit works
