Case Study of Renovation on Alishan Route 18 after Typhoon Morakot

Kung-Tai Chou¹, Wen-Long Wu², Chiao-An Hsiao³, Kun-Hsien Chou⁴
CECI Engineering Consultants, Inc., Taiwan

KEYWORDS: Typhoon Morakot, Road, Slope, Disaster, Remediation measures

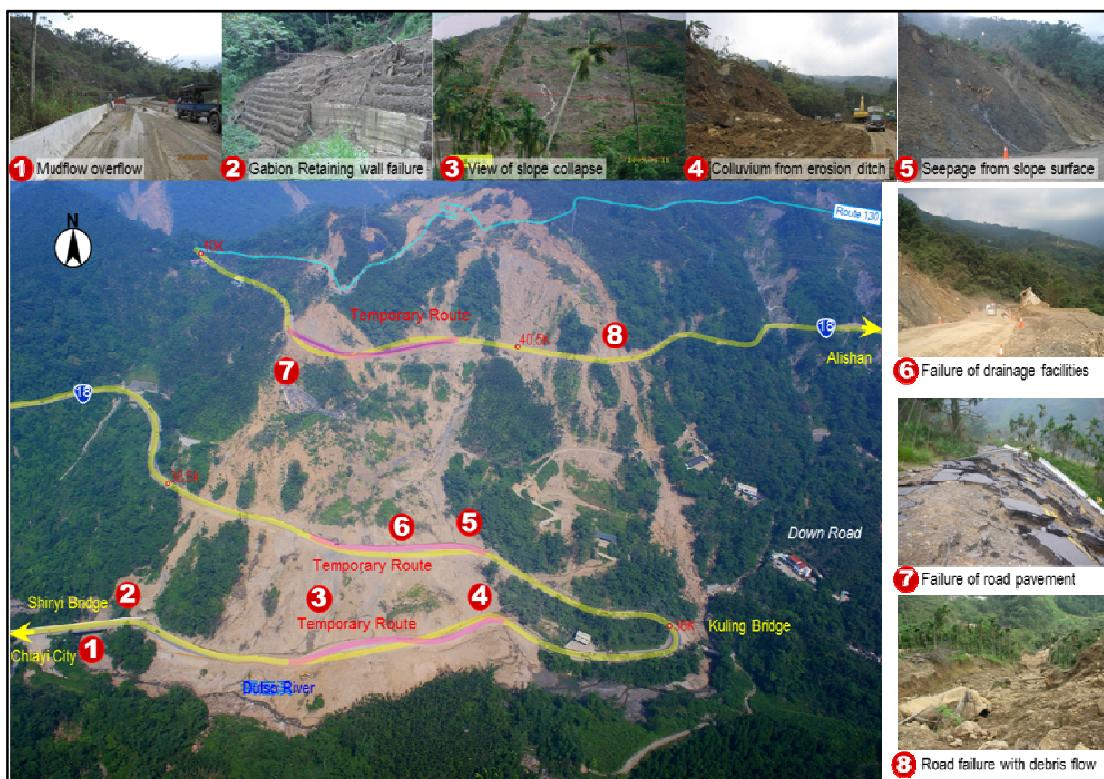
Figure 3 Slope slide disaster photos at mileage 37.5k

location	Cause analysis of disasters	Failure types
37.5k & 40.1k	<ul style="list-style-type: none"> Runoff erosion due to heavy rain Shallow-rooted plant, poor soil and water conservation No vertical and horizontal cut-off drainage facilities in slopes Road drainage not properly segmented and discharged into stream, causing water overflow The exposed toe of dip slope in the east side lead to landslide Rainwater infiltration in west side colluvium deposits soften soil strength and reduce slide resistance of soil that lead to circular landslide of slopes 	<ul style="list-style-type: none"> The upper slopes are classified as dip slope landslide; the lower slopes belong to circular landslide and a large number of earth and rock piled on the roadbed 37.5k ~ 38k

The slope protection works in this section will do best to adapt to the nature and reduce change on the natural environment. The vegetation for slope protection against erosion caused by rain washed is adopted in the safety flat slope. The steep slope or potential landslide will be treated as the possible slope failure. The free-form vegetation measure, lattice beams anchored or row pile retaining wall with rock anchors will be carried out, respectively. Also, the necessary vertical and horizontal drainage ditches will be implemented to reduce the ground runoff and infiltration so that a reducing driving force of landslide can be achieved. The layout of remediation is shown Figure 10. The results of remediation in before and after is given in Figure 11. The repair works are summarized as follows:

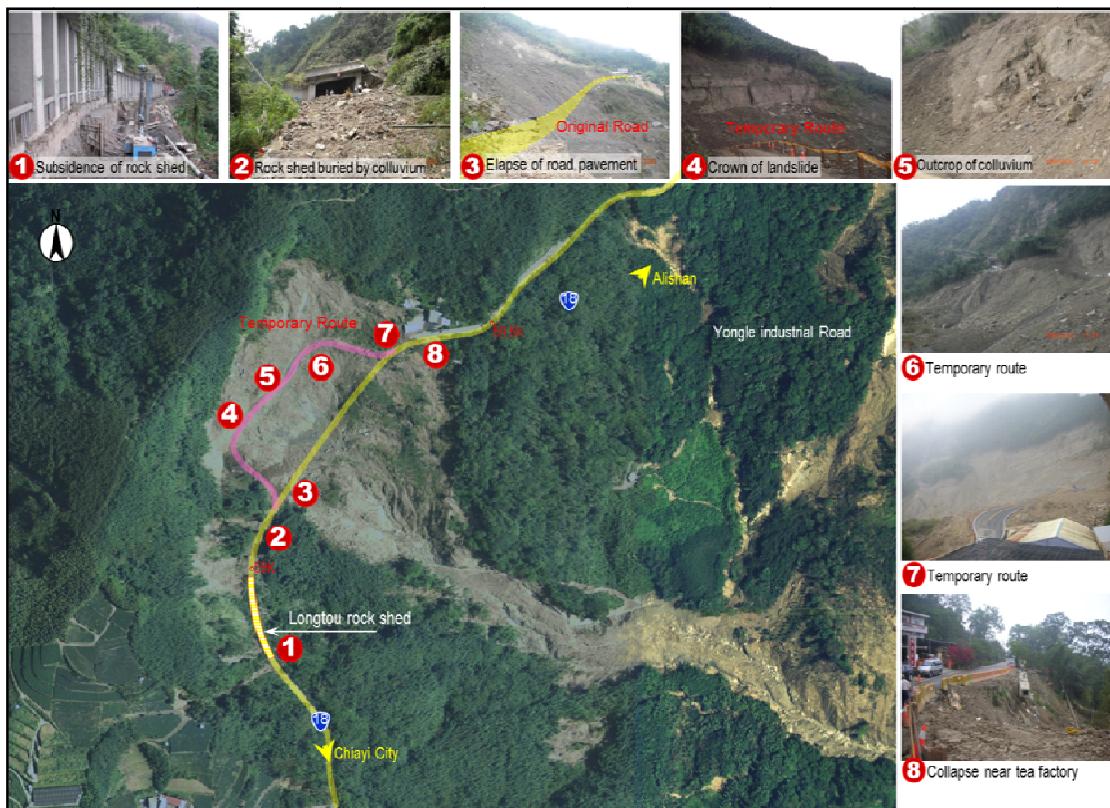
Figure 4 Slope slide disaster photos at mileage 59.1k

59.1k	<ul style="list-style-type: none"> Runoff erosion due to heavy rain No vertical and horizontal cut-off drainage facilities in slopes Formation steep, more broken joints in the upper shale slope, lots of rain infiltration in joints increase tension cracks. Rainwater infiltration in colluvium deposits at lower slopes soften soil strength and lead to slope failure 	<ul style="list-style-type: none"> Topping failure due to the crest rock with high angle joints, the slopes in vicinity of tunnel belong to dip slope plane slide. Other sections are classified as circular landslide

- A. The implementation of source remediation in the upper slide slope consists of removing dangerous wood, free-form vegetation for slope protection.
- B. Gabion retaining wall is set up in vicinity of toe of landslide in the lower slope.

- C. Colluvium deposits near the road belong to circular landslide so that a retaining wall with piles penetrated into bedrock has been installed to protect road embankment.
- D. The tunnel structure at slope failure section will be demolished and replaced with a new tunnel rested on pile foundation that smoothly connect with the existing tunnel.
- E. Retaining walls and rock anchor reinforcement are employed in the sidewall of the new replaced tunnel. The sidewall is also used for the construction access road.
- F. Collapses at upper and lower slope of the existing road are fixed with slope protection and necessary vertical and horizontal drainage ditches. Two submerged dikes are installed at downstream of vertical drainage ditches to reduce undercutting of slopes.

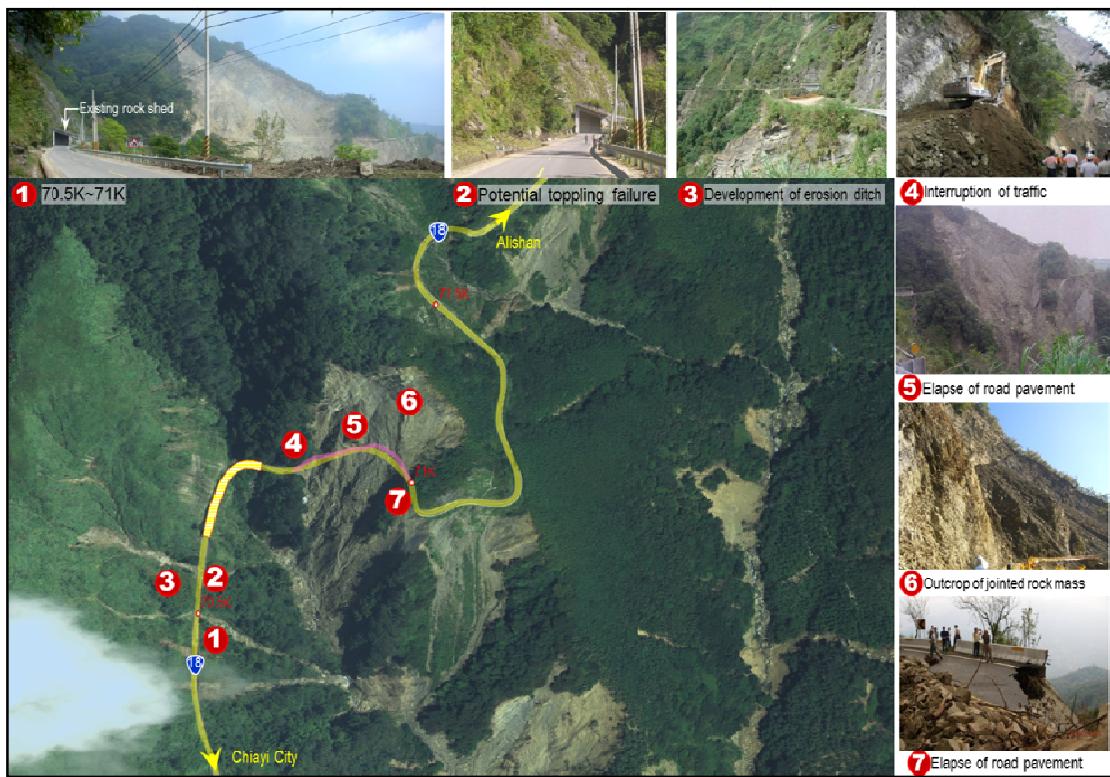
Figure 5 Slope slide disaster photos at mileage 71.1k

71.1k	<ul style="list-style-type: none"> Runoff erosion due to heavy rain After rock crushing and highly weathered, the rain infiltration in rock cracks increase water pressure and soften soil strength. This road section includes streams through, runoff flow wash out slope and rock rushed shift which results in steep terrain in some sections. In the upper slope of road, the heavy rainfalls leads to the broken rocks fall and accumulate on the roadbed. In the lower slope of road, the exposed toe of dip slope leads to landslide and the loss of roadbed. 	<ul style="list-style-type: none"> The upper slopes are classified as circular failure, the upper broken rocks fall and accumulate on the roadbed. The lower slope valleys are wash out by rains, the exposed toe of dip slope lead to landslide in the lower slope.

The upper slopes are classified as circular slide failure. The downslopes belong to dip slope plane failure. It is difficult to use road rehabilitation plan when the road slope is steep and the hinterland is not adequate in this road section. The rehabilitation adopts a new bridge to avoid the landslides area. The main slope stability treatments consist of lawn nursery, rock fall fence and rock anchor curtain wall. The upper slope of bridge abutment (A1) in the east side implements free-form vegetation for slope protection and rock fall fence protection; The upper slope of east bridge abutment (A2) carry out rock anchor curtain wall (dip slope stratum). The

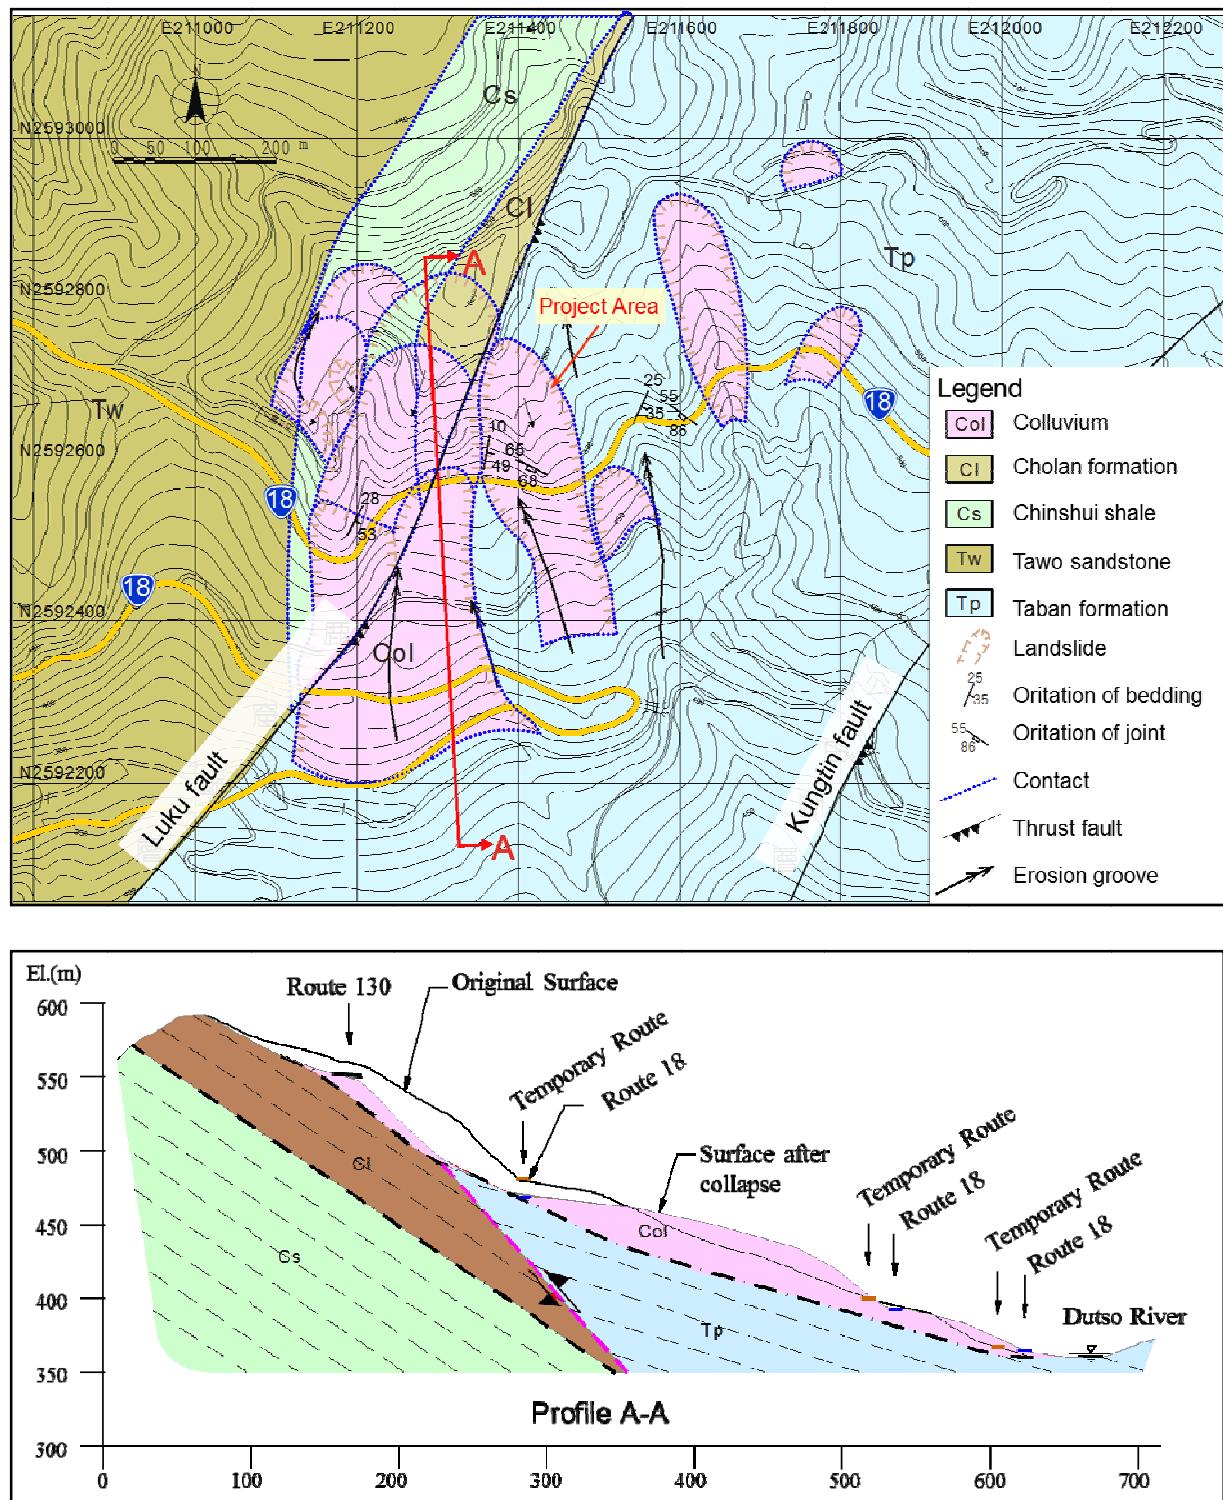
Based on Central Geological Survey (Liu 2000), Luku fault outcropped at mileage 37.5k ~ 40.1k disaster area. The strike of fault is approximately northeast and the dip is 70 degree to southeast. The fault is a reverse fault and the Taban formation above the fault is thrusting to the west to lie on top of Tawo sandstone, Chinshui shale, and Cholan formation. The results of surface geological survey shows that the shattered fault zone outcrops at the disaster area. The fault zone is composed of impermeable materials which is disadvantageous for slope stability.

Figure 6 Geological plan and profile at mileage 37.5k

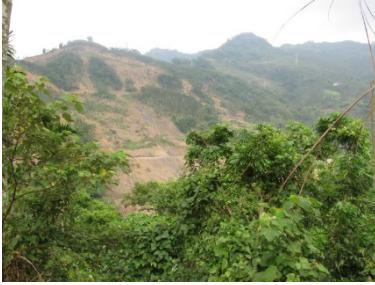
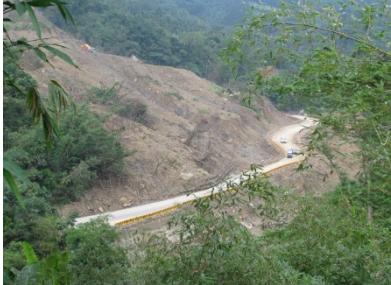
Dip slope landslide at upper slope and circular landslide at 37.5k.	circular landslide at lower slope and mixed type landslide at 37.5k.

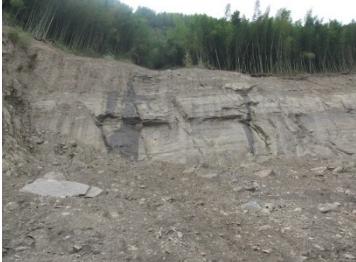
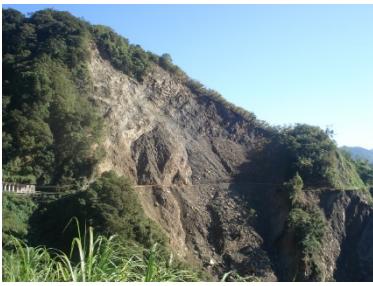
upper slope toppling failure at 59.1k	upper slope circular landslide, Dip slope landslide at lower slope at 71.1k

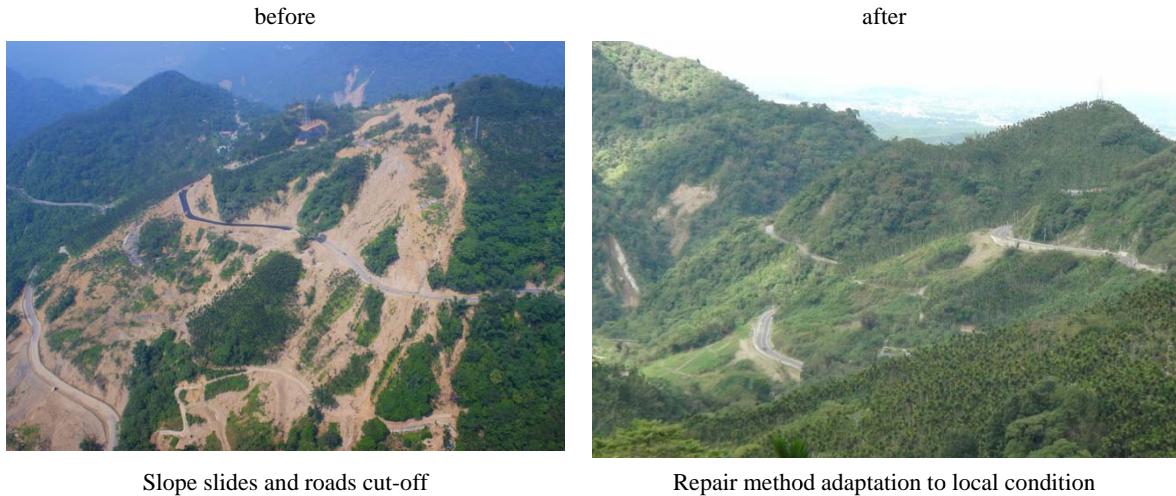
Figure 11 Before and after Photos at Mileage 37.5k of Alishan Route 18

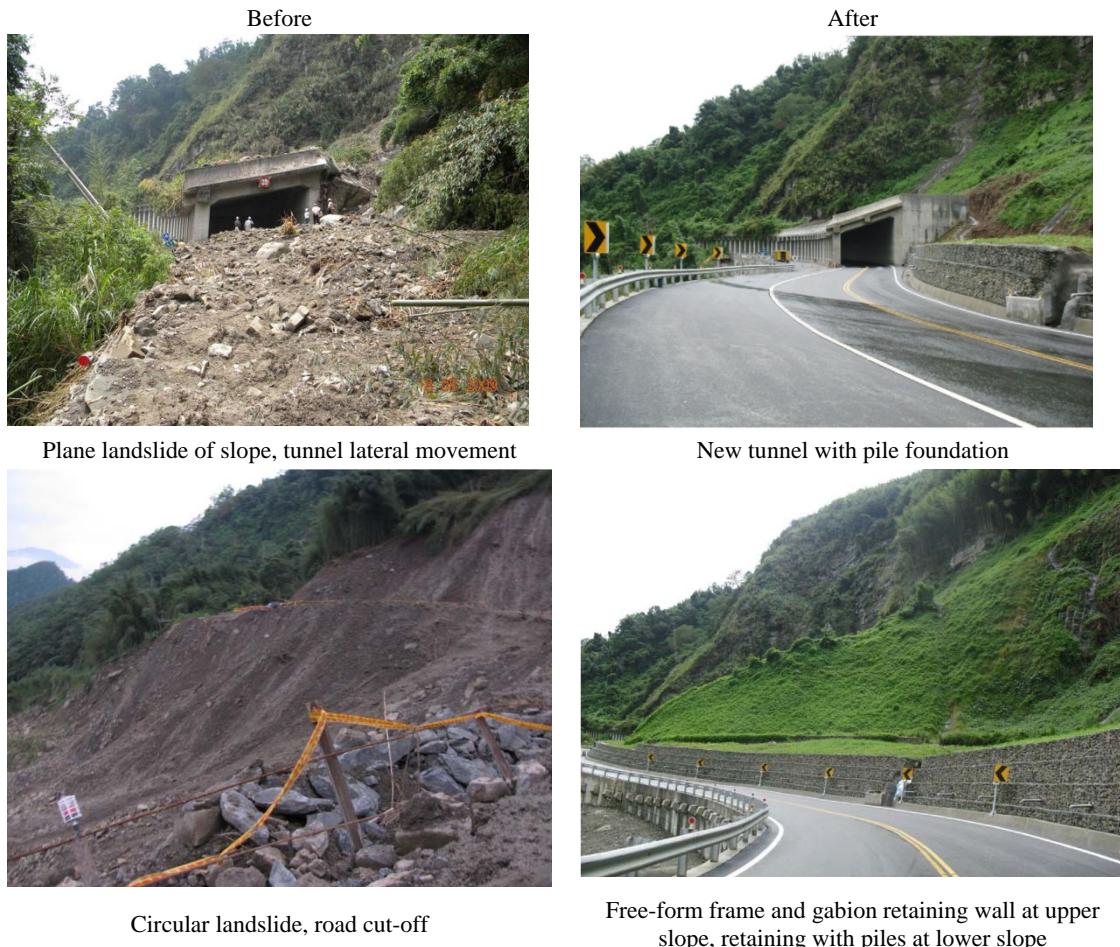
Figure 13 Before and after Photos at Mileage 59.1k of Alishan Route 18

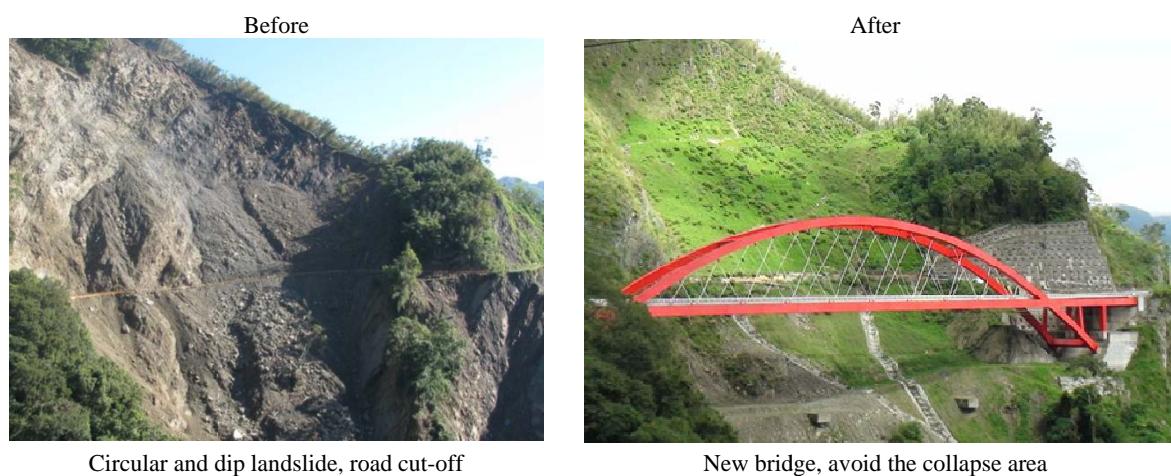
Figure 15 Before and after Photos at Mileage 71.1k of Alishan Route 18

In consideration of the site characteristics of collapse and the geological conditions, a bridge with steel structure is used in this project. The steel structure bridge can not only reduce the weight of the structure and also plan steel block size in accordance with the needs of transport and construction conditions. The steel structure is produced in the factory and its quality can be assured and have a rapid construction. The project employs a half-through steel arch bridge and gives a Tsou aboriginal name in accordance with the aboriginal culture and totem. Photos are shown in Figure 15.
