Advance in Geogrid Reinforced Slopes in Malaysia

T.A. Ooi¹ and C.H. Tee²

Keywords: Soft Ground; Geo-synthetics; Slope failure; Slope rehabilitation

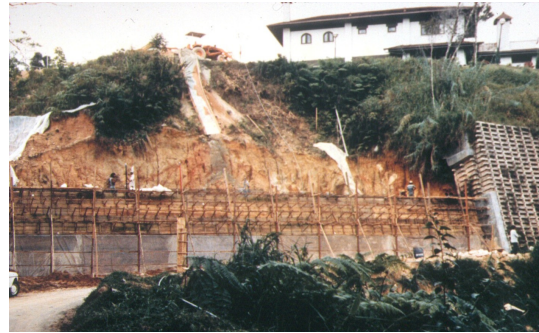
Figure 2a Petronas bungalow with failed slope in 1987

This work was carried out by the late Professor Chin Fung Kee in 1987 and reported by Chin *et al* (1989) at the first symposium on the application of geosynthetic and geofibre in Southeast Asia. Figure 2 shows the collapse of the cut slope and the subsequent rehabilitation. Pictures taken over the years were also included to show the conditions of the rehabilitated slope. The exposed SS1 biaxial geogrid is in perfect condition. The instrumentation and finite element analysis showed that the movements are within acceptable limits.

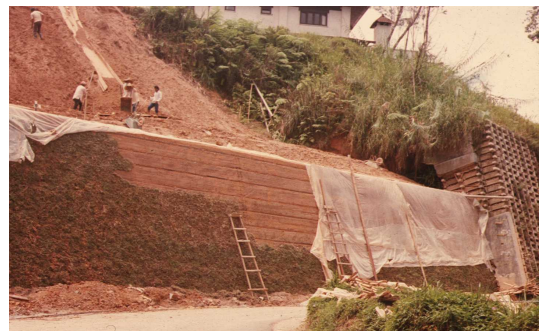
Figure 2c Slope rehabilitation in progress, 1987

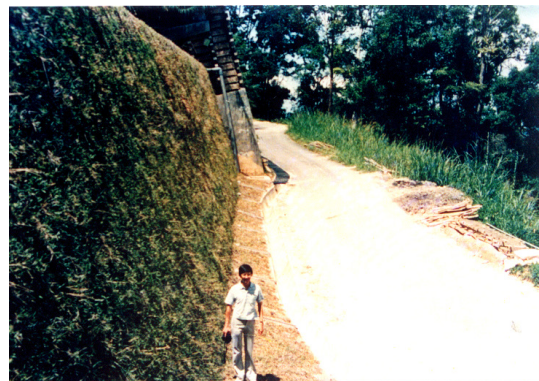
Figure 2e Petronas bungalow slope rehabilitation, 1987
K.Y. Yong shown in the picture visited the site

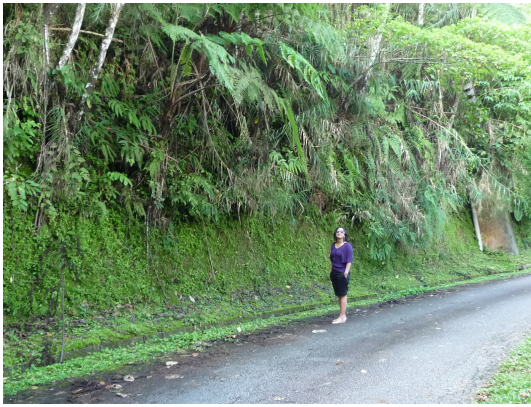
Figure 2h View of Petronas bungalow slope in 2010
by courtesy of Mike Dobie

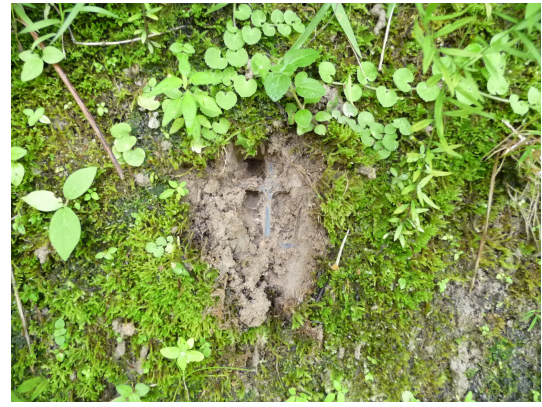
Figure 2i Petronas bungalow slope failure rehabilitation 2010
by courtesy of Mike Dobie

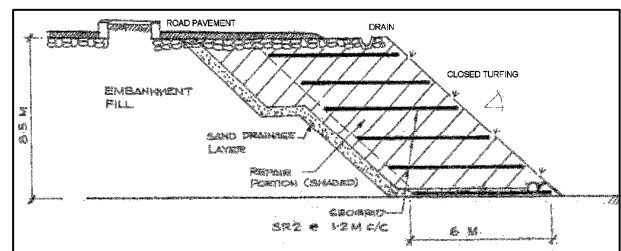
Figure 3a Schematic repair using geogrid, Temerloh Mentakab, 1985

In Malaysia, the use of geosynthetics for reinforcement of road embankment was introduced into JKR in early 1985 in the Temerloh – Mentakab bypass. In this instant, it was not possible to use stabilizing berm technique due to the limited width of the road reserve and the embankment had failed. In order not to encroach into private land, a 45° slope with 8.5m high embankment was reconstructed and reinforced with 6m length of SR2 uniaxial geogrid at 1.2m. The material used was residual soil of sandstone / shale compacted to wet of optimum moisture content at 90% degree of compaction using B. S. heavy compaction. An internal drainage system using sand drainage layer was provided at the back of the cut back slope and the base of the embankment with suitable drainage outfall as shown in Figure 3. This embankment has remained stable for 25 years.

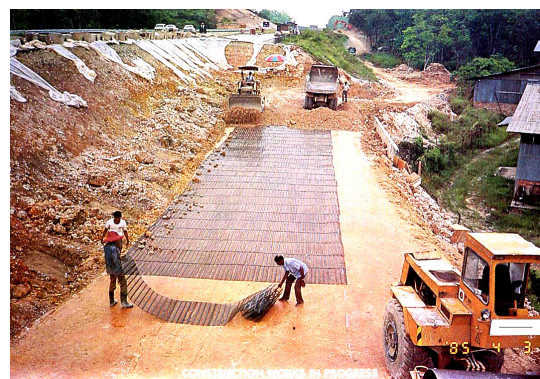
Figure 3b Rehabilitation in progress; laying of geogrid

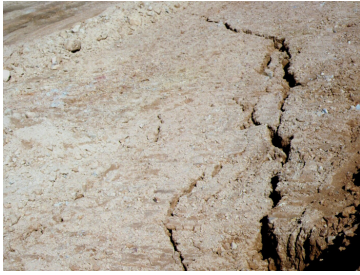
Figure 4a Crack in embankment

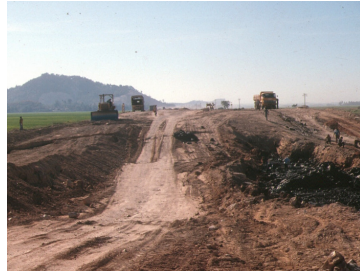
Figure 4b Excavation in embankment

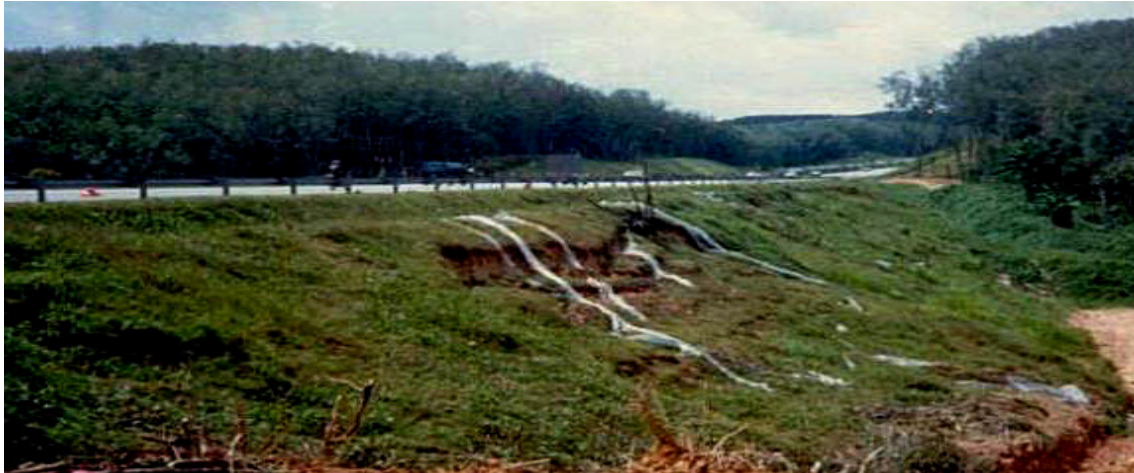
The Senawang – Air Keroh road embankment slope failure happened as a result of not cutting back the loose overfill on slope which has moved down the slope with passage of time. Figure 10a shows picture of the failure. Figure 10b & 10c show typical sections of the schemes for slope rehabilitation. The geogrid alternative was selected by the client in preference to the exhibited design using crib wall supported on precast reinforced concrete (RC) piles. The geogrid solution is more cost and time effective and blends in well with the existing green environment. This method of rehabilitation was often preferred by the client.

Figure 10a Picture of embankment failure, 1989.

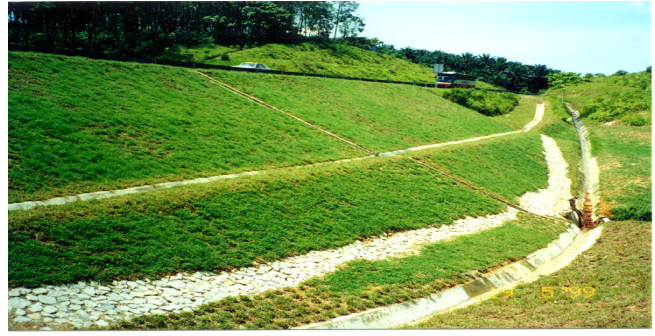
Figure 10e Picture of rehabilitated slope, 1989

The repair work was carried out in 1989 using uniaxial and biaxial geogrids. The depth of excavation of the failed slope was determined using the JKR probe, a light dynamic cone penetrometer. The rehabilitated embankment was about 12.5m high with a slope angle of 33° and reinforced with geogrids and compacted in layers using insitu residual soil. A berm was provided at mid height so that surface and subsoil water can be drained out and collected and led away from the slope. Internal drainage was provided using sand counterfort drain spaced at 3m

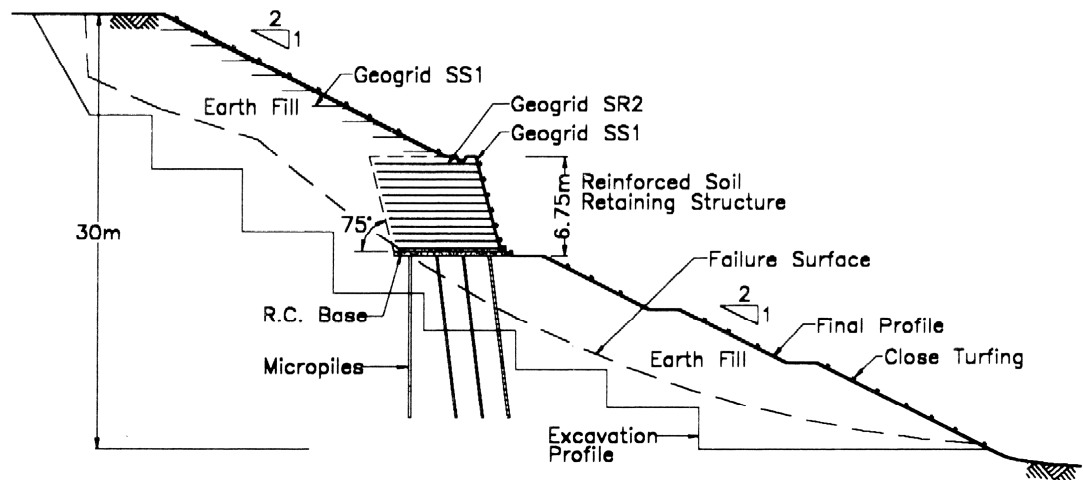
In Malaysia, very careful works has been done in pioneering the use of geosynthetics in very high slope as early as 1985 in a slope failure at Motel Desa, Kuala Terengganu. This is because for the first time geogrid is being designed for the rehabilitation of such a high slope. The total height of the slope failure was about 30m. A geosynthetics reinforced wall of about 7m high was constructed with full instrumentation at about 12m above the toe level of the slope to provide support for the unreinforced top 11m high section of the slope compacted at 25° slope angle. Figure 11 shows a schematic profile of the slope together with the micro pile supported platform and the geogrid reinforced wall at mid-slope. Toh *et al.* (1986) and Chan (1996) reported the details of construction and monitoring work. Subsequent to this work, numerous slopes have been repaired using the same basic

Figure 11 Motel Desa slope failure rehabilitation (after Toh *et al.*, 1986).

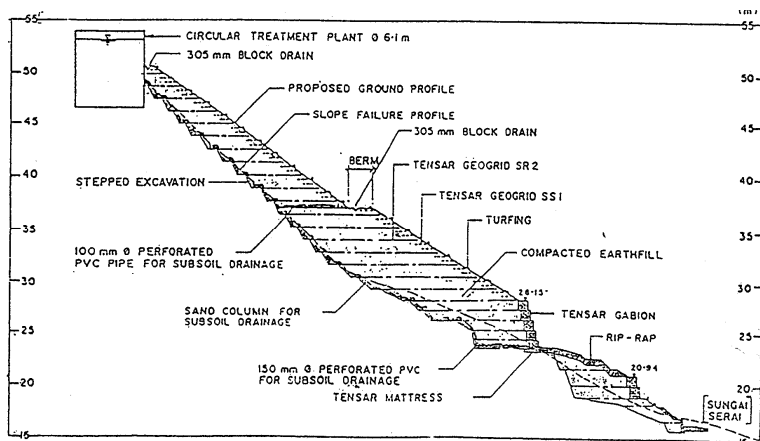
The Sungai Serai treatment plant landslide in Hulu Langat, Selangor is an important milestone for the repair of slope using geosynthetics. The landslide that occurred in January 1987 affected the 6m diameter R.C. circular tank structure located at the top of the failed slope of 33m high. Water from the scour pipe washed away part of the slope and left the tank perched precariously at the top of the slope. The slope has been stable for more than 50 years since completion. Ooi & Tee (2004) at the Malaysian Geotechnical Conference held in Kuala Lumpur in 2004 reported this rehabilitation work. Urgent action was required to immediately reinstate the slope and no insurance company was prepared to issue an insurance cover for the Contractor All Risk (CAR) policy for the work. Work started at the toe of the slope near the river with mattress and tail-in gabions together with rip rap for protection of the river bank for the first 8m height. Another 5m high of tail-in gabions were

Figure 12a Schematic rehabilitation (Figure are in metres)

constructed to provide support for 23m high SR2 uniaxial geogrid reinforced slope with a slope angle of 33°. The slope surface was reinforced with SS1 biaxial geogrid to facilitate turfing and to contain the compacted residual soil. A berm was provided at mid height of the upper slope in order take away the surface run off as well as the subsoil drainage water. Figure 12 shows the schematic view of the section of the slope rehabilitation and picture of work in progress when construction has reached a safe height. In-situ residual granite soil was used in 300mm layers and compacted with geogrid reinforcements to 90% B.S heavy compaction. Internal drainage of the reinforced slope was facilitated by using sand column and 150mm diameter PVC pipes. The completed surface was close turfed and trees planted. Monitoring of slope movement after completion was carried out. To date 23 years after rehabilitation, the slope remains stable. The slope rehabilitation was the first of its kind in putting sustainable development effort into practice by using insitu residual granite soil having angle of internal friction of 26 degree for the reconstruction of a failed slope to 33° slope angle.

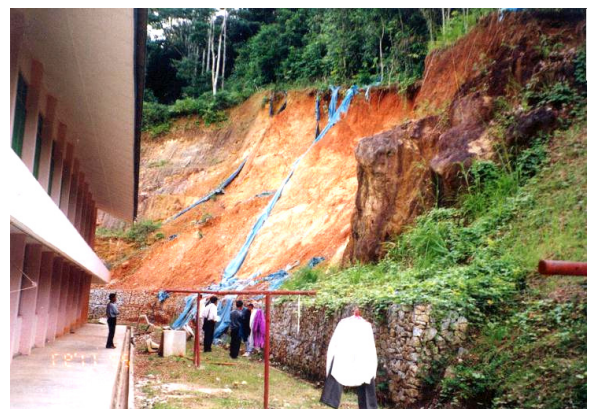
In 1997 landslide occurred behind a school hostel at Tun Saban secondary school in Pengkalan Hulu, Perak as a result of incessant rain in the monsoon season. The 17m high slope was stabilized first by using soil nails at 1.5m intervals as the failed slope was being excavated to profile for the geogrid reinforced slope. Soil nails were necessary to provide the required factor of safety of 1.2 for temporary stage during the construction of the slope. Two levels of 3.6m high geogrid reinforced vertical Modular Block wall were used. The method of construction enables rapid building up of the walls without temporary forms. Figure 14 shows picture of the slope failure, a schematic slope rehabilitation and picture of the completed repair work. The Modular Block wall also provided the support for the upper geogrid reinforced slope of 11.6m high with slope angle of 46°. It carries the perimeter fencing and drainage at the top of the slope. The reinforcement elements used were 160RE, 120RE, 80RE, 55RE, 40RE uniaxial geogrids and SS20 biaxial geogrid. The completed slope was close turfed. The soil nails, apart from giving the required safety factor for temporary stage, also prevented deep seated slope failure and increased the overall safety factor of the geogrid reinforced slope and that of the Modular Block wall. This type of combined technology in soil reinforcement was carried out for the first time. The combined technology was also used in the case of Motel Desa slope rehabilitation where micropiles were used to support the geogrid reinforced soil wall. During that time terminologies such as sustainability and combined technology were not used.

Figure 14a Slope failure above toe wall close to the school block

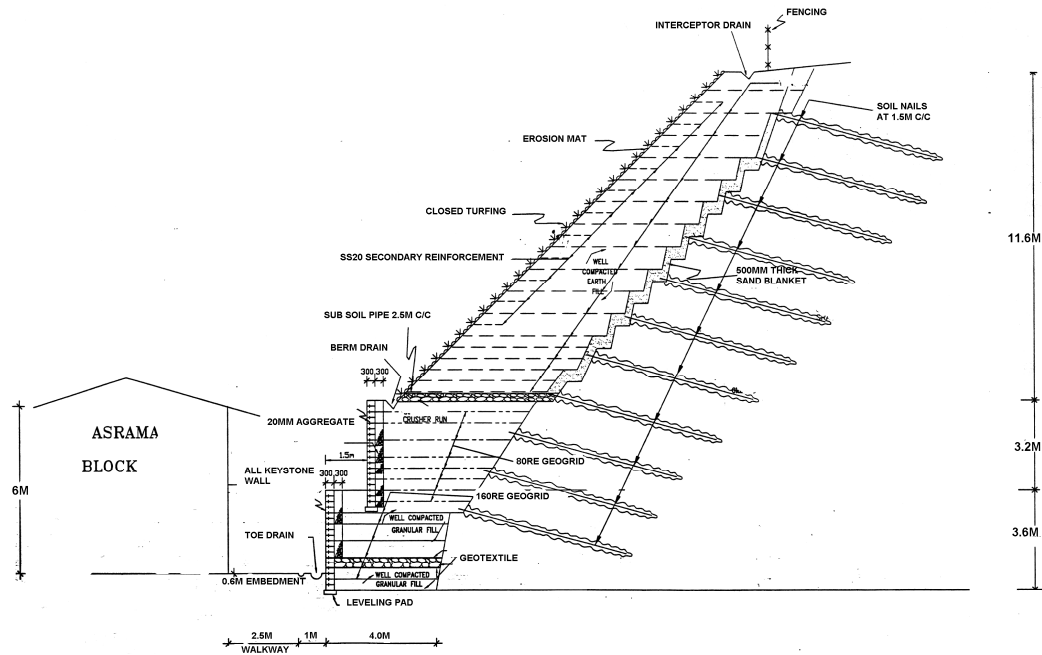
Figure 14b Schematic rehabilitation using combined technology of soil nails, modular block wall and geogrid reinforced slope.

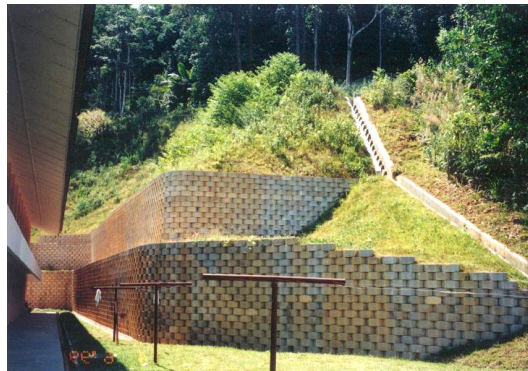
Figure 14c View of Rehabilitated Slope

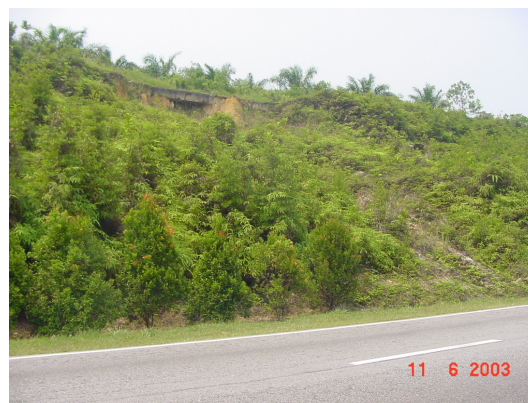
In the October - December 2002 monsoon, landslide occurred at Seksyen 536 along Federal Road FT01 at Tapah, Perak. The slide involved the bottom 17m of a 20m high slope cuttings in Kaolin formation. The client opted for a geosynthetic solution with turfed slope for the rehabilitation work. Rock toe was first constructed at the bottom of the slope with sandfill as the base with two layers of uniaxial geogrid reinforcement. Sandfill base serves as a internal drainage for the sand drainage columns of 1m x 0.5m spaced at 5m centres at the back of the re-profiled slope. On top of the sandfill, base layers of uniaxial geogrid were placed within the residual soil fill compacted in layers to the original slope profile of approximately 32°. Residual soil was used in the reinforced block to replace the existing Kaolin which has high moisture content and is susceptible to softening and landslide. Sandfill is also used extensively because of its low cost, better strength and well drained properties. Figure 15 shows picture of slope failure, a schematic slope rehabilitation, construction of sand layer with rock toe and the rehabilitated slope.

Figure 15a View of slope failure

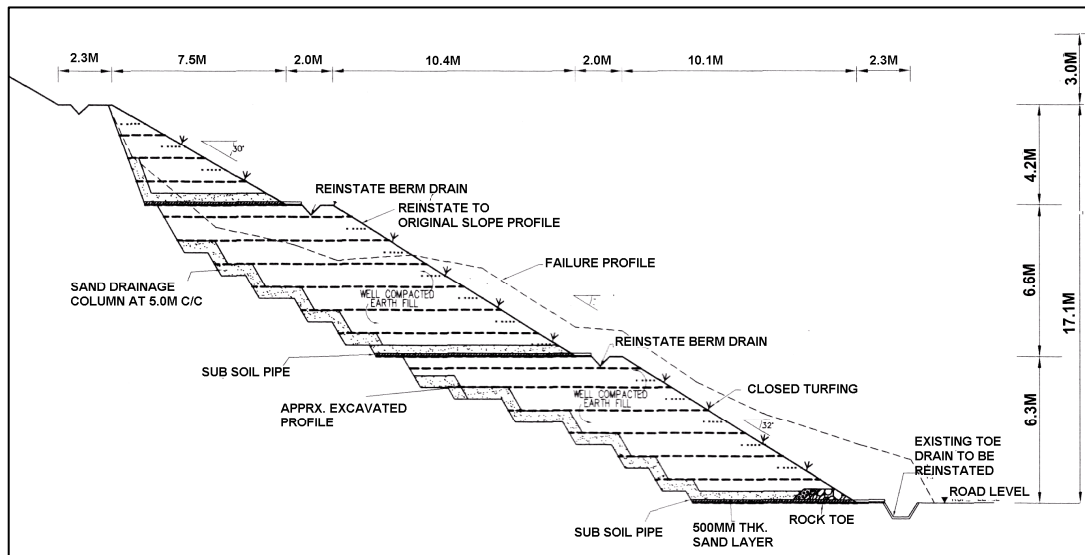
Figure 15b Schematic rehabilitation with emphasis on drainage

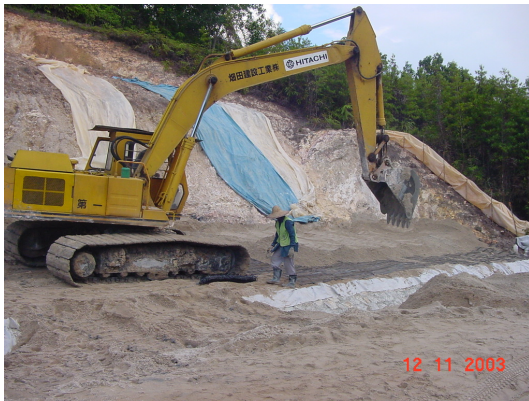
Figure 15c Rehabilitation in progress

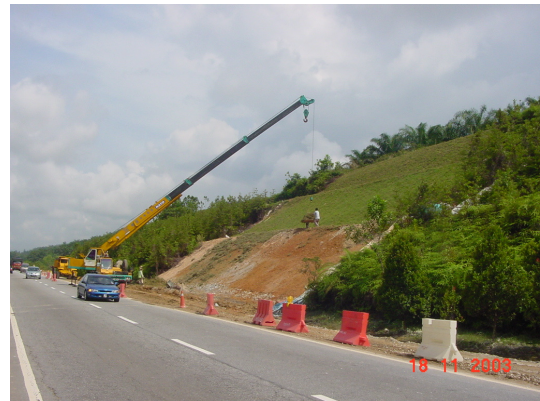
Figure 15d Rehabilitated slope

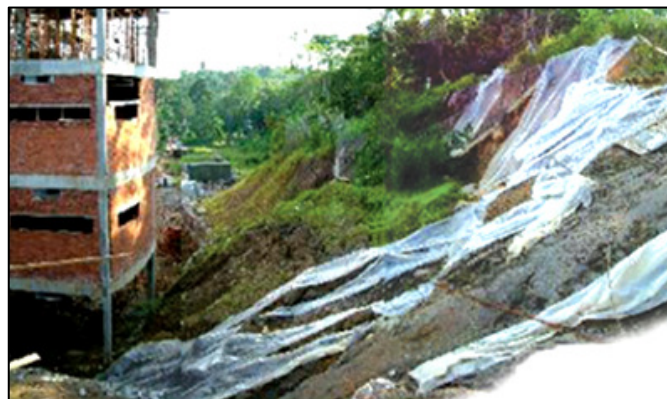
In late 2002, a landslide occurred at a slope behind the Lecture Block of a Sains Kolej in Kuching, Sarawak. An 11m high slope with existing 3m high gabion toe wall moved laterally towards the building columns and burying them. Fortunately, the movement did not cause the collapse of the lecture block columns. Figure 16 shows picture of the slope failure, the schematic slope rehabilitation and the rehabilitated slope. A 3m high basal block of geogrid reinforced Modular Block wall was

Figure 16a Slope failure affecting the lecture block

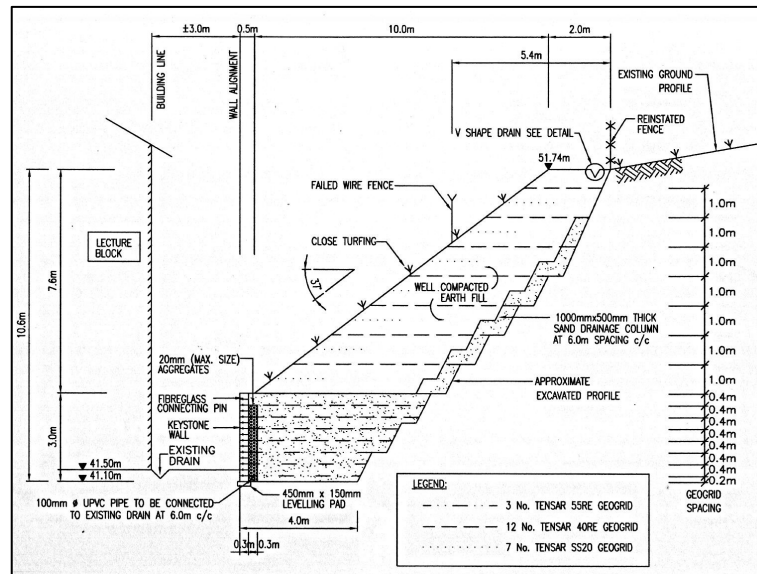
Figure 16b Schematic slope rehabilitation

constructed to replace the damaged gabion wall. From the figure it can be seen that internal drainage was provided by the sand columns spaced at 6m centres. The sand columns are connected to basal block of geogrid reinforced Modular Block wall with granular backfill and aggregate drainage layer at the back of the wall. 100mmØ UPVC drainage pipes are provided at 6m centres to lead the subsoil water to the existing drain. External drainage was also provided by cut-off drain at the top of the slope.

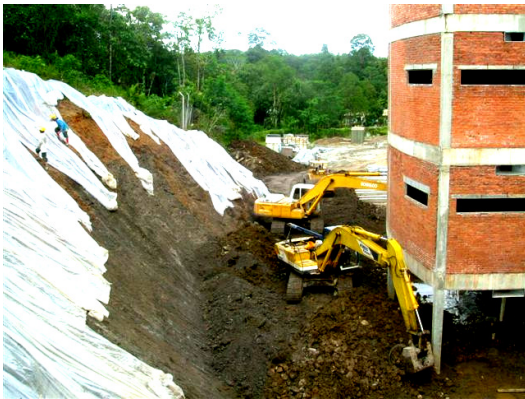
Figure 16c Removal of debris and cutting back of slope

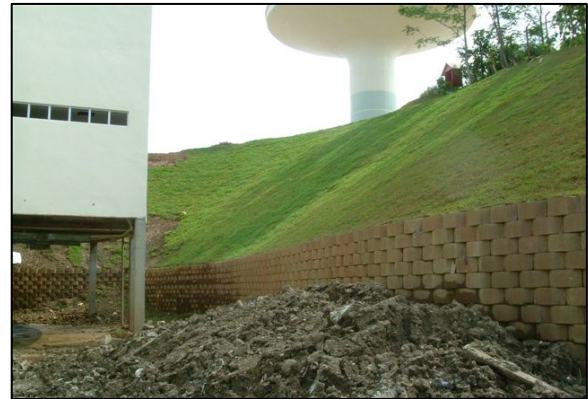
Figure 16d Rehabilitated slope

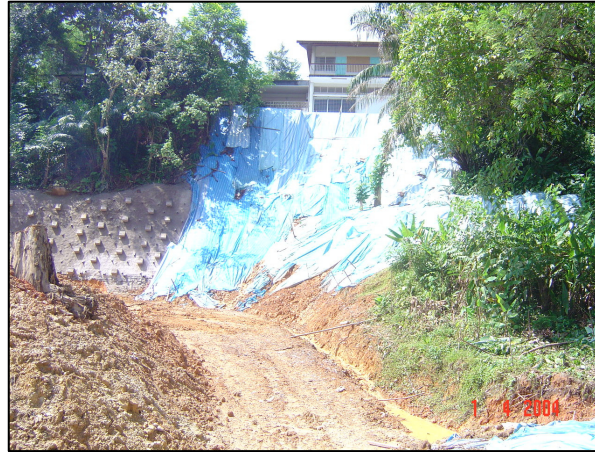
The Faculty of Economics of University Malaya in Kuala Lumpur was constructing an additional block of building in 2004 near a filled slope that was constructed some 40 years ago. The site was very restricted as can be seen from Figure 17. At the top of this slope was a double story university residence. In order to gain space for the construction of an additional block of buildings with car parking bays, it was necessary to cut the former filled slope to a steeper slope angle. Originally, soil nails were prescribed for stabilizing the cut slopes. As the soil nailing work was proceeding for other lower sections of the slope, the higher section of the cut slope collapsed leaving the building on top of the slope perching precariously. Figure 17 shows picture of the failed slope, the scheme for the rehabilitation of slope, stability analysis, construction of Modular Block wall and the rehabilitated slope. It was clear that the 17 m high cut slope collapsed due to inadequate provision or precaution taken by the soil nail contractor to ensure that the slope had an adequate factor of safety during the temporary stage. Had a proper and comprehensive method statement of work been closely followed by the contractor it would have been clear that soil nails should have been installed following closely the cutting down of the slope. The contractor should have soil nailed the slope immediately after cutting instead of doing the soil nailing after

Figure17a Collapse of cut slope during soil nailing

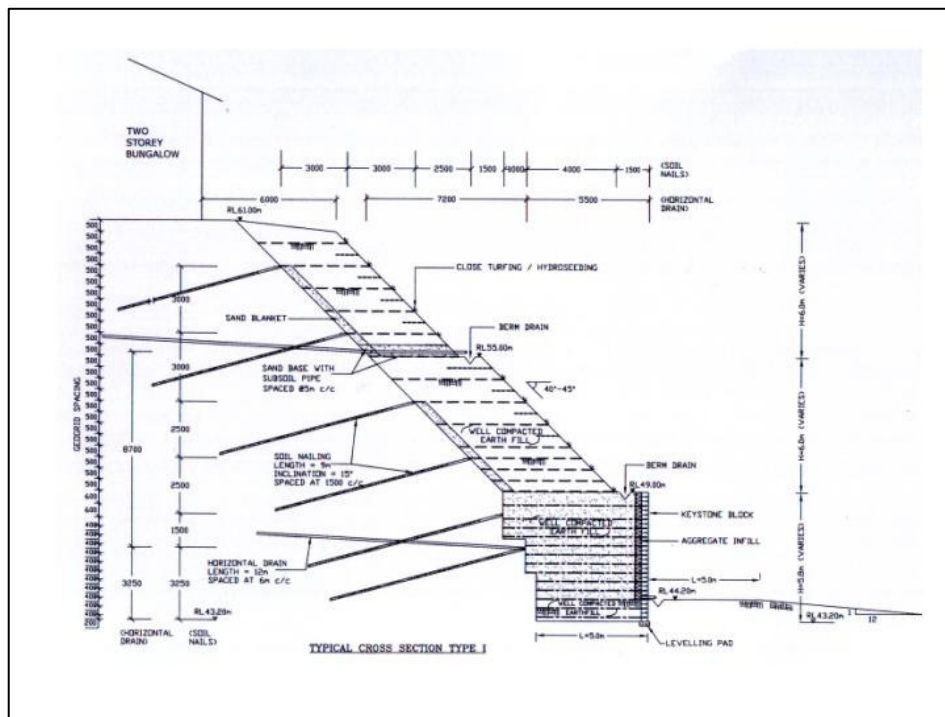
Figure17b Scheme of slope rehabilitation

completion of the entire excavation. The proposed scheme of rehabilitation as shown in Figure 17 considered both short term as well as long term stability of the cut slope. The high slope was located in a former fill over a valley where a stream existed. Despite the fact that filling was done over forty years ago, the material remained a loose tipped fill except for perhaps significant "collapse settlement" that had taken place within the soil fill during the repeated wetting and drying process. Continuous heavy rainfall that happened after the cutting of the former fill slope to a steeper angle was obviously the cause of the slope failure that had affected the perimeter drains and caused cracking of the concrete drain apron. The strategy for reconstruction of this slope is to soil nail the cut slope first to provide the short-term stability and then construct a 5.4 m high geogrid reinforced wall at the toe of the slope to provide for the long-term stability. This also provided a solid base to support the upper reinforced soil slope. The combined technology is employed here to solve a unique problem. Internal drainage system is provided to ensure that the ground water table level is controlled. This method of combined technology using soil nail, Modular Block wall and geogrid reinforcement has been widely used in slope rehabilitation of a number of restricted sites.

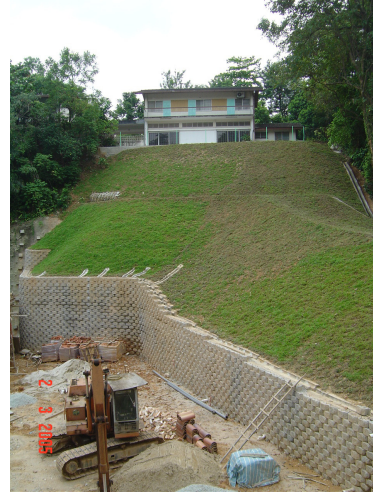
Figure 17e Picture of rehabilitated slope.

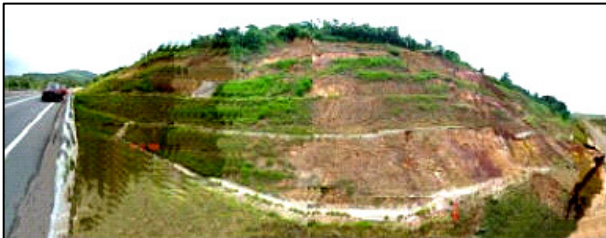
The Kuantan – Kerteh railway landslide at Chainage 19700 happened during the monsoon period of November – December 2005 soon after the project was completed and in operation. The cut slope of more than 40m high consists of residual soil of sandstone/shale formation. Poor drainage caused serious soil erosion and slope toe softening. The slope failure involved a slope height of 37m. Sheet piles were driven in an attempt to prevent the slope toe from encroaching into the ballast of the

Figure 18a Overview of cut slope failure

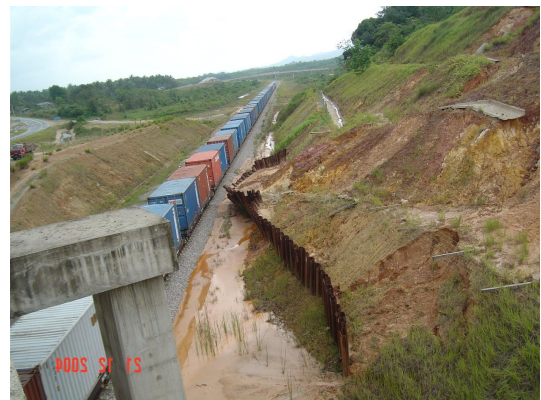
railway lines. The sheet piles tilted badly shortly after installation and threatened to endanger the safe operation of the railway lines. The slope toe including the railway lines were all waterlogged. The detail of this slope repair was reported by Ooi *et al* (2007). Figure 18 shows the picture of the slope movement and the railway lines, the schematic rehabilitation, the construction of the geogrid block and the rehabilitated slope.

Figure 18b Collapse of slope and sheet pile movement

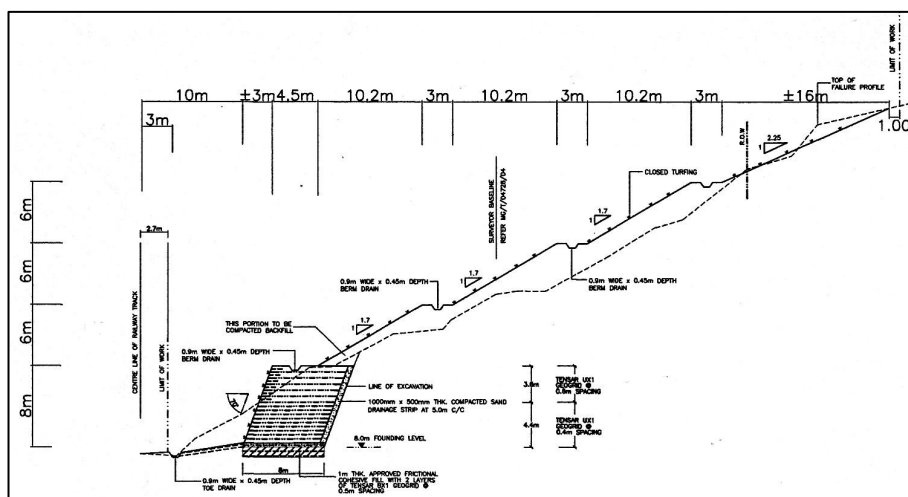
Figure 18c Schematic rehabilitation with setback of slope using reinforced geogrid block

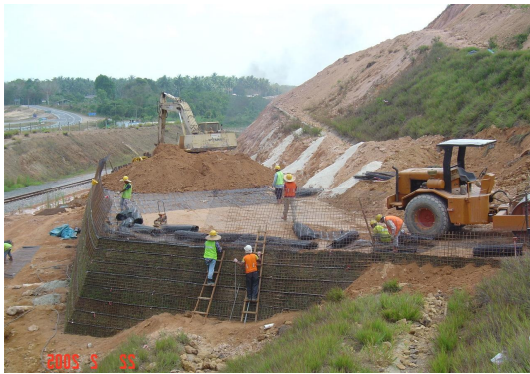
Figure 18d Construction of geogrid block on stabilized base

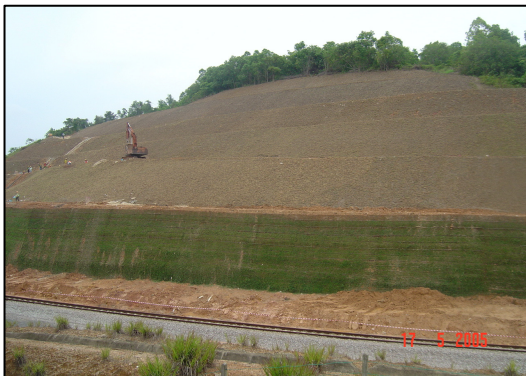
Figure 18f View of rehabilitated slope

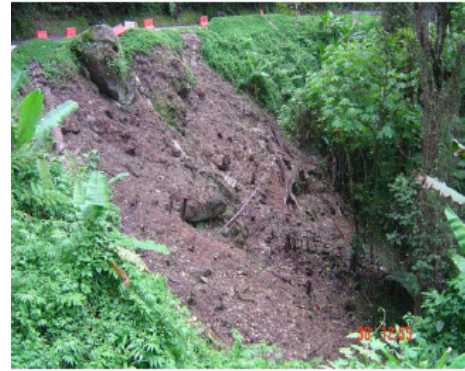
In 2007 a slip occurred at the road embankment of the Tapah-Ringlet road in Batang Padang in the Perak state of Malaysia. The slip affected the traffic flow between Tapah and Cameron Highland. The slip also affected a culvert and the cascading drain of the road. It was observed that the slip was caused by surface water flowing over the embankment during exceptional monsoon rainstorm. Figure 19 shows picture of the collapsed embankment, the schematic rehabilitation, the construction in progress and picture of the rehabilitated slope. It can be seen that for vertical face wall the galvanized, PVC coated rock-filled gabion was used with geogrid as reinforcement and tailed in of gabions to prevent any tilting of the gabions. For slope with 70 degree, steel mesh was used as permanent formwork and 0.5m thick rock-filled faced, wrapped around and reinforced with geogrid. In the case of 45 degree slope closed turfing (full-grown cow-grass cut-out with top soil in size of 300mmX300mm and secured with timber pegs) was adopted. It is important to water and maintain the new turfing for initial period of few weeks until it is capable of being self-sustained. It is normally good practice to provide wide road shoulder to ease traffic flow and to allow easier negotiation of

Figure 19a Collapse of embankment

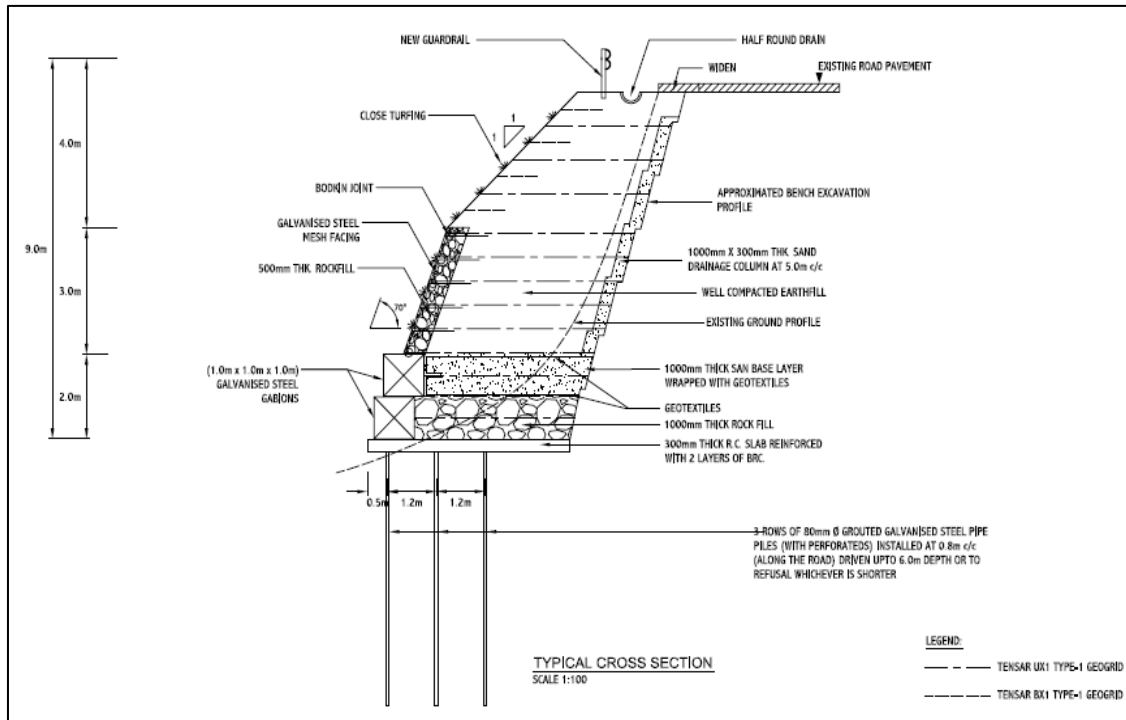
Figure 19b Schematic rehabilitation of embankment failure

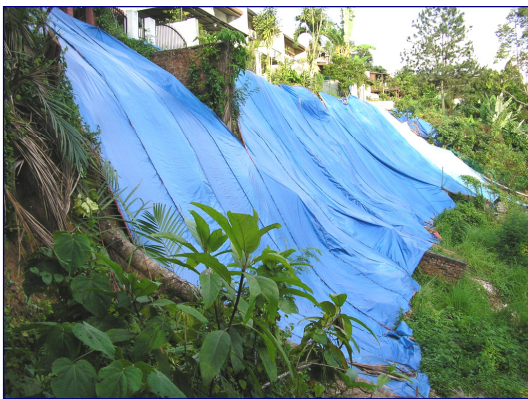
An old filled slope of an existing housing scheme has been a constant source of worries and nightmares to the row of terrace houses on top of the Taman Zooview slope with a commanding view of Kuala Lumpur city centre. The site was a former valley filled by the Taman Zooview developer. Figure 20 shows the condition of the site two years before the landslide, the construction of the anchored reinforced soil wall, the rainfall histogram, the landslide, the rehabilitation and the completed geogrid reinforced soil slope. Figure 20a shows picture of the Zooview slope in 2004 all covered with plastic sheets. Behind the plastic sheets all is not well. An anchored reinforced soil wall was constructed in 2006 as shown in Figure 20b. The year 2006 has been particularly wetter than previous years. Figure 20c shows the histogram of the rainfall 2005 and mean.

Figure 20a Condition of Zooview slope in 2004

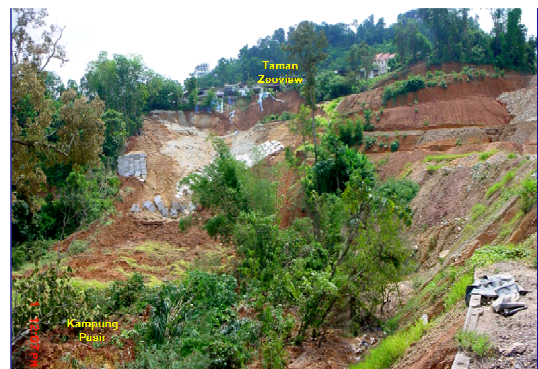
Figure 20d shows the collapse of the anchored reinforced soil wall 10 days after completion during the May 2006 monsoon season. Figure 20e shows a distant view of the landslide area covered in plastic sheets. Figure 20f shows the condition of the slope behind the plastic sheets. Figure 20g shows the schematic of rehabilitation of failed slope. Figure 20h and 20i show the respective picture of lower rock fill and upper geogrid embankment. Figure 20j and 20k shows the earthworks at formation level of the backyard. Figure 20l shows the spacious back garden. Figure 20m shows the devastated condition of the back yard before rehabilitation. Figure 20n shows the rehabilitated slope on completion. Figure 20p shows the rehabilitated slope with turf established.

Figure 20d Collapse of anchored soil wall 31st May 2006

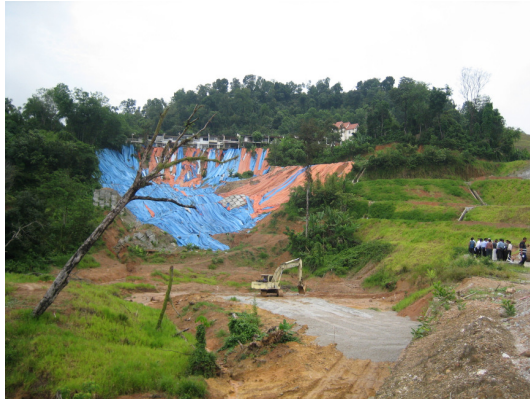
Figure 20e A distant view of the Zooview landslide with plastic sheet cover

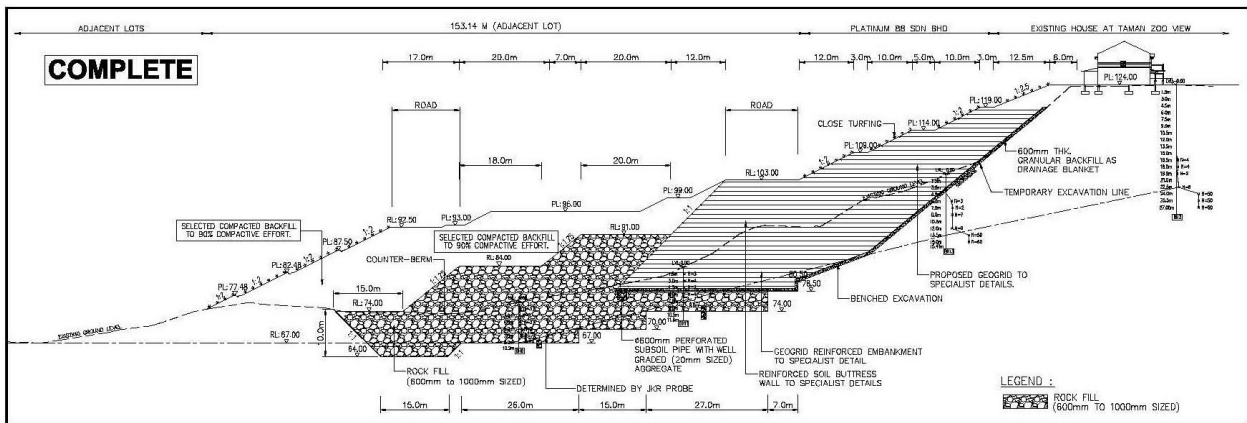
Figure 20g Schematic rehabilitation of slope failure

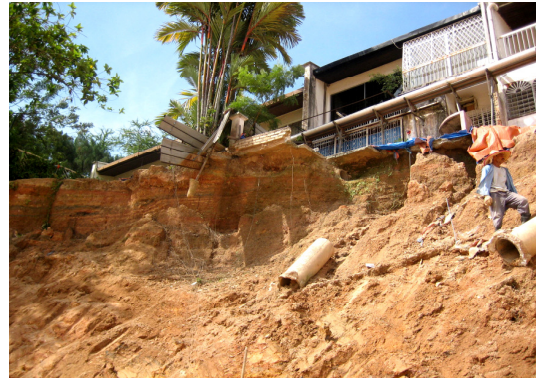
Figure 20m Condition of backyard before rehabilitation

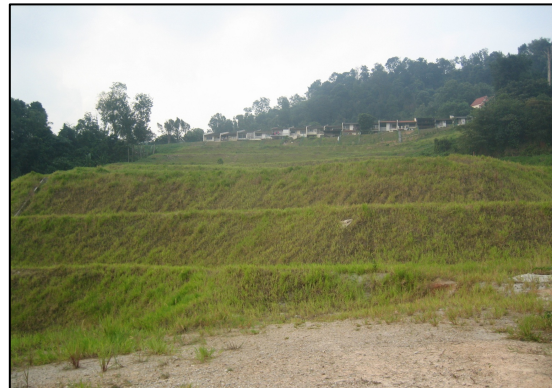
Figure 20p Rehabilitated slope with turf established

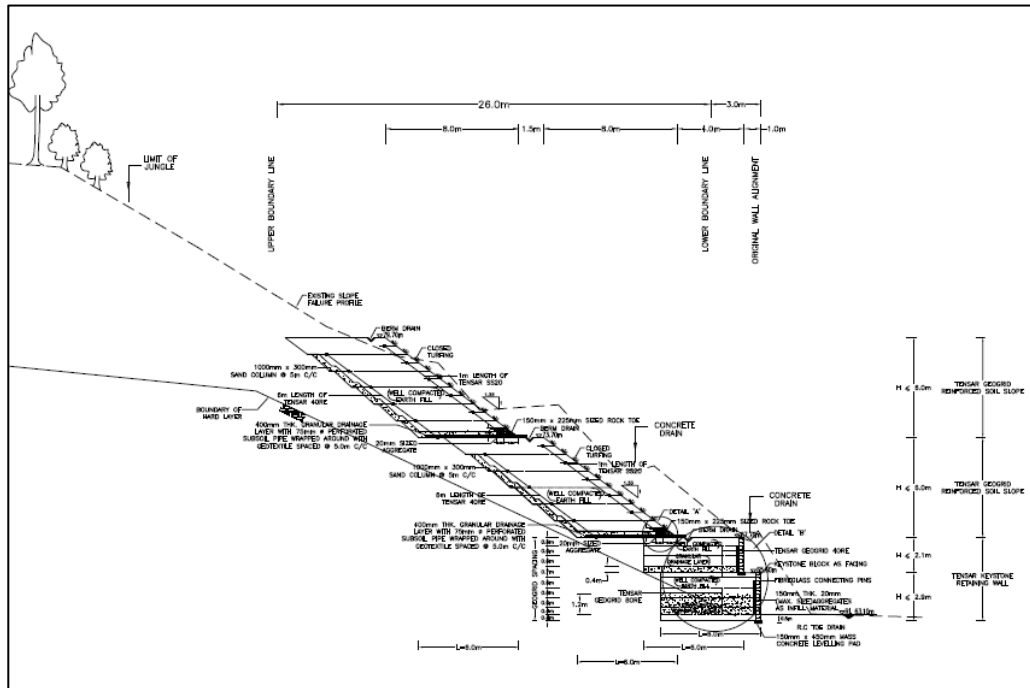
Figure 21f Geogrid solution for rehabilitation of failed slope.

In September 2007 another tender was called to rehabilitate the failed slope as a Design and Build project. Geogrid solution was selected based on the schematic rehabilitation proposal as shown in Figure 21f. This proposal has a minimum factor of safety of 1.55 as shown in the slope stability analysis in Figure 21g. It was the most competitive tender accepted by the client.

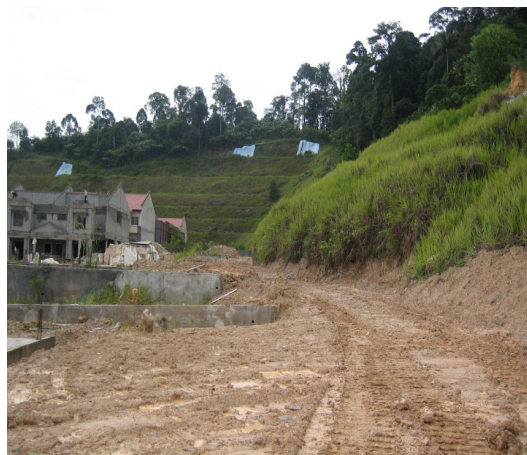
Figure 21h shows the commencement of rehabilitation works in November 2007. It can be seen that the landslide has encroached into the housing development site. Figure 21i shows the construction of slope drainage and Modular Block wall in progress. The rehabilitation work was completed with turfing in July 2008. The exposed fissures of the boulders were patched with cement mortars and formed part of the landscape features of the upper turfed slope. Figure 21j shows the view of completed slope rehabilitation with Modular Block wall and construction of houses in September 2008. Figure 21k shows the picture of the completed slope rehabilitation, Modular Block wall and houses in April 2009. The construction of houses were completed in October 2008. Modular Block wall, geogrid reinforced slopes complete with drainage and turfing were completed in December 2008. By April/June 2009 all houses were constructed, sold and occupied. This is a project where the purchasers are comfortable with the idea of living near a slope. Throughout the design and construction of slope rehabilitation, public safety and drainage were both amongst the top most priority of the client.

Figure 21h Picture shows clearing for access to site.

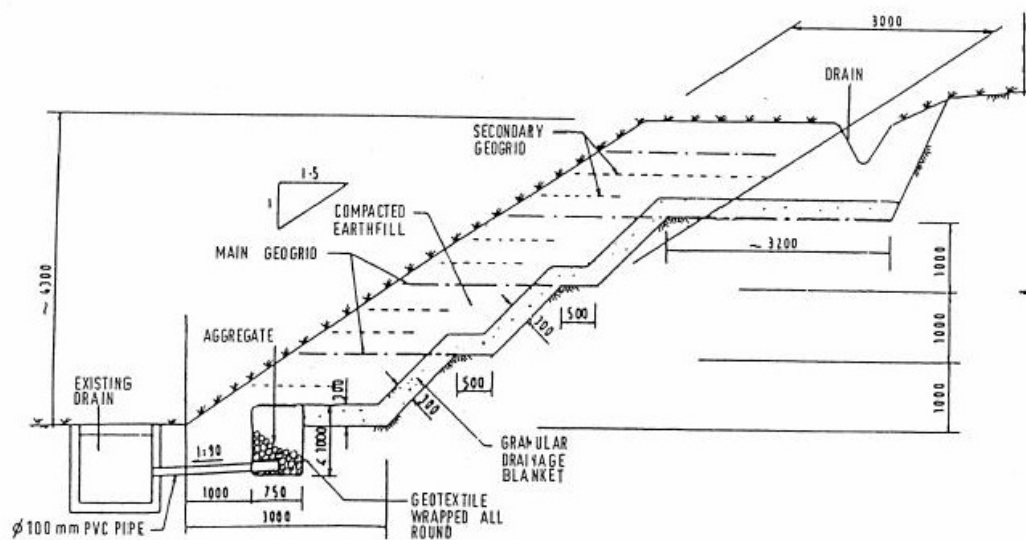
In December 1993, earth slips formed on the hill slopes located at the Telok Blangah Hill Park along Depot Road (Tang *et al*, 2000). The height of the failed slope was about 40 metres, and the width of the affected portion was about 20 metres. The slope is geologically located in the Jurong Formation, which consists of sedimentary rocks such as sandstone, siltstone and shale. The failure surfaces were found to be shallow, at about 1.5 to 2 metres below the ground surface. The stabilization works involved soil reinforcement and slope regrading. The upper half

Figure 22 Slope stabilization using geogrids in Singapore (after Tan S. B., 1997, Yong *et al* 2007)

of the failed slope was reinforced with geogrids made of high strength polymer (high density polyethylene). The bottom half portion of the failed slope was regraded to a gradient which is gentler than 1:2. The geogrids were laid horizontally in continuous strips which had been cut to the design lengths of about 7.5 to 10 metres. The geogrid reinforced soil layers were 800mm thick. As there was a possibility that the slope surface might bulge due to the lateral pressures from the confined backfilled soils, additional 2 layers of 1 metre length secondary geogrids, which act as intermediate reinforcement layers, were laid in between every geogrid reinforced soil layers. Mattings for erosion control were installed at the geogrid reinforced slope. The purpose of the mattings were to facilitate the growth of grasses on the slope surface, as the slope angle of 35° was rather steep. Close turfing and top soil were placed on the stabilized slope surface to prevent erosion and to create a natural and aesthetic appearance.
