## DAMAGE OF PUNCH/DIE TOOLS IN STEEL WIRE ROD SHEAR CUTTING

*In this research work, damage of punch/die tools in a steel wire rod shear cutting was investigated. The tools (punch and die) used in a steel wire rod (JIS SCM420) cutting ranging from 50,000 to 150,000 cutting shots were collected for the investigation. Experimental results showed that the main damage of the tools at the sheared zone was tool edge chipping. The edge of the die was chipped severely when passing 150,000 cutting shots. To investigate the cutting characteristics of the wire rod by the damaged tools, the tools were applied for a shear cutting test using a developed shear cutting tool holder. It was found that the damage of the tools did not remarkably affect the cutting load resistance of the wire rod. However, when cutting the wire rod with the higher-cutting-shot tools, the quality of the sheared edge deteriorated. Namely, the sizes of the rollover and the burr at the sheared edges of the wire rod tended to increase.*

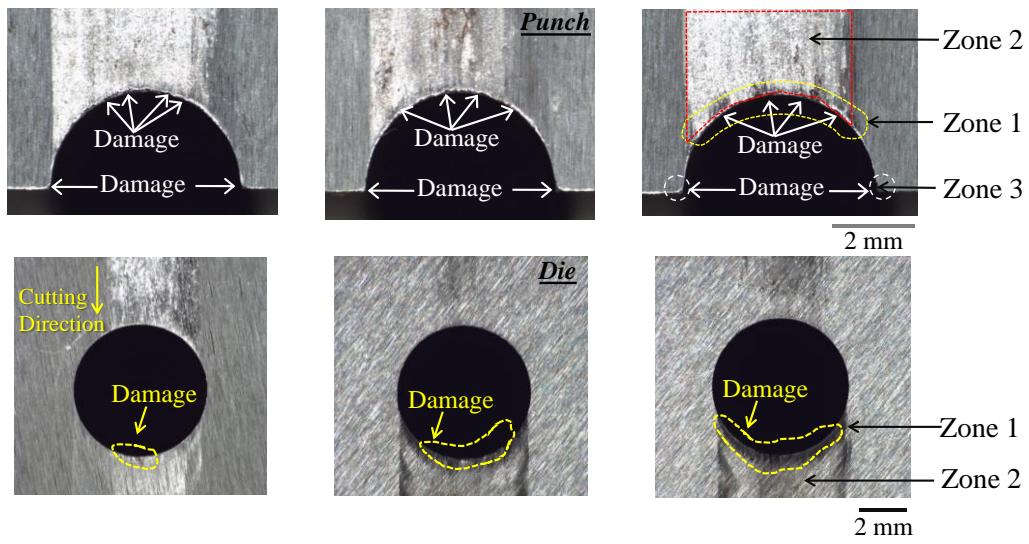
**Fig. 3.** Front-view photographs of the used punches and dies.

Figure 3 shows the macroscopic photographs of the used punch/die tools. As seen in this figure, three damaged areas were observed on the punches. First, at Zone 1, the damage occurred at the cutting edge of the punches. Since this area was acted directly by the load of shear cutting, the damage could be confirmed to be caused by the shear cutting stress. Then, at Zone 2, scratches appeared on the front surfaces of the punched. This seemed to be resulted by the abrasion between the cut wire rod remained in the die and the surface of the punch. Third, the damage was seen in the edge of the punch (Zone 3). At this zone, an apparent metal loss was detected. Considering the damage of this far area from the sheared zone of the punch, it was not caused by the shear cutting stress. However, vibration of the high-speed moving wire rod during shearing possibly resulted in this damage.

At the dies, as seen in Fig. 3, the damage due to the shear cutting stress was detected, at Zone 1. Also, viewing the front surfaces of the dies, the scratches appeared. Based on the overview photographs, when the cutting shots of the tools increased from 50,000 to 150,000, the severity of damage, the tool surface scratch, the metal loss at the punch edges and the damage at the sheared zone, tended to increase.

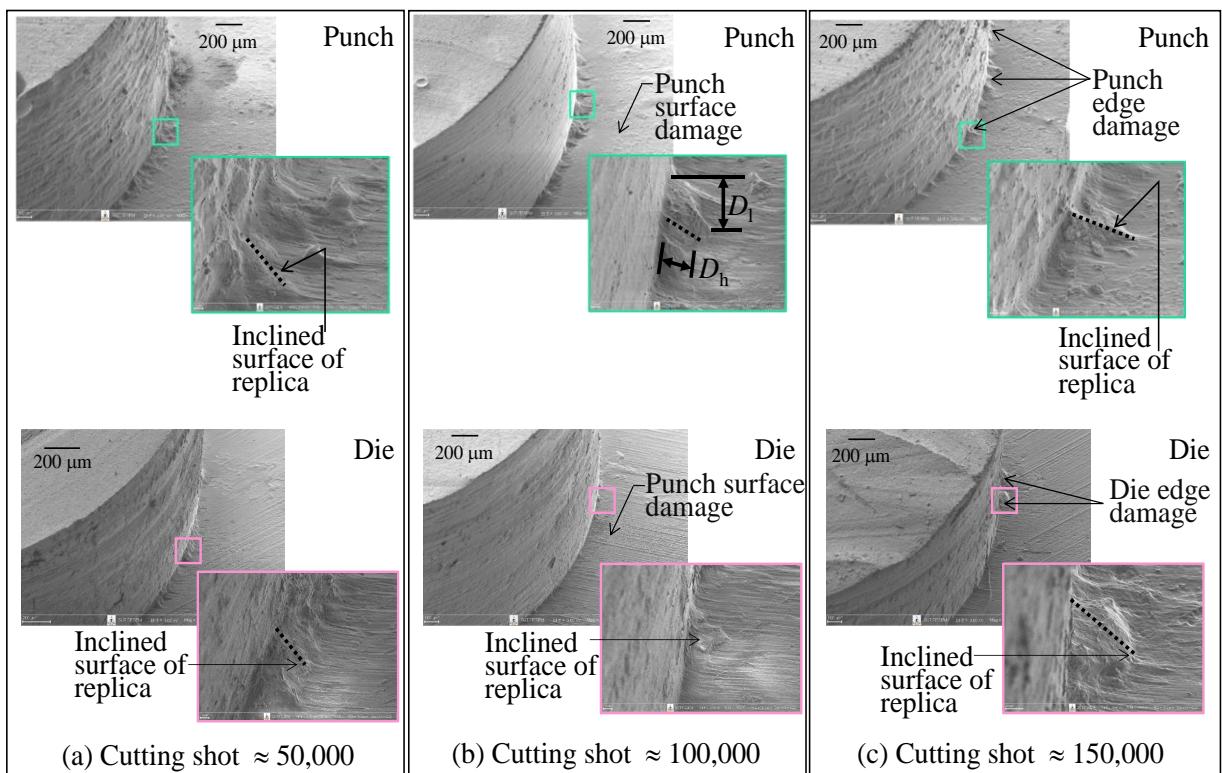
**Fig. 4.** SEM images of replica samples showing damage of punches and dies.

In this work, the authors focused on the examination of the tool damage caused by the shear cutting stress. Since the damage at the sheared zone of the tools occurred at the tool surfaces and splayed inside the tool holes, Two-dimensional micrographs was not usable to clearly see the damage of the tools. So, the authors did the investigation using the replica technique. Figure 4 represents the scanning electron micrographs of the replica samples at the sheared zone. From this figure, it was seen that the damage of the punch and the die due to the shear cutting stress had features of inclined surfaces. Also, this result indicated that the main damage of the cutting tools was edge chipping.

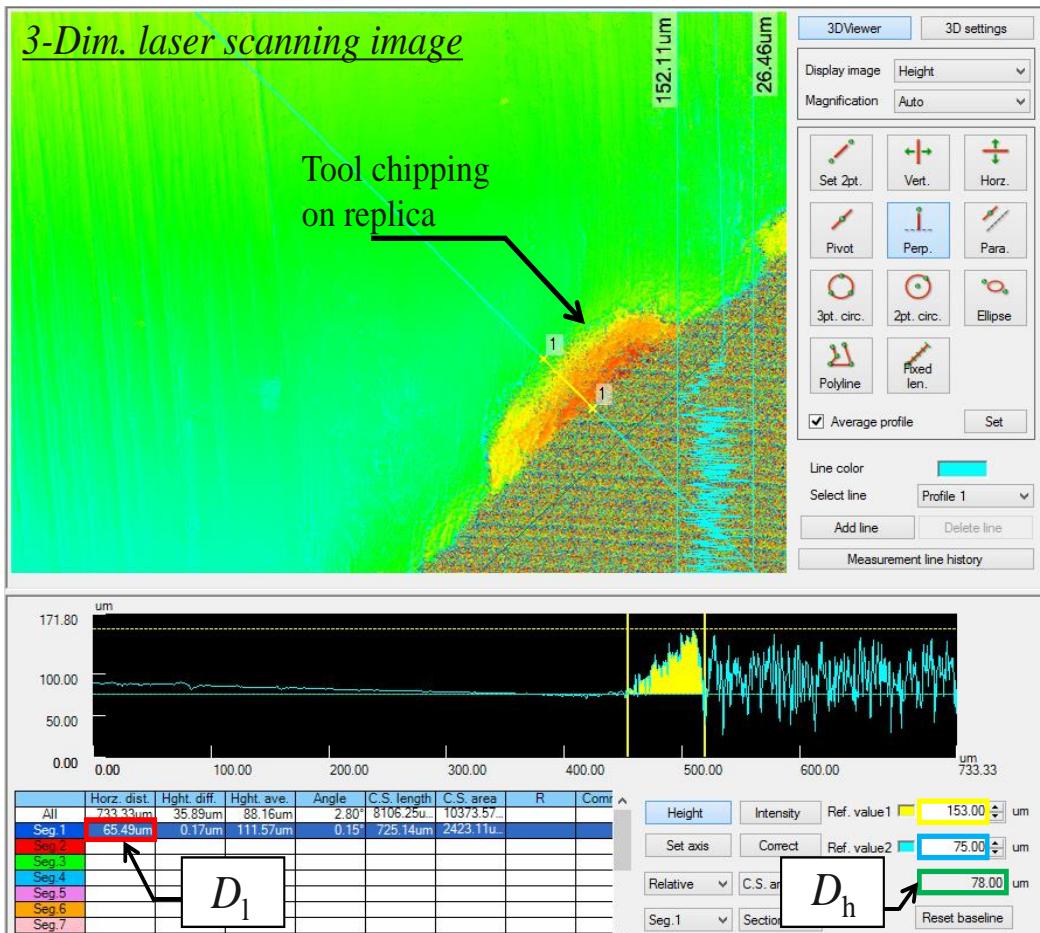
**Fig. 5.** Measurement of damage distances on replica using 3-Dim laser scanning microscope.

To further investigate the progression of the chipping with respect to the tool cutting shots, the replica samples were subjected to a 3-dimensional laser scanning microscope (Keyence, VK-8710). After scanning, the length ( $D_1$ ) and the height ( $D_h$ ) of the chipping (expressed at the chipping zone in Fig. 4) were measured. Figure 5 shows the measurement of the chipping distances by the microscope.

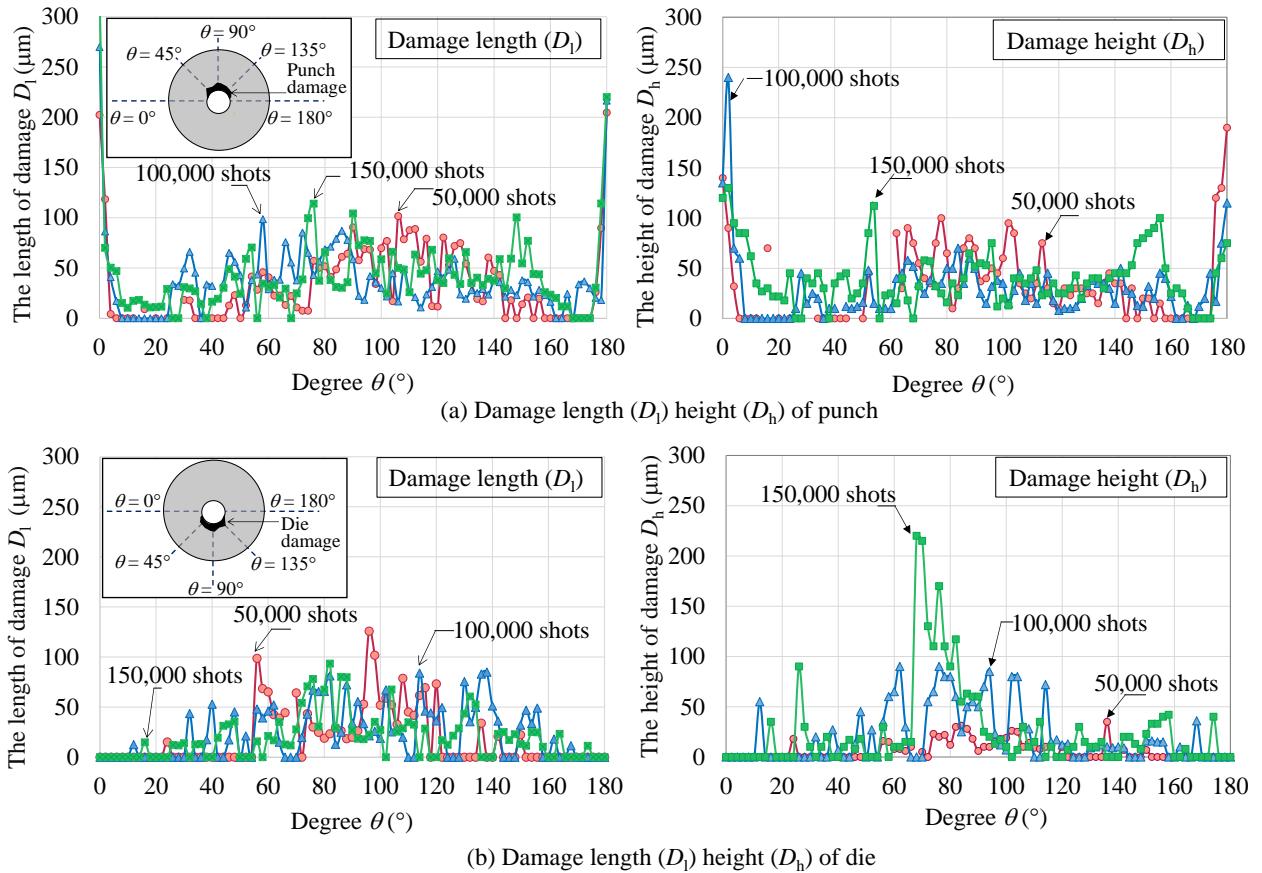
**Fig. 6.** Measured damage length and height at punch and die edges.

Figure 6 represents the damage length and height measured along the circumferences of the punch and the die cutting edges. As shown in such figure, the 90° angle corresponds to the highest cutting edge of the punch while it corresponds to the lowest cutting edge in the case of the die. From this figure, the following tool damage characteristics were revealed: first, at the edges of the punches (at 0 and 180°), the damage was fairly severe and similar in all cases of the cutting shots. This corresponded to the metal loss at the punch edges, as explained above. Second, seeing the damage distances,  $D_1$  and  $D_h$ , the chipping of the punches and died was drastic at the highest cutting edges of the punches and the lowest cutting edges of the dies (at 90°) and tended to decrease for the faraway positions along the circumferences of the punches and the dies. Third, comparing the damage of the tools under different cutting shots, the chipping of the tool cutting edges except the damage height of the punch ( $D_h$ ) was not significantly different. Finally, seeing  $D_h$  in Fig. 6 (b), the damage height of the die near the lowest edge tended to increase with increasing the tool cutting shots. Here, it was confirmed that when the cutting shots increased, there was the progression of the damage, i.e. at the cutting edge of the die.

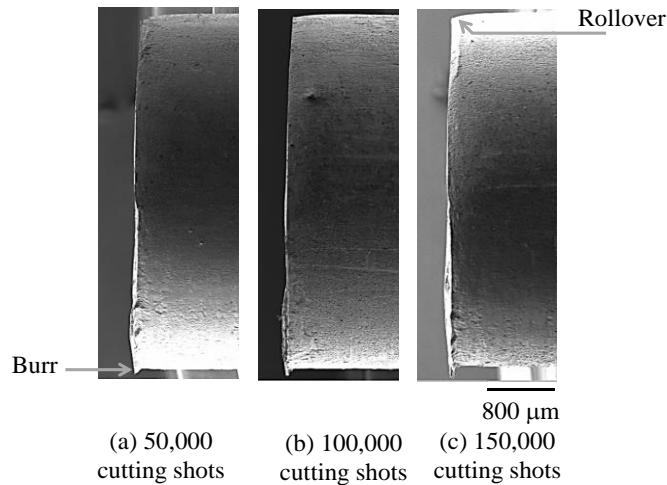
**Fig. 8.** SEM images of steel wire rod sheared edges.

After shear cutting, the sheared edges of the wire rods were examined by the Scanning Electron Microscope. Figure 8 represents the sheared edges of the wire rods cut with the 50,000, 100,000 and 150,000 cutting shot tools. From this figure, rollover and burr at the sheared edges were observed. Their size seemed to be increasing with the tool cutting shots. To examine the sheared edge feature in more details, an image analyser software was utilized to measure the dimension of the burr and the rollover.

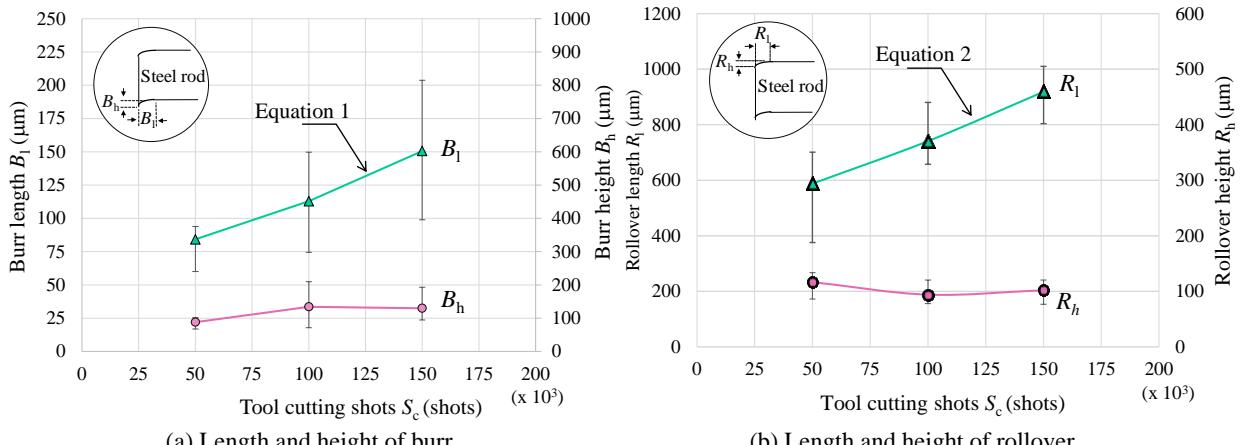
Fig. 9. Relationships between cutting shots and dimensions of burr and rollover at sheared edges.

Figure 9 represents the measured length and the height of the burr and the rollover at the sheared edges. As seen in this figure, the following geometrical features were revealed: (i) for the cutting tool shot ranging from 50,000 to 150,000, the lengths of the burr and the rollover linearly increased when the cutting shot increased. Eqs. (1) and (2) explained the relationships. In these equations,  $S_c$  is the numbers of the tool cutting shots. (ii) there were slight variations of the burr and the rollover heights for the investigation range of the cutting shots. When relating the sheared edge geometry with the tool damage explained before, the lengths of the burr and the rollover seemed to be related to the severity of tool damage.
