FIRE CRACK FAILURE OF A DUCTILE CAST IRON ROLL

ABSTRACT

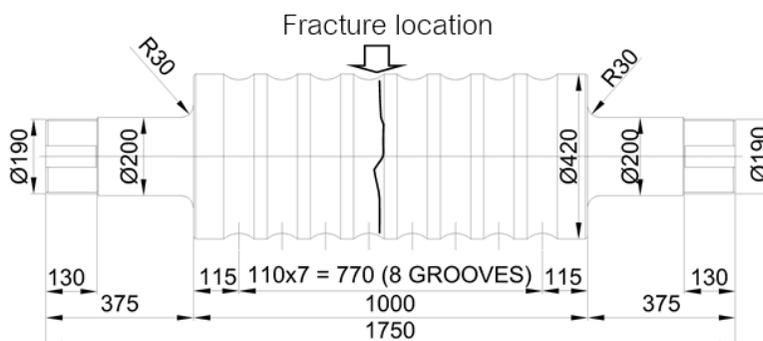
The failed roll was used at an intermediate rolling stand in a continuous hot rolling steel rebar mill in Medan, Indonesia. The roll failed after it was used for rolling approximately 3,500 tons of steel. Normally, the service life of this type of roll is much longer and can be used for rolling up to 65,000-70,000 tons of steel. The mill produced reinforced concrete steel re-bar sized 6 to 22 mm diameter with the reheating furnace capacity of 30 tons/hr. It was designed for rolling steel billets with cross-sectional areas of 45 X 45 mm² square and 82 X 35 mm² oval. The rolling temperature of this rolling stand was approximately 1,000 °C. Nominal dimensions (mm) of the failed roll and fracture point are shown in Figure 1. Chemical compositions of the roll material are shown in Table 1.

Figure 1 Nominal dimensions and fracture location of the failed roll

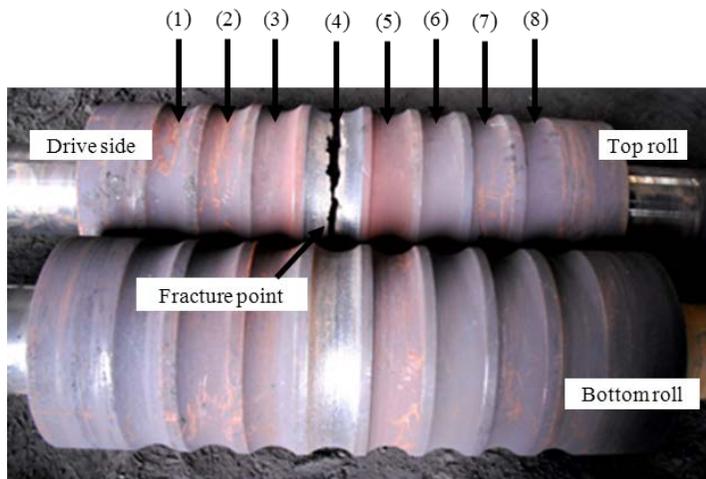
A general appearance of the failed roll is as shown in Figure 2. The failed roll was taken out from the rolling stand and examined visually. The fracture occurred at the 4th groove from drive side of the top roll. The fracture surfaces were slightly flat as shown in Figure 3. The presence of oxides (dark) at the periphery of the fracture surfaces, approximate 10 mm, is readily apparent, as shown in Figure 4. The fire cracks, on oval grooves, were observed on the top and the bottom rolls.

Figure 2 Roll design, oval groove distribution, and position of fracture point

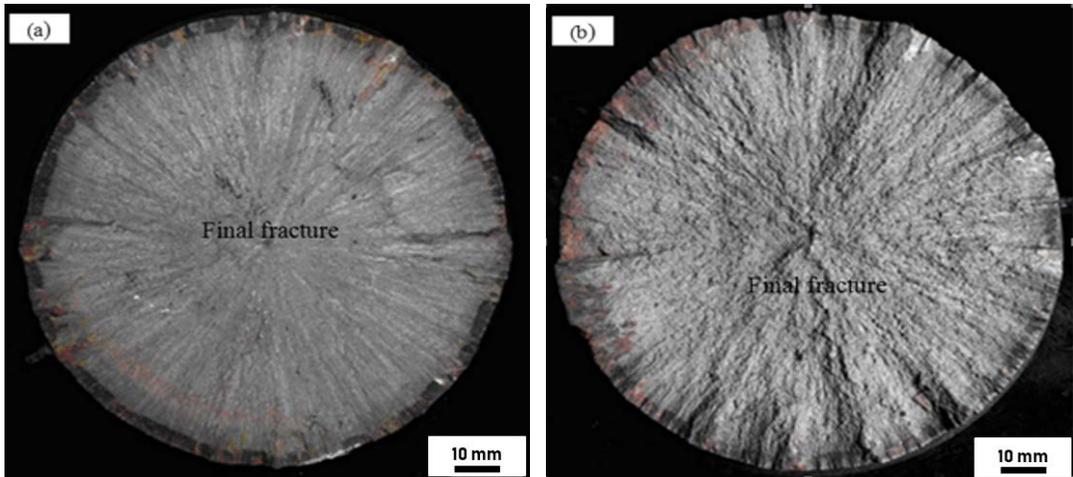
Figure 3 Fracture surfaces of the failed roll (a) drive side (b) top side

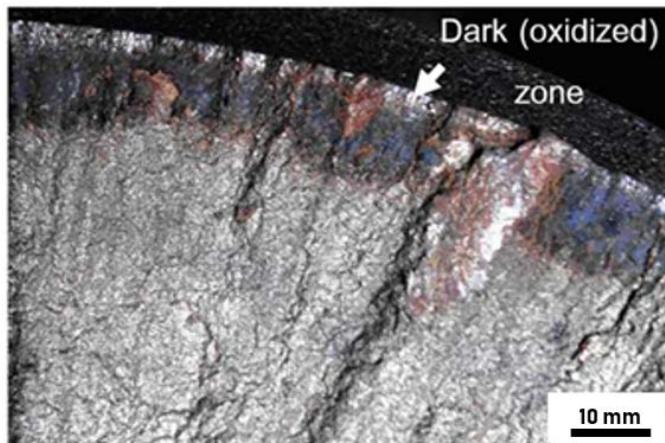
Figure 4 Magnified view of fracture surface

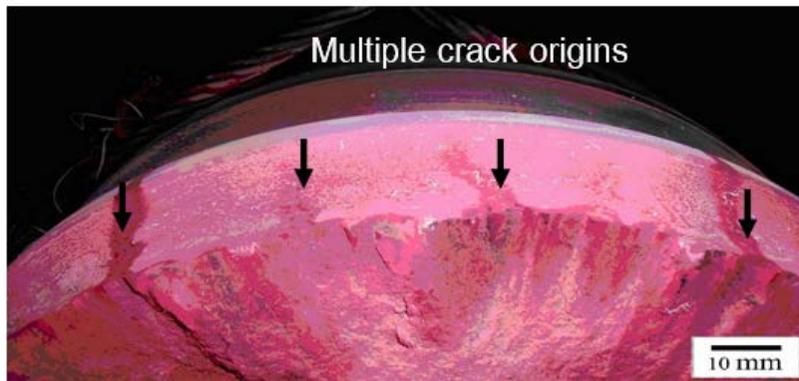
The crack initiations occurred at the surface of oval groove as shown in Figure 5. Numerous fire cracks were observed in the vicinity of the fracture surfaces and surface of oval groove of bottom roll as shown in Figure 6. It can be initially indicated that the failure of the roll occurred due to the fire cracks which subsequently formed a larger crack leading to final failure. From the observation of the groove surface of the rolls, both the top and the bottom rolls occurred the network of fire cracks on the surface of the oval groove as shown in Figure 6, which is indicated both rolls water cooling from supply not enough.

Figure 5 Fracture surface of the crack origins

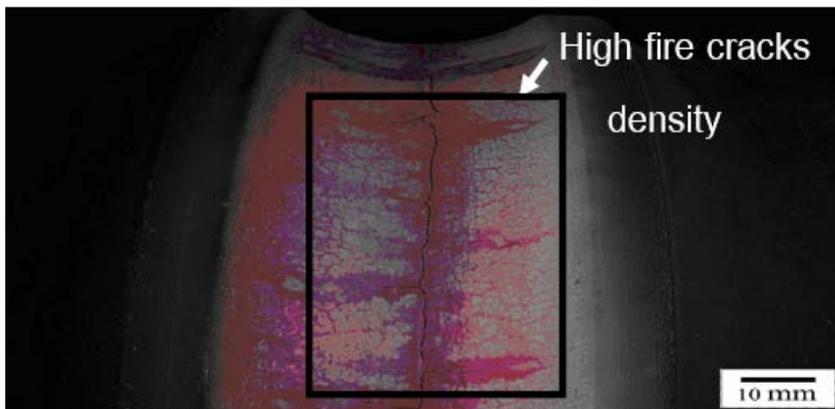
Figure 6 High fire cracks density on oval groove of the bottom roll

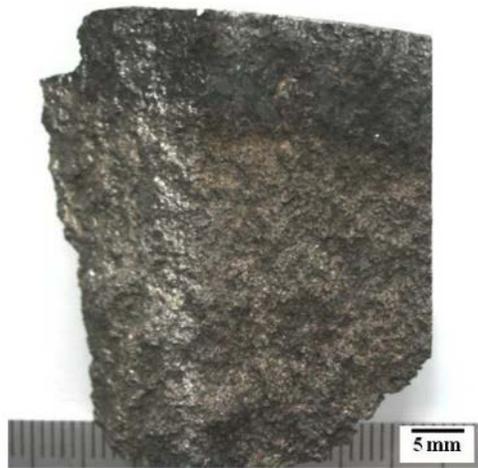
Figure 7 Specimen for SEM examined

The specimen of fracture surface of the failed roll, which is shown in Figure 7 was examined by SEM in order to look more closely at the nature of the fracture. The cracks and oxides were also found in the fracture surface which can be seen in Figure 8. The crack started at the periphery of the oval groove of the roll and then it moved inward to the center of the roll. The oxides, which cover the crack originated surface, was observed. It can be seen that the fracture surface in Figure 8 shows the decohesion surface is rather flat, as shown in Figure 9. Moreover, although the fracture surface is essentially brittle. Figure 9 is, however, primarily brittle (cleavage) and show manifestations of cracking and cleavage steps.

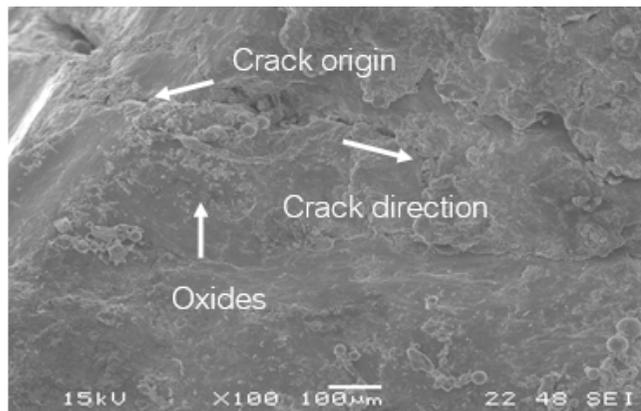
Figure 8 Fractography showing view of the crack origin and oxides

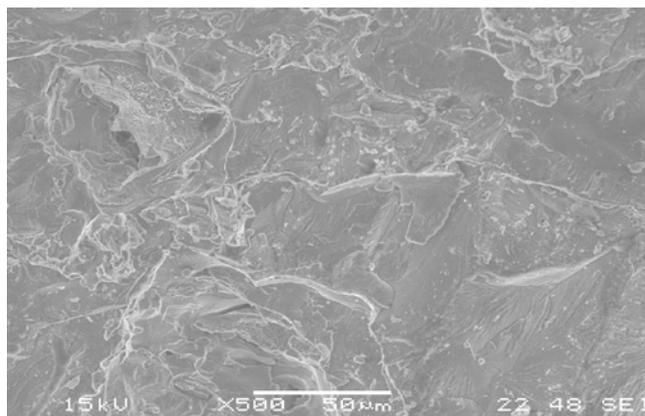
Figure 9 Morphology of brittle features and small ductile zone

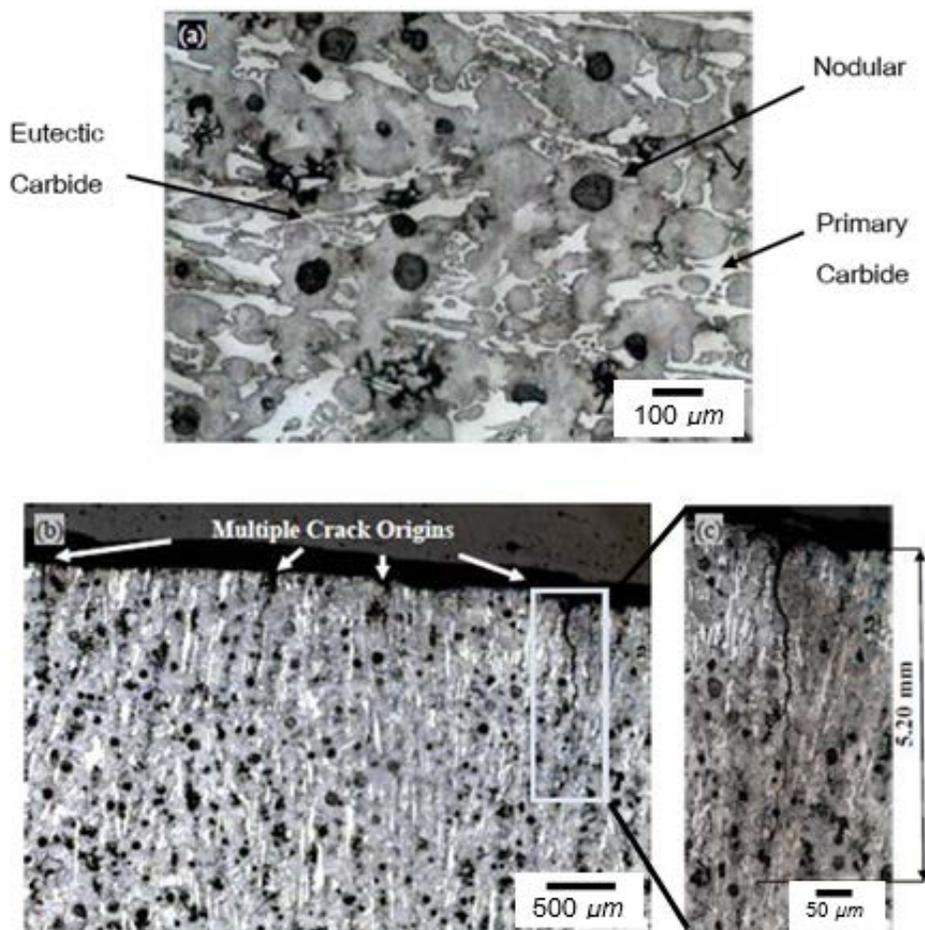
The microstructure consists of nodular graphite and eutectic carbide in pearlite matrix as shown in Figure 10a, typical for ductile cast iron rolls [10]. Multiple cracks were also found on outer shell of roll as can be seen in Figure 10b. These cracks appeared as started at the periphery of the outer shell of the roll and moved inward to the center. Higher magnification micrograph of one of these cracks and crack depth approximately 5.20 mm is shown in Figure 10c.

Figure 10 Microstructure of the failed roll: a) nodular graphite in structure, b) microstructure with multiple cracks, and c) higher magnification morphology of a crack depth (Etched with 2% nital)

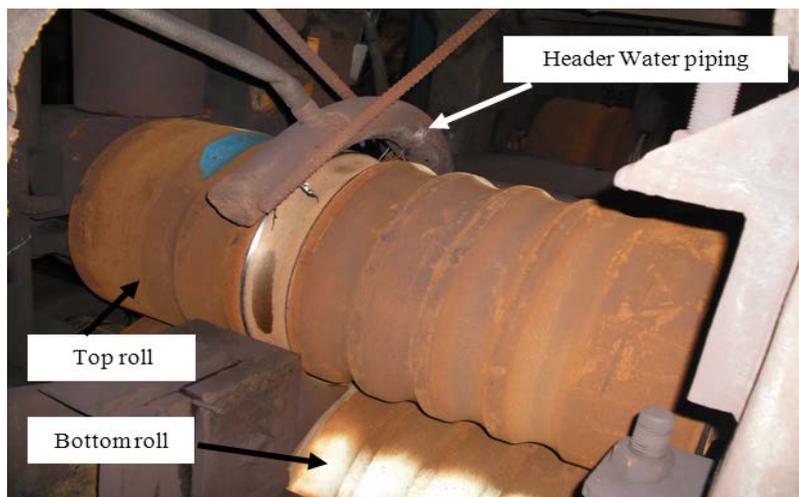
The cooling system for the rolls in this particular mill will be shown in Figure 11. Cooling water was pumped through a steel piping and plastic hose. The control system of water for cooling individual rolls was accomplished by gate valves. Header water piping for roll cooling was installed only at the top of top roll, which means the exit side did not have the water piping. Such design of the cooling system is rather fragile because there was not any warning where things started to go wrong.

Figure 11 Existing roll cooling system

3) Inadequacy in roll water cooling result partly from inadequate design of the roll cooling system.

4) It can be recommended that a robust roll cooling should be redesigned to replace the current one. Header water piping must be moved close to the exit bars where can be guaranteed that the maximum possible temperature will never be critical. Furthermore, the devices, which control water flow rate as same between top and bottom roll, must be added. When such parameters are out of the set values, the system should warn the operator. The recommended design is as shown in Figure 12.
