FAILURE ANALYSIS OF A HERRINGBONE GEAR IN 2-HI PINION GEARBOX USED IN HOT STEEL MILL

ABSTRACT

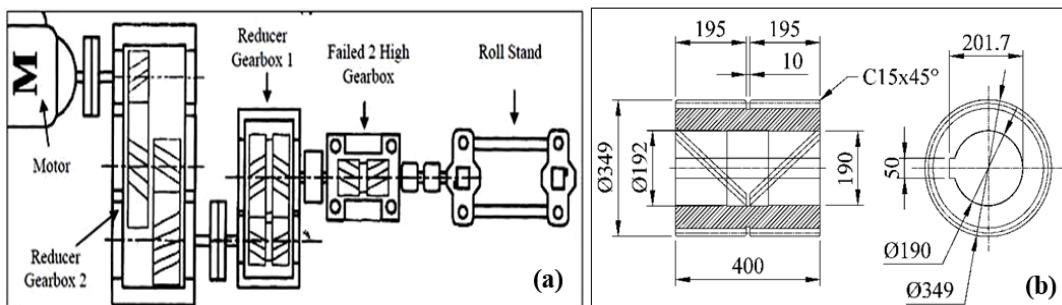
The 2hi-PG was used in the 1st intermediate stand (7th from the first roughing stand). It was designed for rolling billets with cross-section of 45.0×45.0 mm² square to cross-section of 72.0×26.4 mm² oval. The failed gear has 29 teeth and the face width of 390 mm with diametral pitch (P_d) 2.25 inch and helix angle 22.50°. The rotation speed of the 2hi-PG was 65 rpm. The 2hi-PG was driven by a reducer gearbox which in turn was driven by a 300 kW AC motor. Relevant layout of the 2hi-PG and the key dimensions are shown in Figure 1.

Figure 1 Layout of the 2hi-PG with rolling stand (a) and key dimensions (mm) of the failed herringbone gear (b)

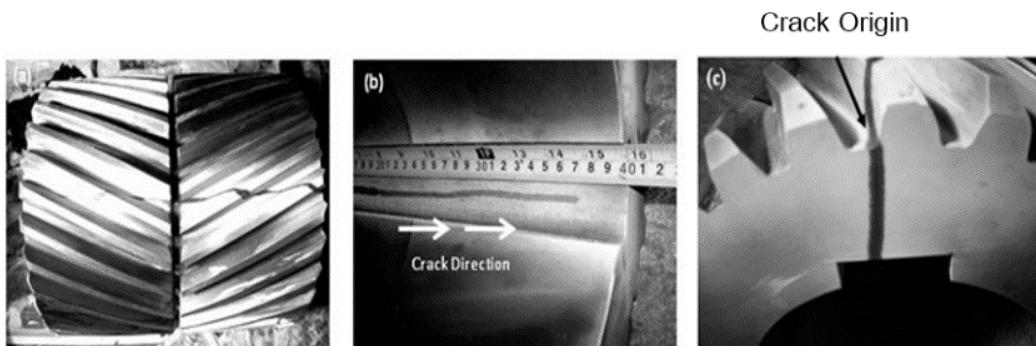
The appearances of the failed gear from various perspectives are shown in Figure 4. Figure 4a shown longitudinal crack on gear teeth, Figure 4b shown longitudinal crack running through approximate 370 mm (92%) of the gear face width (400 mm) and the initial crack occurred at root fillet of the gear teeth and toward to keyway seat as shown in Figure 4c.

Figure 4 Failed herringbone gear: (a) longitudinal crack, (b) direction of crack, and (c) crack origin

The keyway crack in question occurred at middle of keyway seat as shown in Figure 4c. Normally, the keyway cracking occurred at the corners of keyway which is high stress concentration [3]. Because the maximum principal stress from key and keyway overlap occurred at outer as shown at point A in Figure 9 and maximum bending stress due to normal operation condition with stress concentration occurred at same point where high stress is lead to initial crack from the root fillet gear tooth toward to middle of the keyway seat.

The cause of the herringbone gear failure was excessive stress resulting due to the keyway and the key overlaps lead to initial crack.

It is recommended the extreme care must be taken in main dimensional when using keys and keyways to assembly on a shaft the dimensions of the keyways and keys should be made in accordance with an accepted standard within the recommended value before assembly the herringbone gear into the shaft.

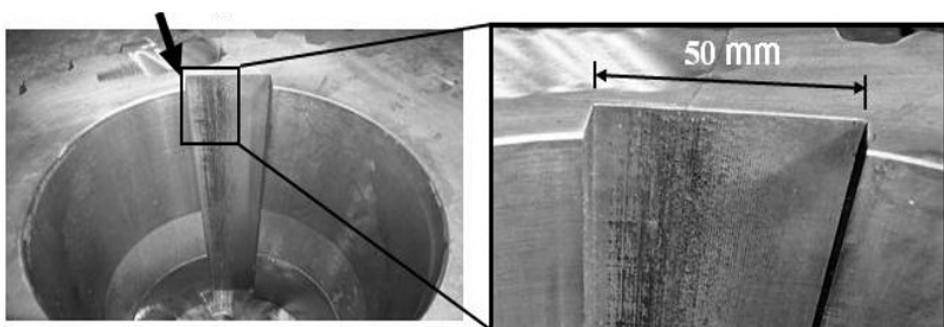
Probable Rubbing Wear

The surface of keyway seat has interference fitting as heavy rubbing (black color) approximates 20 mm width of keyway and 300 mm long start from initial crack side as shown in Figure 5. It was indicated no clearance between the key and the keyway seat. Heavy rubbing on keyway seat was indicated using heavy force when assembly pressed the shaft into the bore of gear.

Figure 5 The appearance of dark marks

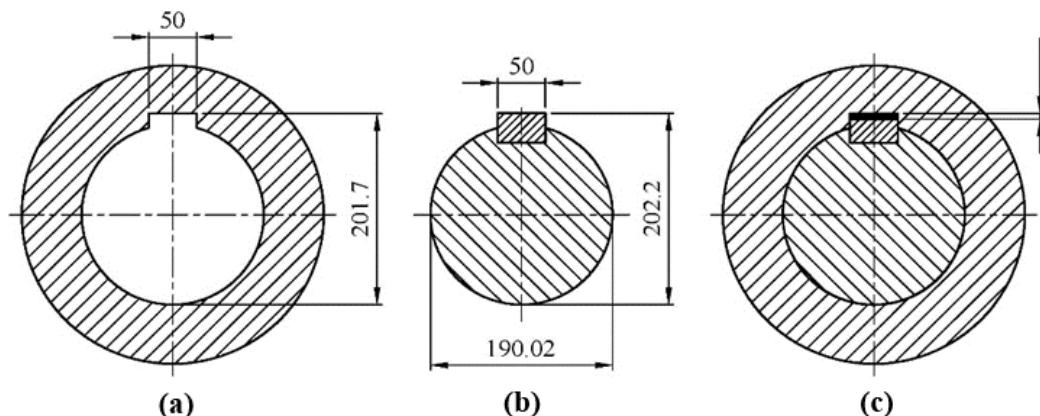
The diameters of the shaft and the bore of the failed gear were 190.02 mm, 190.00 mm, respectively. The dimensions of the top keyway with shaft and the top keyway seat with bore of the failed gear were 200.20 mm and 201.70 mm respectively as shown in Figure 6. This means that the shaft with the key will be higher than the top keyway seat with the bore, and the interference is 0.50 mm.

It was indicated poor manufacturing due to assembly person no taking care of dimension of the key and the keyway to mount on a shaft. Normally, the top key should never be allowed to contact on the keyway seat. It is a good rule to allow from 0.50 to 0.76 mm clearance between the key and the bottom of the keyway seat.

Figure 6 The dimensions of the bore gear and the shaft (a) bore of the failed gear (b) the failed gear shaft and (c) interference

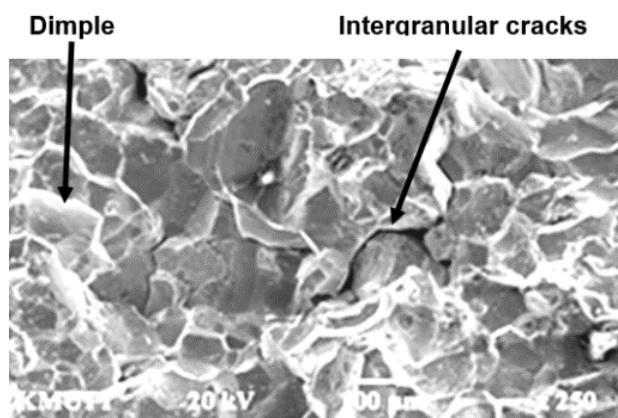
The fracture surfaces reveal that the fracture surfaces are rock candy and dimples was observed at the fracture of the gear hub as shown in Figure 7. Additionally, the presence of extensive sub- surface cracks at the loading surface of the failed gear was an indication that during operation and keyway and key overlap. Crack occurred place between the grains and the fracture surface was intergranular fracture as shown in Figure 7. The fracture surface indicated that the gear was subjected to a very high stress mode 1. The fracture takes place between the grains; and that fracture surface has a "rock candy" appearance which reveals the shapes of the individual grain. The surface of the fracture tends to be perpendicular to the principal tensile stress.

**Figure 7 Fracture surface with intergranular cracks**

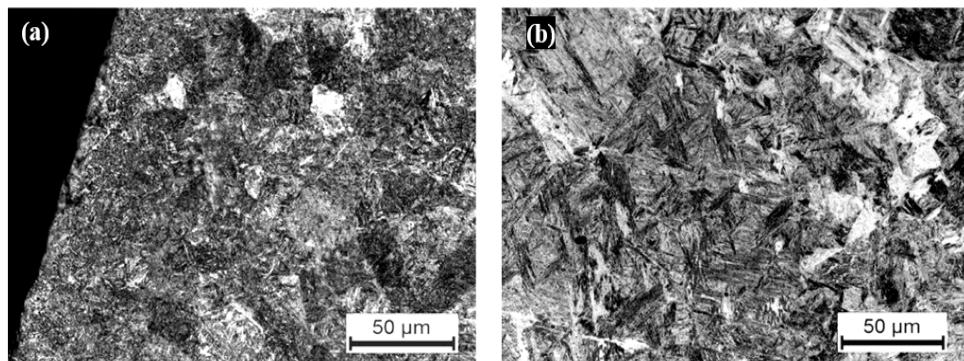
The case microstructure of the failed gear is homogeneous fine-laths tempered martensite as shown in Figure 8a. The core microstructure is tempered martensite as shown in Figure 8b. The microstructures of the case and core of the gear indicated that the failed gear material was quenched and tempered which is common practice in heat treatment of gears. No abnormality was found in the microstructure.

Figure 8 The microstructure of gear material (a) homogeneous fine-laths of tempered martensite, (b) tempered martensite

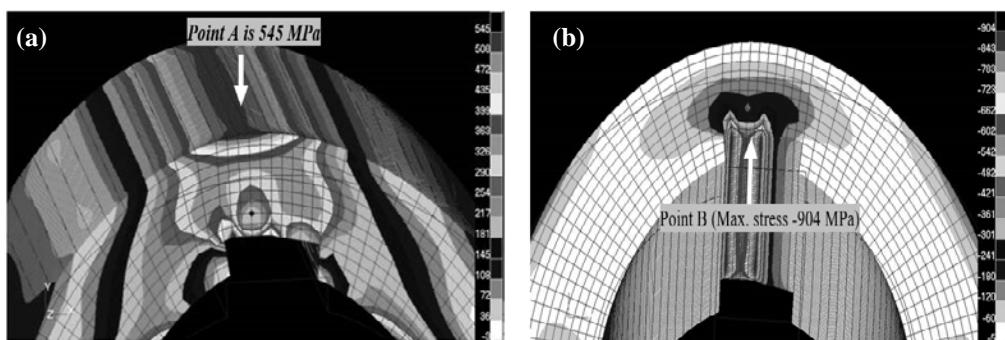
Calculation by FE method, the result of the maximum principal stress at the outer surface due to key and keyway overlap was 545 MPa as shown Figure 9 which is from a combination of the overall hoop stress of the gear. The compressive stress of 904 MPa is at the surface of the keyway seat where the forced displacement is applied as shown in Figure 9, but the initial crack could not be started from the compressive side. It is initial crack start from the outside to keyway seat as it has the tensile stress. It can be seen that the stress due to the key and keyway overlap is as same the stress resulting from the load in normal operating condition.

The combined both stress (i.e. the bending stress from normal operation, that from key and keyway overlap) was 1104 MPa which were higher than material allowance leading initiated crack.

Figure 9 Stress analysis (a) Maximum principal stress (tensile stress) (b) Maximum principal stress (compressive stress)
