# Safety Issues of Bus Transport in Thailand – A Lesson Learnt From an In-Depth Accident Investigation

Lamduan Srisakda

## 4. AN EXAMPLE OF BUS/COACH ACCIDENTS IN-DEPTH INVESTIGATION: ROLLOVER OF DOUBLE-DECK TOUR BUS.

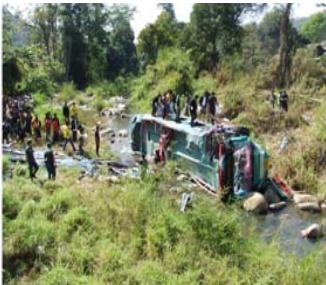
Figure 2 – Bus rolled with its right side on ground. The roof, upper floor passenger cabin and all seats were thrown away during rollover.

On January 19, 2007, a double deck tour bus travelled on mountainous highway from Chiang Rai to Chiang Mai. At 1100 AM Driver was unable to control his bus speed as it approached a sharp reverse curve and bridge. It went straight, hitting the concrete barrier at high speed, rollover, and finally rested in the stream bed. The roof, passengers and all 44-upper deck seats were totally ejected from its upper floor resulting in 17-deaths at scene and 35 injuries (Figure 2). From the in-depth investigation the causes and contributing factors were:

**Human Factors:** Driver not familiar with the route, Improper use of gear and pumping to much brake. Speed too high

**Vehicle Factors:** Strength of bus superstructures not adequate to protect passengers during rollover accidents. Passenger seats thrown away during the accident.

**Road Factors:** Lower design standard resulted in steep grade and winding road

– The structural integrity of the super-structure joints is not adequate to protect passenger during rollover. In Figure 2 the roof and its supporting columns disappeared, there was no survival space for passengers.

– Introduce the measure on restriction or ban of double deck bus on steep grade and winding routes.

– Providing survival space for passengers via quality control of the strength of bus superstructures. The regulation should specify that, in order to register, the bus should pass a specified test (the UN-ECE Regulation 66 as an example), or the certification of bus manufacturers by the DLT should be adopted.

– Avoid the ejection of passengers from the bus by means of safety belts or laminated side windows.

– Avoid the loosening of passenger seats by firmly secured them to the bus floor.
