# Common Blind Spots in Ground Investigation, Design, Construction, Performance Monitoring and Feedbacks in Geotechnical Engineering

Shaw-Shong Liew

G&P Geotechnics Sdn Bhd, Kuala Lumpur, Malaysia

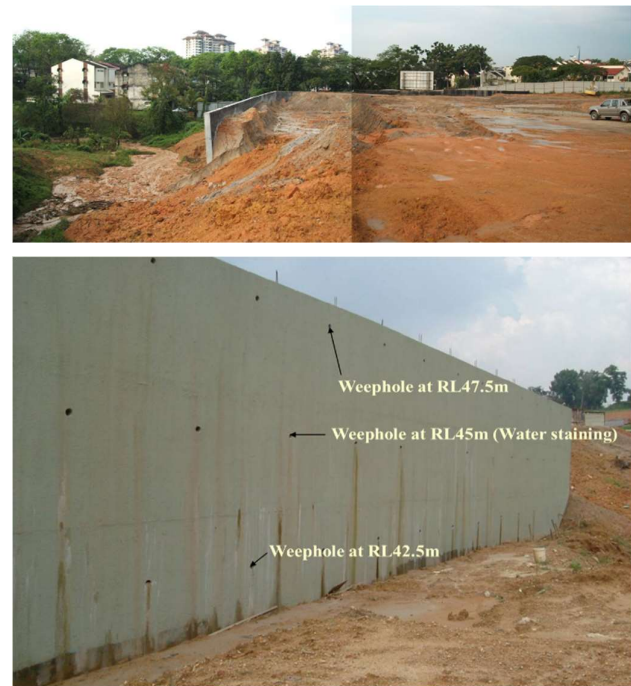
Figure 1 Overall Site Condition and Evidence of Rising Groundwater Level in the Wall Backfill

This case study involves a distressed piled retaining structure of 7.5m high over soft soils as shown in Figure 1. In view of the underlying weak alluvial deposits at the predevelopment natural stream as shown in Figure 2, the retaining structure was supported by five rows of vertical 200mm driven precast concrete square piles with carrying capacity of 450kN. During backfilling of the constructed retaining wall, excessive lateral movement was observed. As evidenced in Figure 1, rising groundwater level was evidenced from the water staining at weephole drains probably resulted from building up of seepage at the previous stream.

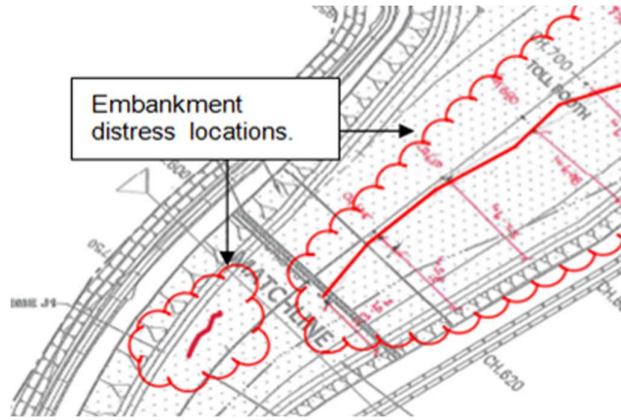
Figure 3 Layout Plan of embankment distress

10% strain and prefabricated vertical drains as ground treatment option. The embankment distresses were observed with primarily longitudinal crack lines on the embankment surface along the main alignment direction during construction stage of the embankment. Layout plan of the embankment distress is as shown in Figure 3.

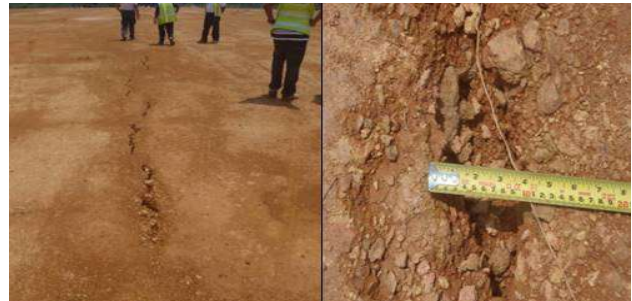
Figure 4 Longitudinal Crack found on the Embankment

Figure 4 shows a close up view of longitudinal cracks found from the embankment. The crack pattern was not of random nature, but rather a near straight line running along the longitudinal direction of the embankment alignment. From the trenching excavation across the crack line, the depth of the cracks was found to be about 300mm to 500mm from the formation level after partial fill removal of 1m from the staged constructed embankment to reduce embankment loading at the time of investigating the cracking. The crack is generally of “V” shape (i.e. wider gap at the top and diminishing as going downward). Water was poured into the cracks with seeping out observed at the bottom of the cracks confirming the depth of the cracking.

As informed by the site team, the cracks appeared after a prolonged drought season, hence there was a suspicion of development of shrinkage cracks due to loss of moisture at top desiccate formation of the fill after exposing to very hot direct sunlight. However, the cracks did not have the feature of typical radial shrinkage resulting with the random honey comb crack pattern. In addition, the embankment fill was found very well compacted as evidenced by the observed resistance to the hydraulic excavator in performing the trial pit trenching during the site visit and inspection. It was not unreasonable to expect that the compacted embankment fill can be brittle and easy to crack when subjecting to any differential straining.

As the cracks are shallow and “V”-shaped by nature, it is likely a flexural crack with the tension zone at the top of the embankment. Furthermore, brittle behaviour of well compacted embankment fill is prone to cracking, when subjected to differential straining or localised straining near to the embankment slopes can be.

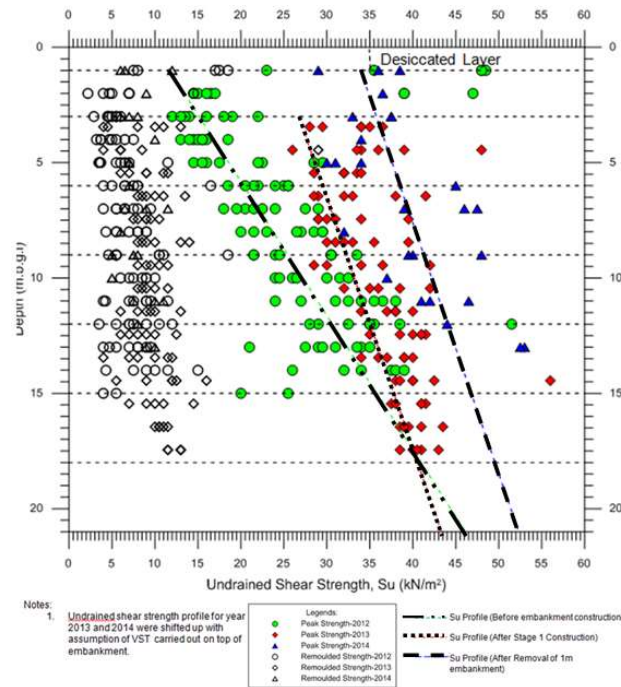
Figure 5 Interpreted Undrained Shear Strength at Different Stages of Embankment Construction

shear tests to obtain and verify the performance of gain-in undrained shear strength after consolidation at each rest period. Figure 5 shows the profiles of vane shear test results before embankment construction in 2012 and after embankment construction in 2013 and 2014.

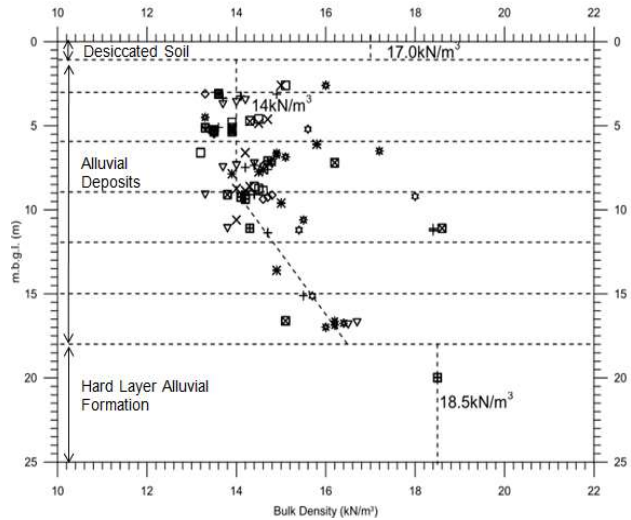
Figure 6 Interpreted Subsoil Bulk Density

Bulk density of the proposed site prior to embankment construction works were summarised in Figure 6. The average bulk density of the alluvial subsoil samples obtained from the SI is 14kN/m<sup>3</sup> for top 9m soil and gradually increases to 16.5kN/m<sup>3</sup> for the subsequent depth from 9m to 18m of the alluvial clay layer.

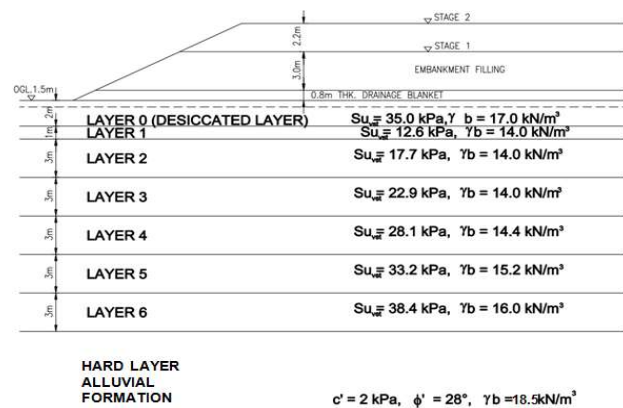
Figure 7 Typical Cross Section of Embankment in Stages

blanket, the embankment was filled up to each designed staged construction thickness and rest for consolidation.

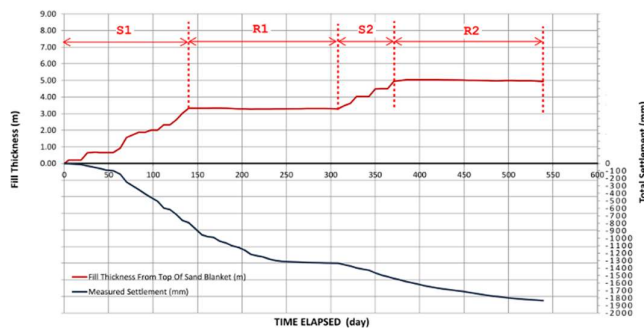
Figure 9 Filling Sequence and Settlement of Embankment Monitored by SG580

Filling sequence and performance of the embankment at the distressed area was monitored by the settlement gauge (SG580) as shown in Figure 9. The filling sequence of embankment was divided into four stages which consist of Stage 1 filling (S1), Stage 1 rest period (R1), Stage 2 filling (S2) and Stage 2 rest period (R2).

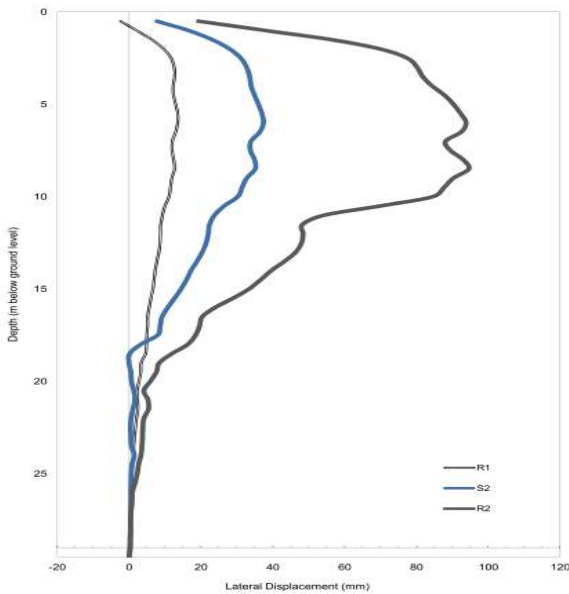
Figure 10 Inclinometer I6 Monitoring Results

Figure 10 presents the inclinometer monitoring results from inclinometer I6 installed at a location of about 4m beyond the embankment toe. It shall be noted that the inclinometer monitoring was only started 2 month after Stage S1. As such, it was expected that portion of lateral displacement will not be recorded in the inclinometer monitoring results. The recorded maximum lateral displacement is about 100mm. The top 11m indicated more lateral soil displacement implying larger plastic straining in the subsoils, which can develop into a slip surface leading to embankment distresses.

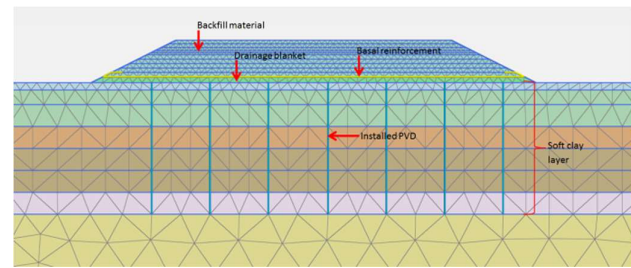
Figure 11 FEA Modelling For Back Analysis

Back analysis for embankment performance was carried out with Finite Element Analysis (FEA) method using engineering software "PLAXIS" to simulate the filling sequences in order to back analyse the performance of the extendible basal reinforcement. The FEA modelling is shown in Figure 11.

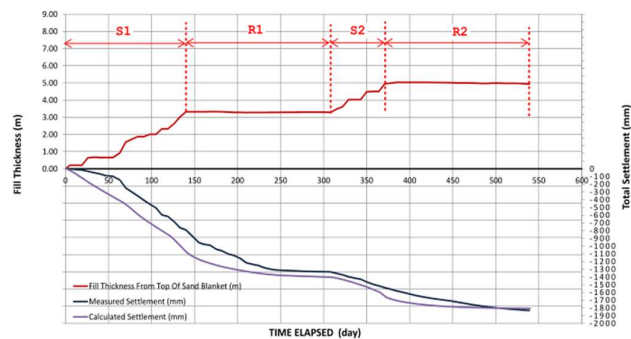
Figure 12 Comparison of Back Analysed Settlement Trend with Actual Measurement

Backfilling stages and construction sequence were modelled in accordance with the actual conditions (i.e. filling thickness and time period). Back-analysis with reasonable range of subsoil parameters and coupled consolidation model have been performed to compare with the actual measurements. Findings from PLAXIS were

tabulated in Figure 12. The back analysed settlement trend with time is compared with measured settlement profile of settlement gauge (SG580).

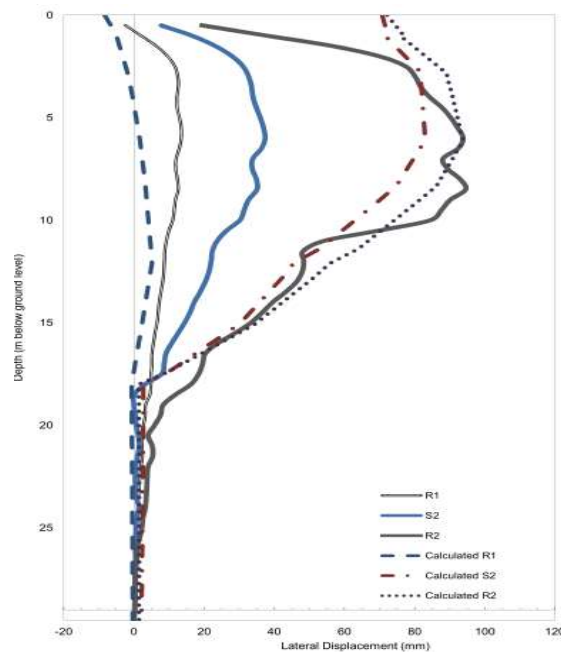
Figure 13 Comparison of Lateral Displacement Profile

In order to best simulate the actual condition of the constructed embankment, both settlement trend and lateral deformations profiles from back analysis are required to reasonably match with the actual performance of embankment. The lateral deformations from back analysis was plotted and compared with the actual conditions in Figure 13.

As portion of the lateral displacement is not recorded in early stage of the embankment filling due to delayed installation of the inclinometer, thus, the back analysis was performed to estimate the possible lateral displacement before installation of inclinometer while the incremental lateral movement profile at subsequent construction stage still match well with the measured profiles. It was found that the subsoils have undergone lateral displacement of 160mm prior to the monitoring and it is expected that total lateral displacement of 260mm was experienced in the subsoil beneath the embankment before the cracks were observed. If taking this lateral subsoil movement of 260mm at 4m beyond the embankment toe and where the crack was discovered, the average mobilised tensile straining of the subsoil from the crack location to the embankment toe plus the distance of inclinometer I6 of 18m would be estimated to be 1.44%. This strain level is no way close to the characteristics strength of the basal reinforcement.

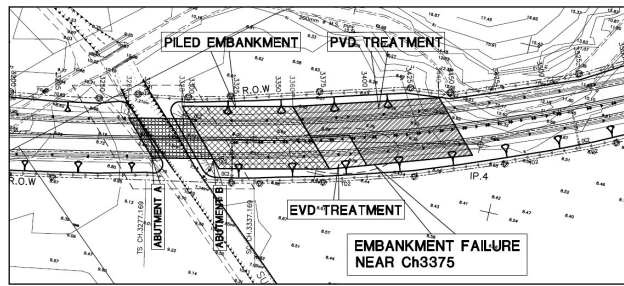
Figure 14 Layout of distressed bridge abutments and embankment

Liew, et al (2010) presented a case study involving a construction of 3-span concrete bridge (Pier 1 & 2 at Ch 3286 & Ch 3307 and Abutment A & B at Ch 3266 & Ch 3328 respectively) over alluvial formation with ground level at about RL8.5m and river invert at about RL7.2m. Fill of 1.5 to 2m thick over the 10m thick weak alluvial deposit was required for the piling platform at RL10.50m. Generally, the fill thickness at the site is about 5.4m above the original ground level. Subsurface exploration confirmed that the underlying weathered residual soil of 7m thick is found above the weathered meta-sedimentary formation of primary sandstone derivatives. The subsoil parameters are summarised in Table 3. Due to higher embankment fill (5.4m) and relatively weaker ground condition at the Abutment B side, the approach embankment was supported on 200mm×200mm RC pile foundation at 1.8m grids for a stretch of 30m long and the lower embankment was on the treated ground using Prefabricated Vertical Drains (PVD) with surcharge. Trial Electrically-conducting Vertical Drains (EVD) was applied at the small area of 20m×20m replacing the originally designated PVD treatment. Both abutments were supported with one front row of raked piles and rear row of combined vertical and raked piles for both the lateral and vertical resistances.  $\phi$ 400mm Prestressed spun concrete piles were used for the abutment piles. Figure 14 shows the layout of distressed piled embankment and the embankment on two ground treatment techniques near Ch 3375.

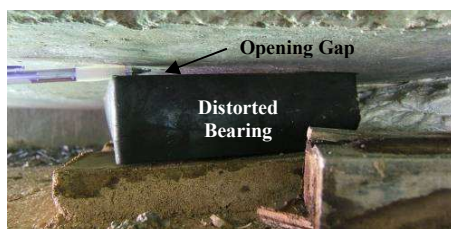
Figure 15 Shearing distortion of rubber bearing

- Thereafter, spalling of concrete and gap opening at the bridge deck near Abutment B were observed.
- After the failure of EVD embankment and piled embankment, most electrometric rubber bearings at Abutments A and B suffered observable shearing deformation as shown in Figure 15.

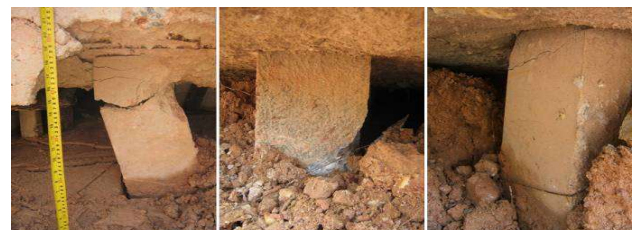
Figure 18 Settlement of piling platform and flexural damage of embankment foundation piles

- As shown in Figure 18, the filled piling platform has settled about 400 to 1000mm in magnitude beneath the piled RC slab and flexural cracks were observed at numbers of free standing piles at the piled embankments.

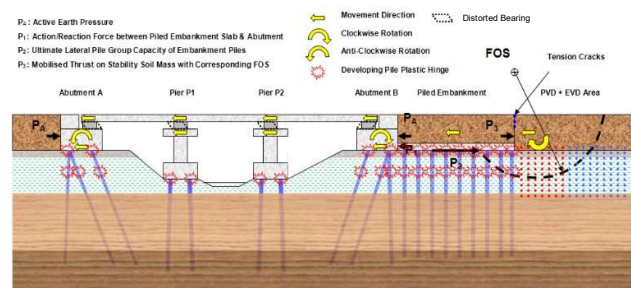
Figure 19 Schematic bridge movements

undrained strength of 10kPa. With the plastic deformation of the underlying weak subsoil under the embankment loading at the PVD and EVD treated area and marginally low safety factor (FOS), the piles would gradually approach flexural yielding condition and exhibit excessive pile movements and rotation at the plastic hinge formed. The lateral thrust of the relatively unstable embankment on treated ground with potential failure mechanism behind the piled embankment could have also imposed excessive flexural stress to the RC piles. The net horizontal thrust after deducting the lateral resistance of the group piles beneath the embankment then pushed Abutment B, bridge decks and Abutment A. The bearing distortion shape agrees well of the load path traversing from the Abutment B through bridge decks and the piers and finally reaching Abutment A. A schematic diagram of such scenario is shown in Figure 19.

For the remedial design, it was crucial to simultaneously remove the active lateral earth pressure behind both abutments to avoid unbalanced lateral loading and replace with geotextile reinforced backfill preventing lateral load from imposing to the abutments. The embankment removal and reconstruction were closely monitored

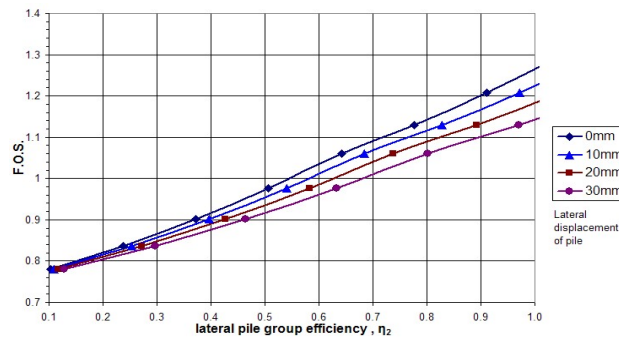
Figure 20 Safety factor of embankment stability with lateral pile group efficiency and pile eccentricity effect

Assuming both abutment piles and piled embankment foundation piles had reached the ultimate pile group capacity simultaneously, the safety factor of the embankment stability in longitudinal direction is at best 1.14 to 1.26 depending on the pile eccentricity due to lateral displacement. It is also possible that some piles had compromised its lateral resistance ahead of others leading to even lower safety factor than the aforementioned marginal value.

Creeping foundation movements due to occurrence of plastic deformation of underlying weak subsoil will cause unacceptable serviceability conditions of piles and gradually undermine the structural integrity of the bridge structure. In fact, the entire system including the bridge, pile embankment and the embankment was at the marginally stable condition with very low safety factor. The summary of the safety factor of the embankment stability at the PVD and EVD treated embankment behind the piled embankment with consideration of the pile eccentricity effect is presented in Figure 20.

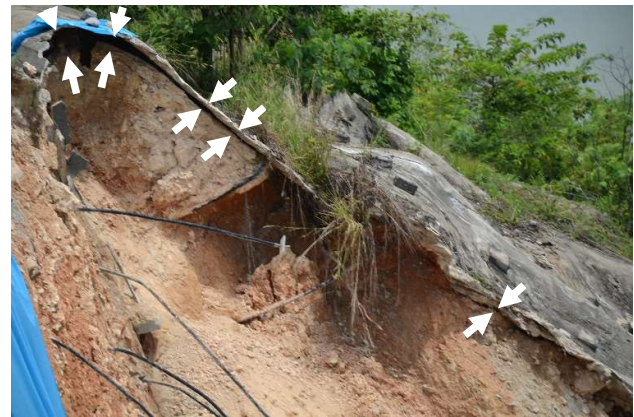
Figure 21 Gap Formation between Soil Nailed Slope and Shotcrete Facing

In soil nailed slope design, full facing covering the slope surface attached to the anchoring soil nails are usually considered with dual purposes, namely full surface protection preventing erosion from surface runoff and, more importantly, to attain high facing load at the nail head to mobilise higher nail structural strength when the geotechnical pull-out capacity is available with higher overall factor of safety for slope stability. However, this wishful design expectation might not be materialised when the supply of moisture between the slope material and the atmosphere is substantially cut-off by the full shotcrete or gunite facing. Without maintaining the equilibrium of moisture in the soil slope, there will be volumetric shrinkage of the soil slope resulted from depletion of moisture. The shrinkage can result in detachment of contact between the slope surface and hard rigid shotcrete/gunite facing surface. Figure 21 shows the evidence of shrinkage of soil slope forming a gap ranging from 50mm to 275mm beneath the shotcrete surface of the failed nailed slope. From the inspection of the soil material beneath the shotcrete surface, the moisture is remarkable lower than the exposed ground surface.

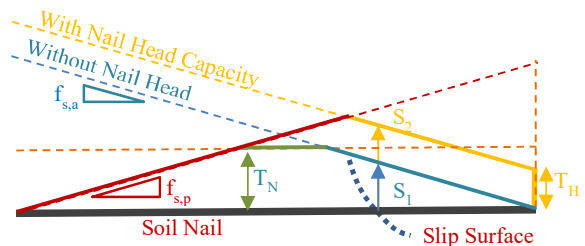
Figure 22 Nail Force Diagram with and without Nail Head Capacity

Figure 22 shows a typical nail force diagram of a soil nail embedded in the slope where the available nail resistance along the entire soil nail shall be the lowest envelope among the envelopes of passive pull-out resistance ( $f_{s,p}$ ), active push-out resistance ( $f_{s,a}$ ), nail structural tensile capacity ( $T_N$ ) and nail head structural capacity ( $T_H$ ).

Consequently the expected face loading ( $T_H$ ) at the nail head will diminish resulting in reduction in mobilised nail resistance at any critical slip surface cutting through the nail from  $S_2$  to  $S_1$  if there exists a gap and thus reducing the overall factor of safety of the slope stability. As such, when considering the shrinkage factor resulting from depleting moisture content of fully covered slope surface, the porous facing design with adequately slope face exposure for maintaining the moisture equilibrium may be more appropriate to reduce variation of the resulting safety factor of slope stability. Such soil shrinkage is usually not considered by geotechnical designer for slope works as it is hard to believe its reality until being observed.

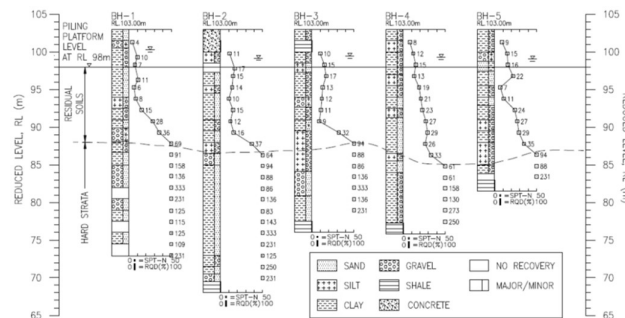
Figure 23 Borehole logs of subsoil profiles

As observing the rapid rate of disintegration of the exposed weathered bedrock formation and instability of many cut slopes formed in the same formation, it is believed that swelling and flaking behaviours of these formations can be prominent when subject to stress relaxation. Interpreting from the exploratory boreholes, the overburden weathered materials mostly consist of sandy CLAY and at fairly consistent depth of encountering competent hard stratum (SPT-N  $\geq 50$ ) as shown in Figure 23.

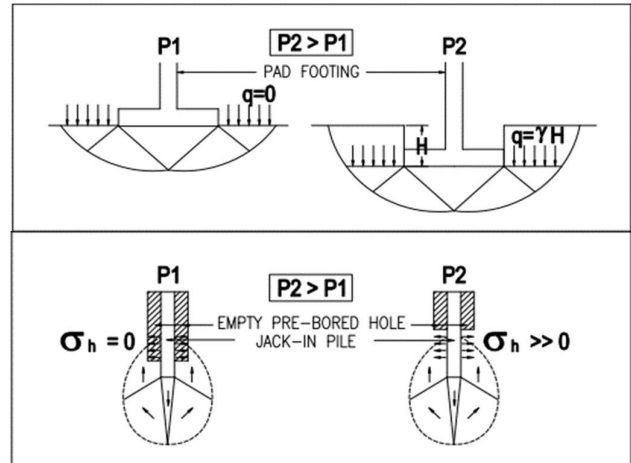
Figure 24 Pressure bulb and plastic zone for shallow foundation and pile foundation

Certain piles were terminated either at the base of empty pre-bored hole or with noticeably short penetration below base of the pre-bored hole. These piles were expected to experience capacity reduction resulting from stress relaxation due to overall low confining effective stress near the pile tip as illustrated in Figure 24.

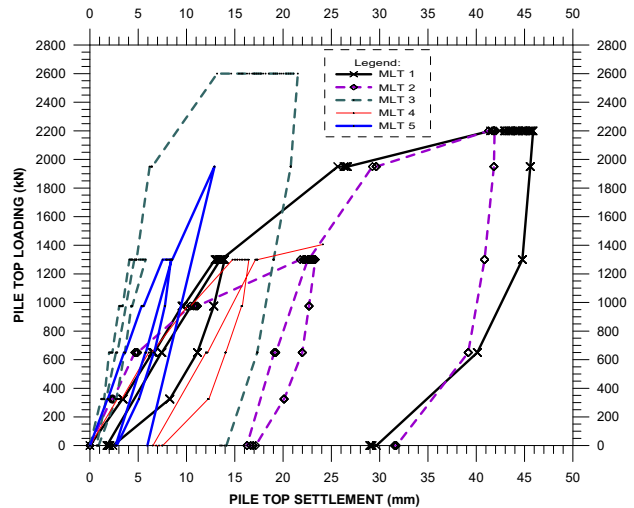
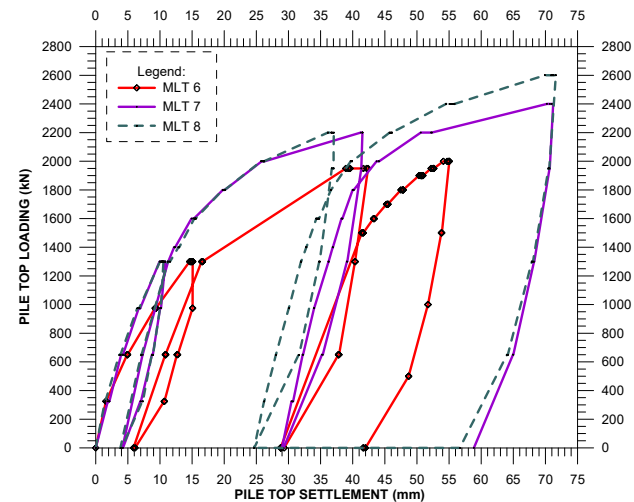
Figure 25 Pile top loading (kN) versus pile top settlement for (a) contractually scheduled MLT results and (b) additional MLT results

All additional MLT piles (MLT 6 to MLT 8) had been previously installed with termination criterion reaching 2.2 times of working capacity but MLT 6 and 7 piles failed to achieve the required maximum test load, except for MLT 8. This clearly implies the high possibility of pile capacity degradation resulted from stress relaxation. MLT for piles with deeper penetration below the base of pre-bored hole have obviously shown better settlement performance at one (1) time working load in the first cycle. The load-settlement curve of all three test piles in Figure 25(b) has gentler gradient in the first loading cycles whereas the gradient of subsequent reloading cycles becomes steeper. This is the clear evidence of phenomenal soil softening after the termination of jack-in pile. However, further reloading of the pile to higher load in the subsequent load test cycles had allowed the founding soil stratum regaining the soil compactness rendering stiffer pile base response. The test results further enhance the findings of potential stress relaxation at pile tip due to insufficient stress confinement within the effective stress bulb of the end bearing pile tip as a result of insufficient pile penetration below the base of pre-bored hole. The restoration of initial higher

The performance of three (3) additional MLT on working piles in this investigation provides clear evidence of the varying degree of pile capacity reduction with respect to the corresponding pile penetration below the base of oversized empty pre-bored hole without the annulus backfilled. To overcome the shortcomings, it is worthwhile to consider sealing off the annulus between oversized pre-bored hole and pile shaft to prevent ingress of water and remove the condition of free annulus surface that leads to softening of pile tip material within the plastic zones. This can be easily achieved by placing appropriate amount of cementitious grout into the pre-bored hole before lowering the pile for jacking operation. The depth of cementitious grout sealing shall sufficiently cover the upper plastic zone of the stress bulb after volumetric displacement of grout at pile termination. The recommended minimum grout sealing depth shall be approximately 5 times pile size above the base of pre-bored hole. It is always better to have the grout fully fill up the annulus gap in the empty pre-bored hole to avoid buckling condition of pile if the free standing length in the pre-bored hole is significant.

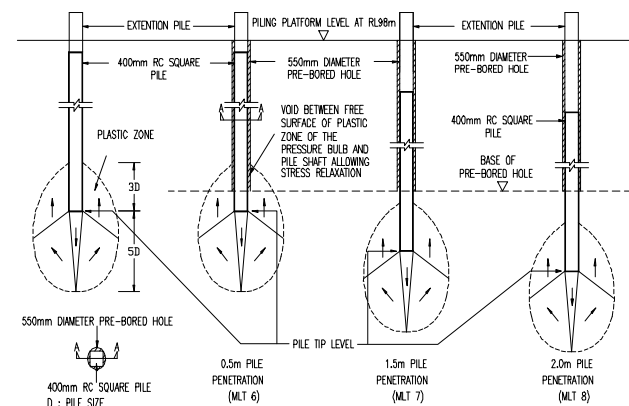
Figure 26 Schematic diagram of stress relaxation effect with relative position of pre-bored hole and pile stress bulb

Piles installed into pre-bored hole without backfilling the annulus are exposed to the risk of pile tip softening and consequently leads to reduction in pile load carrying capacity and softer response in pile tip stiffness. The base softening effect in the bearing soil stratum affecting the end bearing capacity of the pile can be logically expected when the empty annulus in the pre-bored hole is nearer to the pile base. The empty annulus with virtually zero confining stress provides pre-requisite condition for time dependent stress relaxation of soils to take place especially when the free surface is exposed to water. When the pile has sufficient penetration below the pre-bored base, the stress relaxation effect at the upper most soil (beyond influence zone of the stress relaxation above pile tip) would not affect the effective stress bulb near the pile tip, thus the pile end bearing capacity. Figure 26 shows a schematic diagram of the stress relaxation and the stress bulb of pile tip end bearing.

The depth of influence zone at pile tip is complicated and influenced by many factors such as angle of shearing resistance of the founding soil at proximity of pile tip, pile diameter, stiffness, in-situ effective stress at pile tip, homogeneity of the soil and etc. For piles in more compressible silty sand with fines content over 15%, the upper plastic zone is between 0.5D and 1.5D and the lower plastic zone ranges from 1.5D to 3D where D is pile size (J. Yang, 2006). Meanwhile, the influence zones for sand with  $\phi' = 30^\circ$  are 1D to 3D upwards and 3D to 5D downwards (Hideki Hirayama, 1988). As such, it is worthwhile to seal-off the annulus between oversized pre-bored hole and pile shaft to remove the condition of free surface and to prevent ingress of water potentially leading to softening of pile tip founding materials within the plastic zones of pile tip.

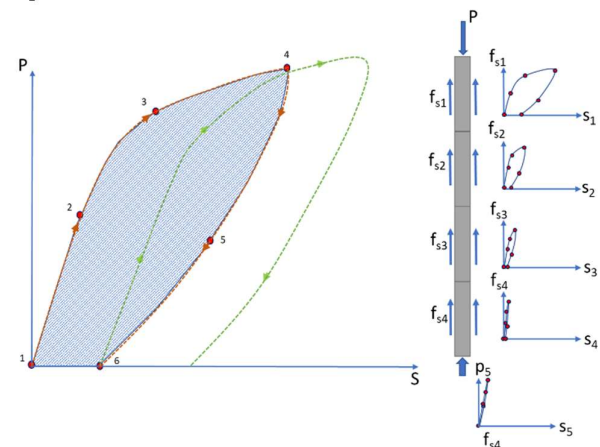
Figure 27 Schematic diagram of Pile Load Test Results

Figure 27 shows a typical load settlement curve of static maintained load test results. The portion from Point 1 to 2 denotes linear elastic behaviour when there is no part of the pile-soil system attaining either interface slippage and dislocation of soil grains. Full recovery of elastic strain of pile structure and foundation soil is possible with this range of loading. However, when the pile loading enters beyond Point 2, either soil yielding or interface slippage at the upper portion of the pile-soil system occur. The lower pile segments may remain elastic behaviour. When the loading is stressed beyond Point 3, more soil yielding and interface slippage occur and extend to lower pile segments resulting more irrecoverable straining. Upon reaching the first maximum test load at Point 4 following with unloading process to Point 5 and subsequently to Point 6, partial restoration of the stored elastic strain energy in the pile-soil system takes place.

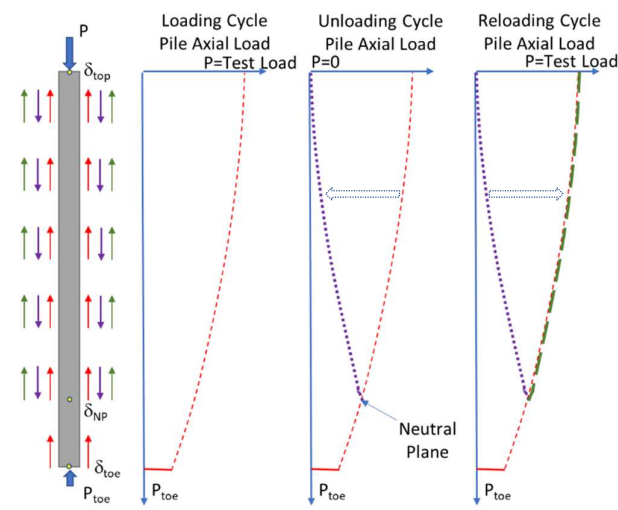
Figure 28 Schematic diagram of Pile Load Test Results

When the restoration of elastic strain between the pile and the soil becomes inconsistent due to either soil grain dislocation or interface slippage, the reaction at the upper pile segments can be in a reverse direction, hence preventing full release of the elastic strain in the piles becoming the lock-in load in the pile. As illustrated in Figure 28, the static equilibrium of the pile-soil system at this state is attained with downward drag force at the upper pile segment and upward resistances from the lower pile segment and pile toe. Maximum compressive load is located at the neutral plane where the downward and downward resistances meet. When the test pile is reloaded again, normally the initial stiffer response at the beginning of reloading can usually be observed when comparing to the earlier loading cycle. This is primarily due to much lower elastic shortening ( $\delta_{top} - \delta_{NP}$ ) with relatively high pile stiffness when reloading of the pile by taking over the downward drag load in the soil above the

neutral plane to reach static equilibrium. It can be logically expected that the pile deformation,  $\delta_{NP}$ , at the neutral plane when first attained in the loading cycle shall remain unchanged in the unloading and reloading cycle as the upward resistance is the same for these three loading cycles.
