# Characteristics and Consequence of Nepal Earthquake 2015: A Review

**ABSTRACT:** An earthquake is a natural disaster that comes in different parts of the earth every year. Most of them are very weak and unnoticeable. But some of them are too severe to cause a great loss of lives and destruction of properties. A major earthquake happened in Nepal on 25<sup>th</sup> April 2015. More than 8,000 people died and more than 19,000 people got wounded in this earthquake. People of Nepal had anticipated but never experienced such a devastating earthquake. This paper deals with the Gorkha earthquake in Nepal, its causes and characteristics, previous earthquake history of Nepal, consequences etc.

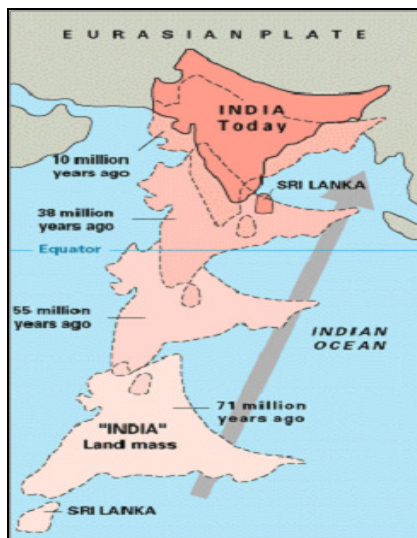
Figure 3 Collisions between Indian and Eurasian Plates (IRIS Education & Public Outreach and The University of Portland)

The earthquake activity in Nepal is caused by the ongoing continental collision between Indo-Australian and Eurasian plates (Figure 3). The Himalaya Mountains and the Tibetan Plateau were created by that collision. The collision zone wraps around the northwest promontory of the Indian sub-continent in the Hindu Kush region of Tajikistan and Afghanistan then extends to the southeast through Nepal and Bhutan. The motion of India into Asia is nearly perpendicular to the Himalaya Mountains in Nepal. So that earthquakes from reverse thrust faulting are the most common kind of earthquakes in the central Himalayan region. This earthquake occurred as the result of thrust faulting (reverse faulting) between the sub ducting Indo-Australian Plate and the overriding Eurasian Plate to the north.

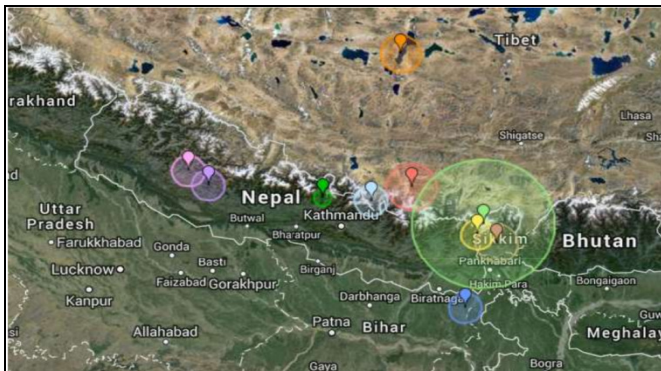
Figure 5 Recent earthquakes near Kathmandu city (Samyog Shrestha)

Nepal and particularly Kathmandu valley are seismically vulnerable, however study of the seismic hazard potential of the valley has not been performed systematically. The map in Figure 5 shows epicenters of earthquakes since 1990 (ML > 4.0) within the collision zone. Note the belt of earthquakes along and south of the Himalaya mountains sweeping through Nepal (yellow outline). Four earthquakes with ML > 6.0 have occurred within 250 km of the April 25 Gorkha earthquake over the past century. The largest ones included a Mw 6.9 in August 1988 and a Mw 8.0 in 1934 which severely damaged Kathmandu. The 1934 earthquake is thought to have caused around 10,600 fatalities. Kathmandu city has been subjected to frequent earthquakes of moderate intensities and about once in a century to disastrous earthquake of higher magnitude. Earthquake was first recorded in Nepal on June 7<sup>th</sup>, 1255 AD. In that earthquake, one third of the total population in Kathmandu was killed by a 7.7 Richter scale. Recent earthquakes near Kathmandu city are shown in Figure 5. Table 1 shows information of some historical earthquake in and around Nepal.

- ▼ Gangtok, Sikkim, India. October 3, 2013. Magnitude 5.3
- ▼ Banepa, Nepal. August 30, 2013. Magnitude 5.0
- ▼ Tulsipur, Nepal. June 28, 2013. Magnitude 5.0
- ▼ Tulsipur, Nepal. August 23, 2012. Magnitude 5.0
- ▼ Kishanganj, West Bengal, India. March 27, 2012. Magnitude 5.0
- ▼ Kathmandu, Nepal. November 12, 2011. Magnitude 4.2
- ▼ Gangtok, Sikkim, India. September 14, 2011. Magnitude 6.9
- ▼ Darjiling, West Bengal, India. June 3, 2011. Magnitude 5.0
- ▼ Kathmandu, Nepal. December 29, 2010. Magnitude 5.2
- ▼ Khandbari, Nepal. February 26, 2010. Magnitude 5.5

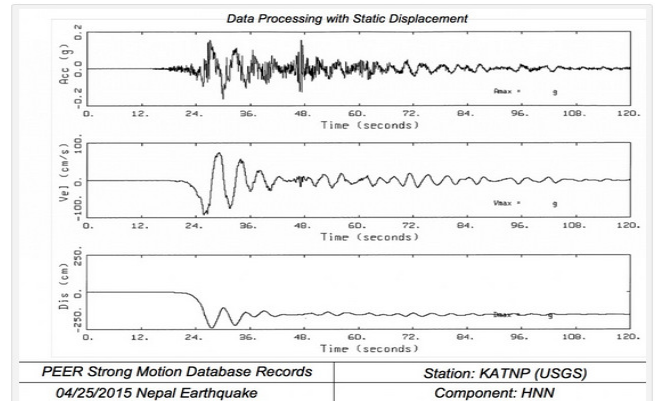
Figure 19 Strong motion record of Nepal earthquake (PEER Berkeley)

The ground motion during the earthquake was too strong. A strong motion record from a station KATNP (USGS) is shown in

Figure 11. In Figure19, the upper plot shows acceleration, middle shows velocity, and bottom shows displacement of the ground, revealing motion due to elastic seismic waves, but also the finite net southern shift of 1.5 m.

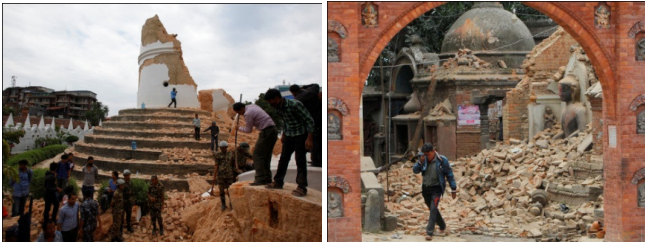
Figure 20 Damages of some historical places (National Post News)

Across many districts of the country, thousands of houses were destroyed with entire villages flattened, especially those near the epicenter. Several of the churches, temples and monasteries in the Kathmandu valley were destroyed. Several pagodas on Kathmandu Durbar Square, a UNESCO World Heritage Site, collapsed, as did the Dharahara tower, built in 1832. The collapse of the latter structure killed at least 180 people. Manakamana Temple in Gorkha district is also destroyed. The northern side of Janaki Mandir in Janakpur was also damaged. Many temples, including Kasthamandap, Panchtale temple, the top levels of the nine-story Basantapur Durbar, the Dasa Avtar temple and two dewals located behind the Shiva Pārbati temple were destroyed by the earthquake. Some other monuments, including the Kumari Temple and the Taleju Bhawani Temple got partially collapsed. The top of the Jaya Bageshwari Temple in Gaushala and some parts of the Pashupatinath Temple, Swyambhunath, Boudhanath Stupa, Ratna Mandir, inside Rani Pokhari, and Durbar High School have been destroyed. In Patan, the Char Narayan Mandir, the statue of Yog Narendra Malla, a pati inside Patan Durbar Square, the Taleju Temple, the Hari Shankar, Uma Maheshwar Temple and the Machhindranath Temple in Bungamati were destroyed by the quake. In Tripureshwar, the Kal Mochan Ghat, a temple inspired by Mughal architecture, was completely destroyed and the nearby Tripura Sundari also suffered significant damage. In Bhaktapur, several monuments, including the Fasi Deva temple, the Chardham temple and the Vatsala Durga Temple of 17<sup>th</sup> century were fully or partially destroyed.

Outside the valley, the Manakamana Temple in Gorkha, the Gorkha Durbar, the Palanchok Bhagwati, in Kabhre Palanchok district, the Rani Mahal in Palpa district, the Churiyamai in Makwanpur district, the Dolakha Bhimsensthan in Dolakha district, and the Nuwakot Durbar were partially destroyed. The north eastern parts of India also received major damage. Heavy shocks were felt including the states Utrakhnad, Uttar Pradesh, West Bengal and many other states. A huge damage was caused to the property and the lives of the people. Figure 20 to Figure 23 shows images of different damages in the earthquake.

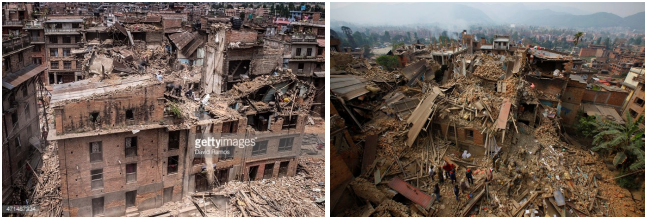
Figure 21 Damages of superstructures (globalnews.ca)

Apart from damages to heritage and historical monuments, a large number of houses have collapsed. The damages to houses have occurred in many districts. In general adobe and brick / stone in mud have collapsed, while properly constructed RCC buildings have mostly survived even in Barpak area, the epicenter of Gorkha earthquake of 25<sup>th</sup> April 2015.

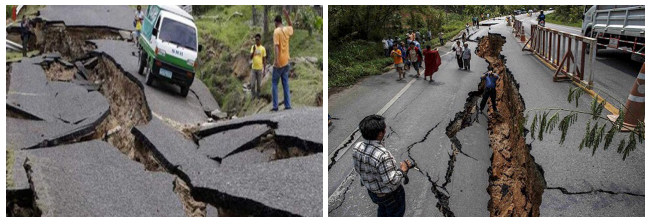
Figure 22 Damages of Transport system (mormonsoprano.com)

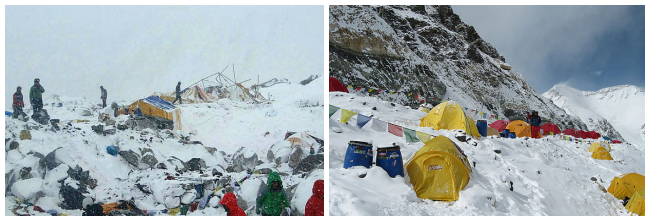
Figure 23 Damages in Everest (www.telegraph.co.uk)
