# Performance of Piled Raft Foundation Subjected to Strong Seismic Motion

**ABSTRACT:** This paper offers a case history of a low-rise building, located in Ibaraki Prefecture, supported by a piled raft in medium to dense sand underlain by over consolidated silty soil. To confirm the validity of the foundation design, field measurements were performed on the foundation settlement and the load sharing between the piles and the raft from the beginning of the construction to 80 months after the end of the construction. During the monitoring period, 44 months after the end of the construction, the 2011 off the Pacific coast of Tohoku Earthquake struck the site of the building. The peak horizontal ground acceleration of  $3.24 \text{ m/s}^2$  was observed in the neighbourhood of the building. Although the foundation settlement near the centre of the raft increased by 4 mm from the pre-earthquake value of 21 mm to 25 mm, no significant changes in the load sharing between the piles and the raft were found after the strong seismic motion.

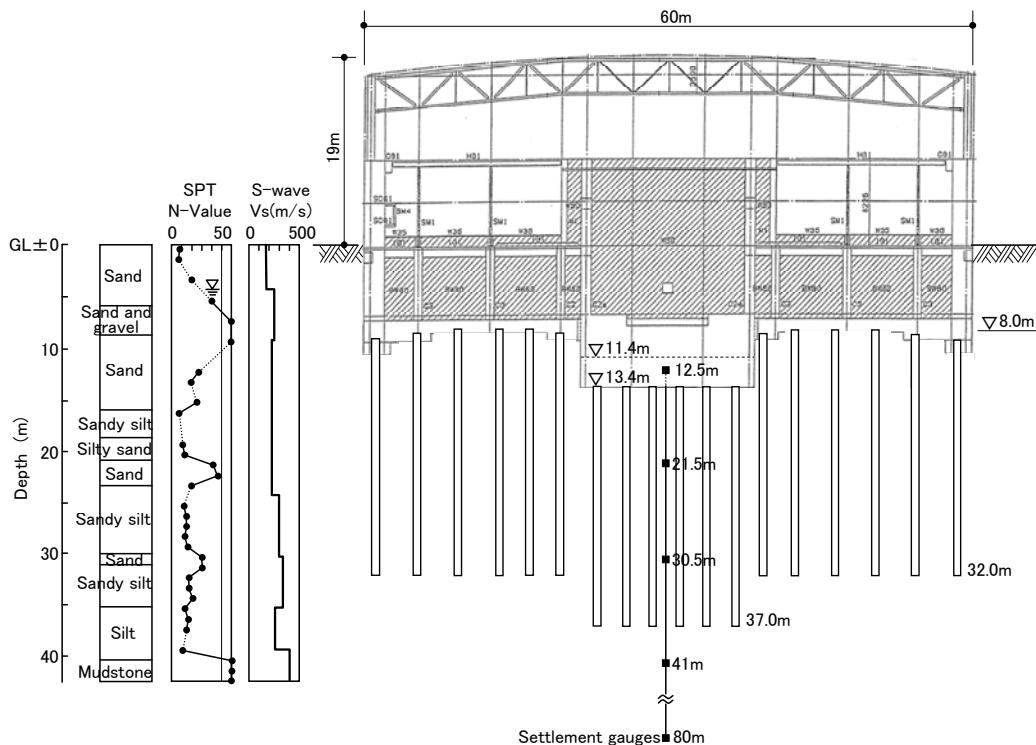
Figure 1 Schematic view of structure with soil profile

The hadron experimental hall is located at J-PARC (Japan Proton Accelerator Research Complex) in Ibaraki Prefecture (Photo 1). The J-PARC is a joint project between KEK (High Energy Accelerator Research Organization) and JAEA (Japan Atomic Energy Agency) to study material and life science, hadron and particle physics using high-intensity and high-energy proton beam. Figure 1 shows a schematic view of the structure with a soil profile, together with the results of shear wave velocity measurements of soil. The hadron experimental hall, 19 m in height above the ground surface, is a steel reinforced concrete structure. The subsoil consists of loose to dense sand with SPT  $N$ -values of 7 to 40 to a depth of 6 m from the ground surface, underlain by diluvial dense sand-and-gravel with SPT  $N$ -values of 60 or higher and medium to dense sand with SPT  $N$ -values of 20 to 60 to a depth of 16 m. Between the depths of 16 to 23 m, lie medium sandy silt, loose silty sand and dense sand. Between the depths of 23 and about 40 m, lie stiff sandy silt and silt layers with unconfined compressive strengths of 180 to 480 kPa, underlain by a weathered sandy mudstone.

The groundwater table appears about 4 m below the ground surface. The shear wave velocities derived from the P-S logging using down-hole technique, carried out at a neighbouring site, were 230 to 250 m/s in the medium to dense sand just below the foundation levels and 400 m/s in the weathered mudstone.

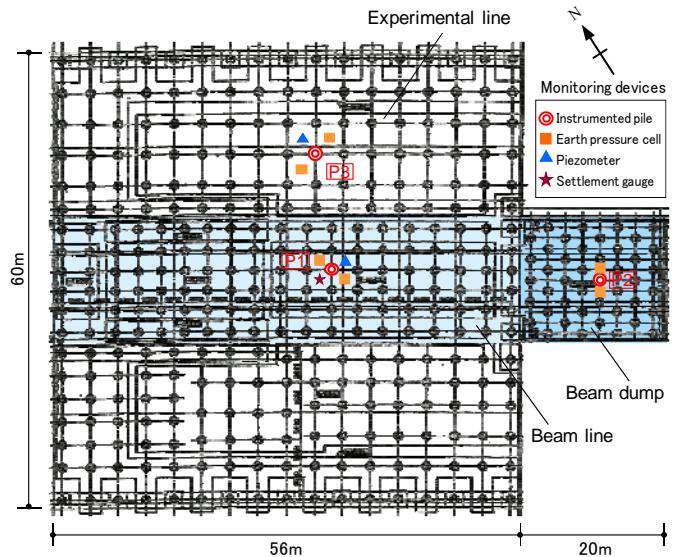
Figure 2 Foundation plan with locations of monitoring devices

Figure 2 shows the foundation plan with a layout of the piles. The hadron experimental hall consists of a beam line, an experimental line and a beam dump. The average pressure over the raft was 259 kPa (196 kPa) in the experimental line, 350 kPa (294 kPa) in the beam line and 442 kPa (294 kPa) in the beam dump: the figures in the parentheses were the live loads. The live loads were relatively large, 67 to 84% of the total load, because a lot of iron and concrete shielding blocks were to be set up after the end of the construction. The foundation level of the beam line is at a depth of 11.4 m, partly 13.4 m, and that of the beam dump is at the depth of 13.4 m, while the foundation level of the experimental line is at a depth of 8.0 m from the ground surface (Photo 2). A reinforced concrete mat was founded on the dense sand-and-gravel and medium to dense sand, so that the allowable bearing capacity at the foundation levels was much higher than the average contact pressure. If a raft foundation were used, the maximum settlement would be estimated to be greater than the allowable value of 40 mm due to the compression of the cohesive soil layers below the depth of 23 m. Therefore, to reduce the settlement of the raft foundation, a piled raft foundation consisting of 371 PHC (pre-tensioned spun high-strength concrete) piles was proposed. The PHC piles are 22.0 to 25.5 m in length and have diameters varying from 0.60 to 0.80 m (330 piles of 0.60 m, 35 piles of 0.70 m and 6 piles of 0.80 m).

Field measurements were performed on the vertical ground displacements below the raft, the axial loads of the piles and the contact pressure between the raft and the soil, as well as the pore-water pressure beneath the raft from the beginning of the construction to 80 months after the end of the construction. The locations of the monitoring devices are shown in Figure 2. The LVDT-type transducers were installed near the centre of the raft at depths of 12.5, 21.5, 30.5 and 41.0 m to measure the relative

displacements to a reference point at a depth of 80 m from the ground surface, as shown in Figure 1. Three piles, P1, P2 and P3, 0.6 m in diameter were installed with a couple of LVDT-type strain gauges at the pile head and the pile toe. A pair of LVDT-type earth pressure cells was installed beneath the raft near the instrumented piles. The LVDT-type piezometers were installed near Piles P1 and P3.

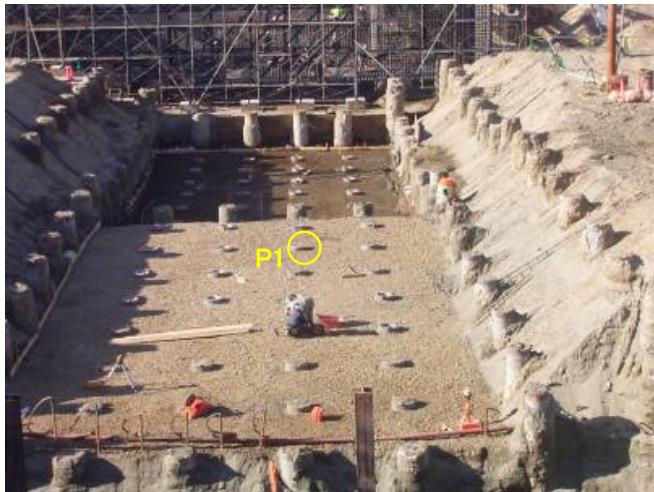
Photo 2 View of ground surface at foundation level in beam line

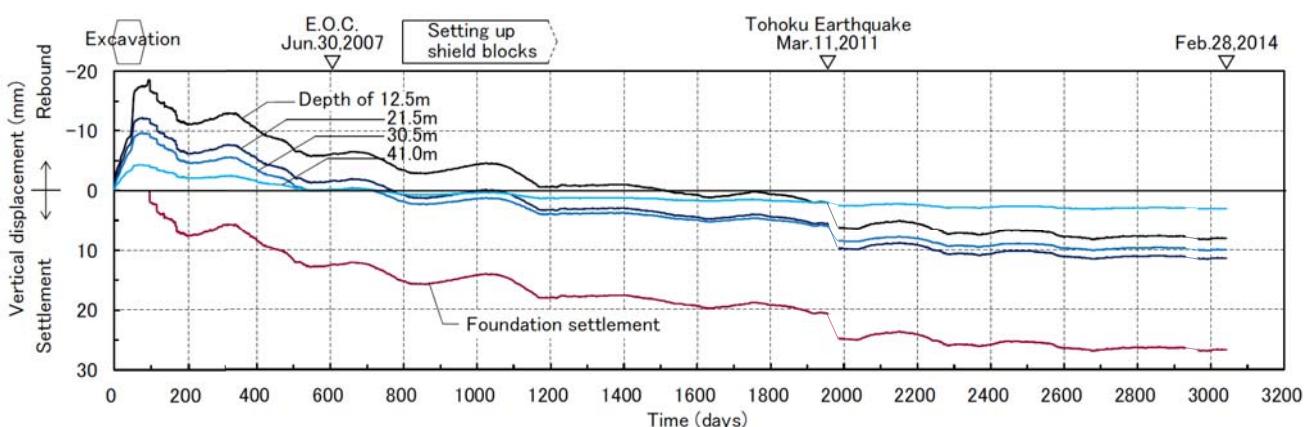
Figure 3 Measured vertical ground displacements in beam line

Figure 3 shows the measured vertical ground displacements relative to the reference point near the centre of the raft. The ground displacement at the depth of 12.5 m was approximately equal to “foundation settlement” when it was initialised just before the casting of the foundation mats. The foundation settlement was 12.4 mm at the end of the construction. Thereafter, the settlement increased due to the setting up of the shielding blocks and reached 20.7 mm on March 11, 2011, just before the 2011 off the Pacific coast of Tohoku Earthquake. Figure 4 shows the measured axial loads of Pile P1 and the contact pressure and the pore-water pressure beneath the raft near Pile P1. Figure 5 shows those of Pile P2 and the contact pressure and the pore-water pressure beneath the raft near Pile P2 where the values of the pore-water pressure were estimated from those near Pile P1. The measured pile-head load of Pile P1 increased considerably after the end of the construction due to the setting up of the shielding blocks. The measured contact pressure increased gradually after the end of the construction, while the measured pore-water pressure was almost constant.

After the earthquake, a part of the shielding blocks were removed to align experimental devices in the beam line. This caused the decrease in the total load and the foundation settlement in the beam line, as shown in Figure 6(a) and Figure 3. The shielding blocks were set up again about six months after the earthquake and the foundation settlement increased. Thereafter, the foundation settlement was stable and reached 26.7 mm at the end of the observation, 36 months after the earthquake. The hadron experimental hall resumed operation in January 2012, after the alignment of the experimental devices.

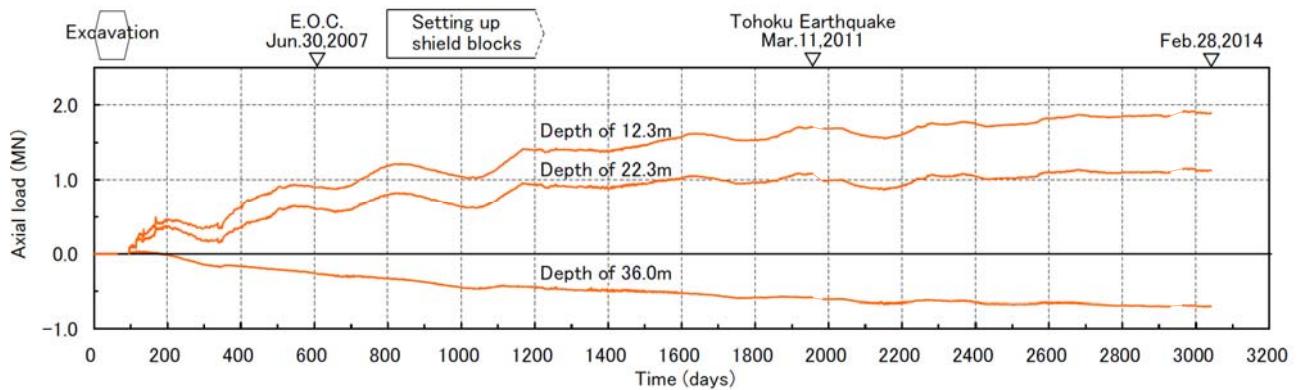
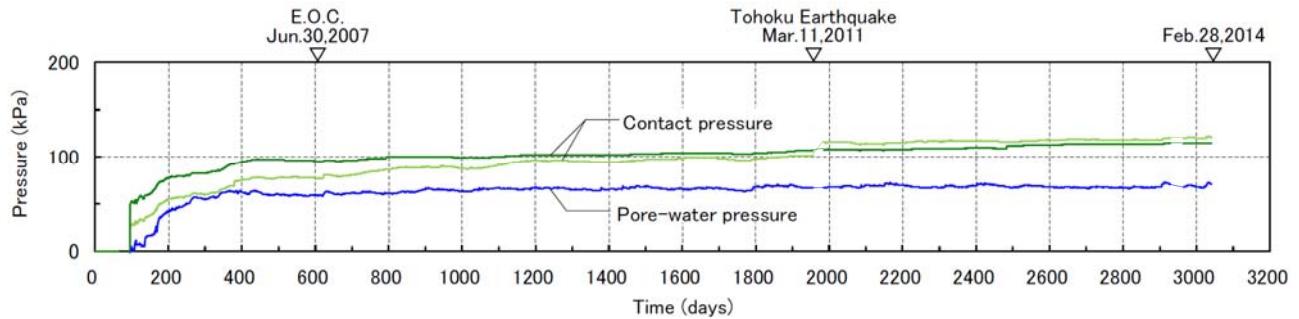
(a) Axial loads of Pile P1

(b) Contact pressure and pore-water pressure

Figure 4 Measured axial loads of pile and contact pressure in beam line

The axial loads of Pile P1 decreased only slightly and the contact pressure near Pile P1 increased slightly after the earthquake as shown in Figure 4. On the other hand, the axial load of Pile P2 at pile head increased 30% and the contact pressure near Pile P2 increased 39% after the earthquake as shown in Figure 5. The increase in the loads of both the pile and the raft seemed to be caused by the loss of the vertical frictional resistance on the basement walls due to the subsidence of the backfill sand induced by the strong seismic motion. So, a part of the structure load, which was supported by the frictional resistance, was transferred to the bottom of the raft and distributed to the soil beneath the raft and the piles. The increase in the pile load and the contact pressure appeared remarkably in the beam dump because the ratio of the perimeter to the planar area was relatively large. The measured pore-water pressure was not affected by the seismic motion as shown in Figures 4(b) and 5(b).

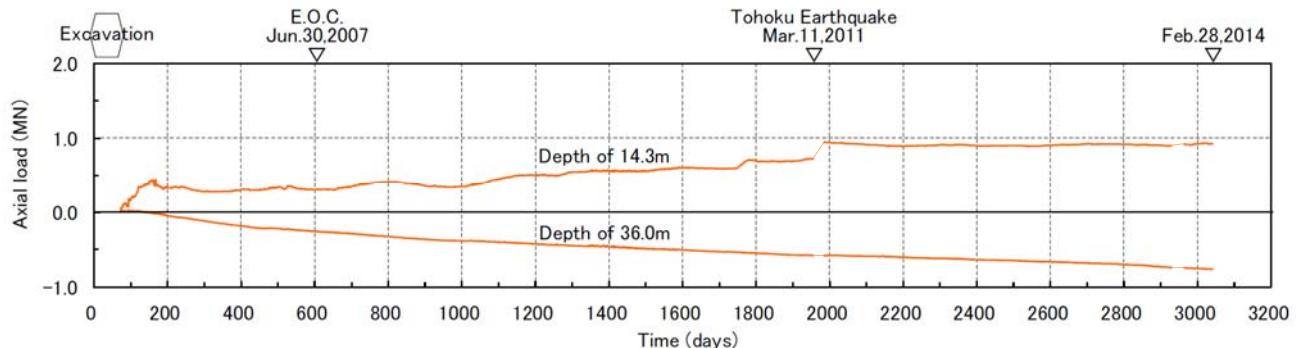
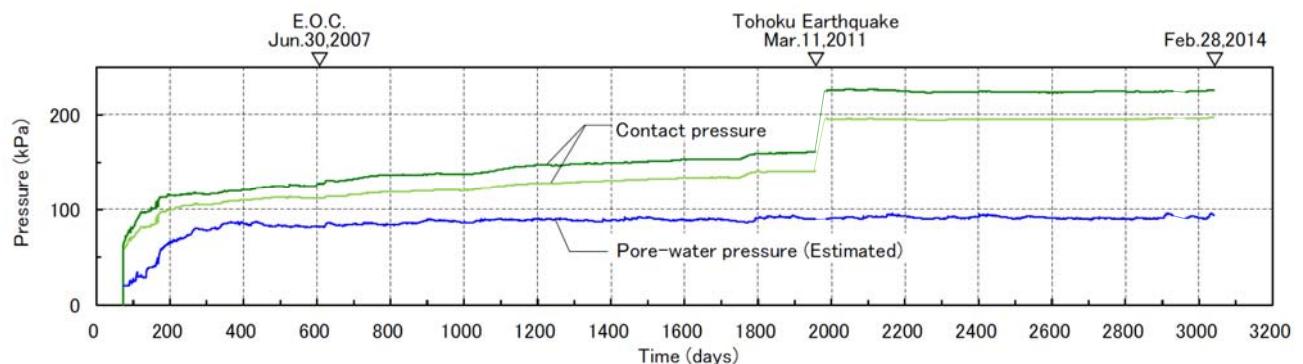
(a) Axial loads of Pile P2

(b) Contact pressure and pore-water pressure

Figure 5 Measured axial loads of pile and contact pressure in beam dump

As for Pile P3, the measured pile-head load was approximately zero even after the end of the construction. This was likely that the actual load was much smaller than the design load in the experimental hall and the load was carried mostly by the buoyancy force.

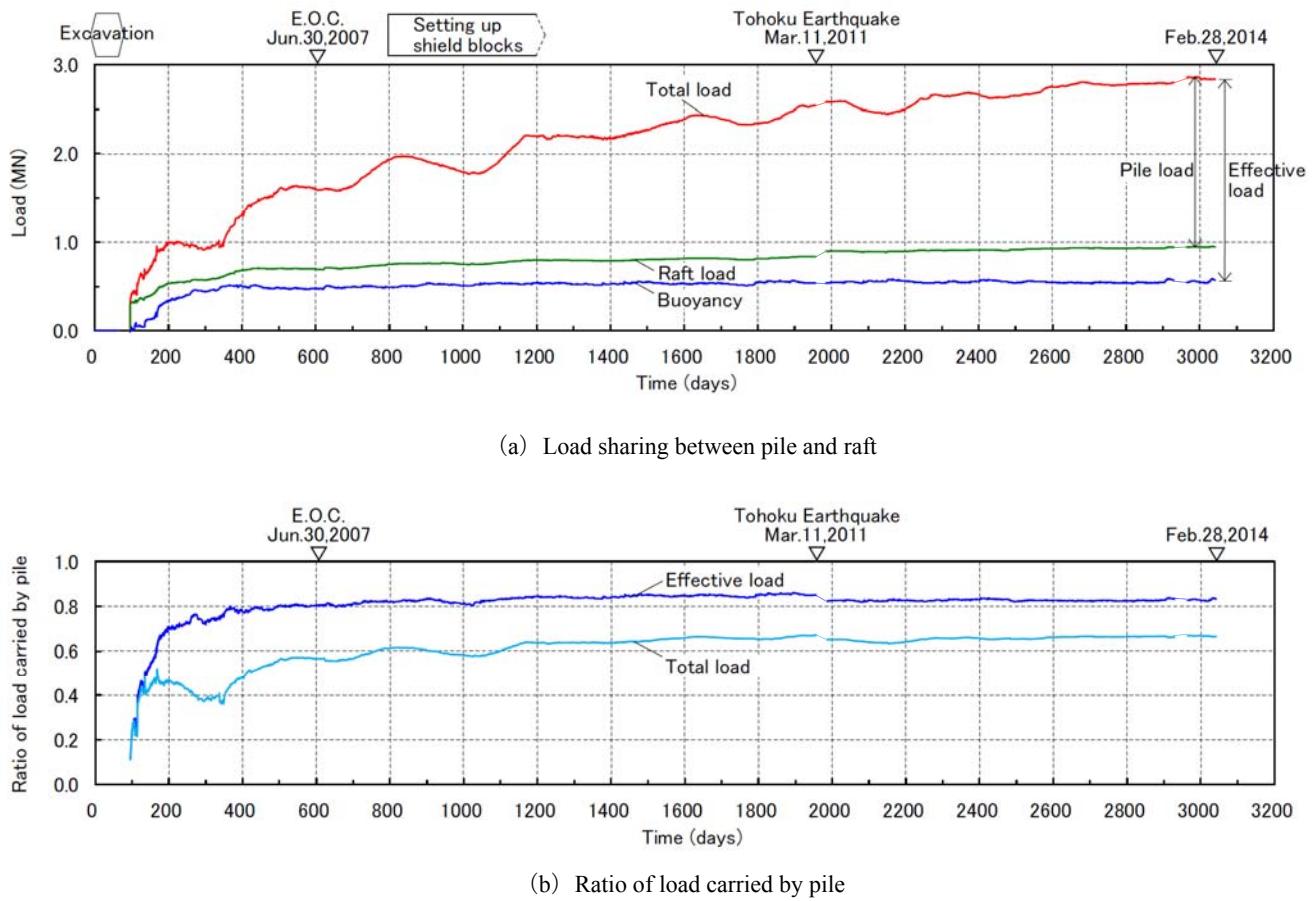
Figure 6 Load sharing between piles and raft in tributary area of Pile P1

Figure 6 shows the time-dependent load sharing among the piles, the soil and the buoyancy and the ratio of the load carried by the pile to the effective structure load versus time, together with that to the total structure load versus time, in the tributary area of Pile P1.

Here, the total load was the sum of the measured pile-head load and the raft load, which was derived from the mean value of the measured contact pressures, and the effective load was the total load minus the buoyancy. Figure 7 shows those in the tributary area of Pile P2. The ratios of the load carried by the piles to the effective load were estimated to be 0.85 in Pile P1 and 0.67 in Pile P2 just before the earthquake. The ratios of the load carried by the piles to the total load were estimated to be 0.67 in Pile P1 and 0.45 in Pile P2.

The ratio of the load carried by the piles to the effective load in the tributary area of Pile P1 decreased only slightly from 0.85 to 0.82 and that of Pile P2 decreased slightly from 0.67 to 0.57 28 days after the earthquake. Thereafter, the ratios of the load carried by the piles to the effective load were quite stable, i.e., 0.83 for the former and 0.57 for the latter at the end of the observation, 36 months after the earthquake. Incidentally, though the monitoring system was suspended again at the beginning of November, 2013 because of data storage capacity trouble, the system was restored in December, 2013 as shown in Figures 3 to 7. Meanwhile, the ratios of the load carried by the piles to the total load decreased only slightly from 0.67 to 0.65 in Pile P1 and from 0.45 to 0.43 in Pile P2 28 days after the earthquake. Thereafter, the ratios of the load carried by the piles to the total load were quite stable, i.e., 0.67 for the former and 0.43 for the latter at the end of the observation.

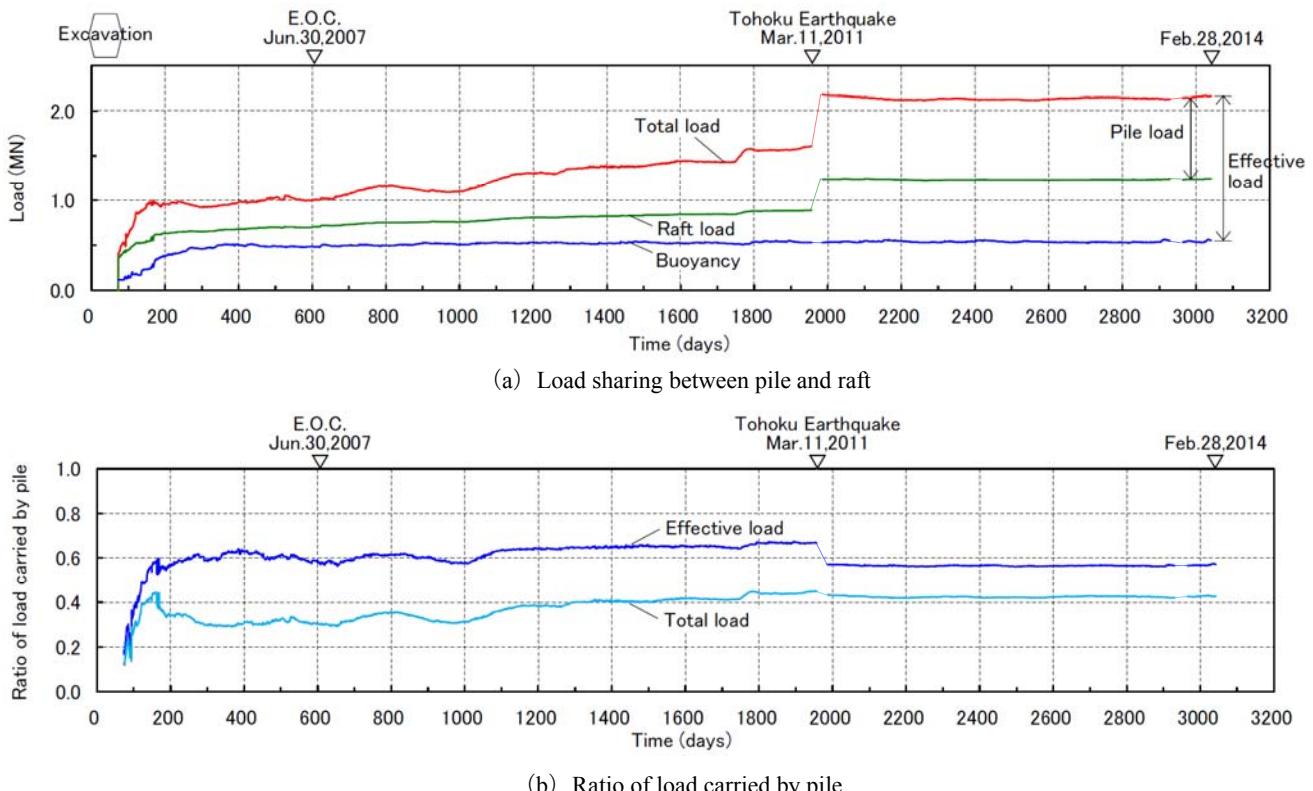
Figure 7 Load sharing between piles and raft in tributary area of Pile P2

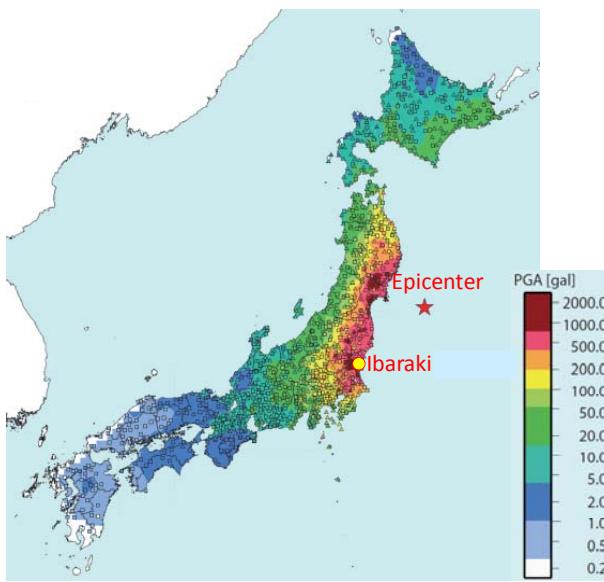
Figure 8 PGA map derived from strong motion records  
(Kunugi et al., 2012)

The 2011 off the Pacific coast of Tohoku Earthquake, with an estimated magnitude of  $M_w = 9.0$  on the Moment Magnitude Scale, struck East Japan at around 14:46 (local time) on March 11, 2011. Figure 8 shows peak ground acceleration map derived from strong motion records of K-NET and KiK-net (Kunugi et al., 2012). The distance from the epicentre to the building site was about 270 km and the seismic intensity in the site was estimated to be “6 weak” according to JMA (Japan Meteorological Agency).

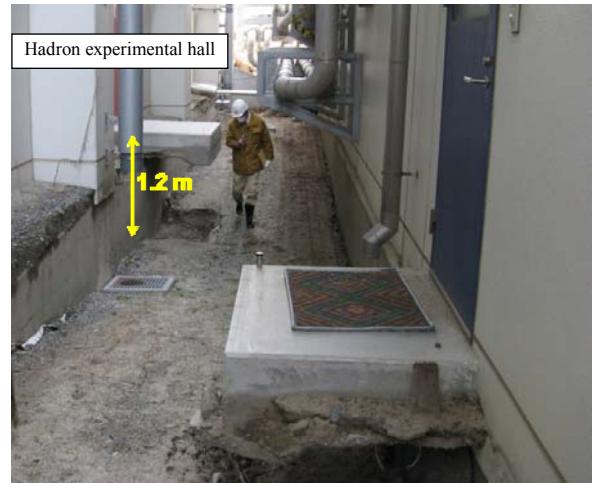
Photo 3 Ground subsidence along building

Photo 3 shows the ground subsidence along the northeast side of the hadron experimental hall near the north corner. The ground subsidence reached a maximum of 1.2 m, which was presumed to be caused by compaction of the backfill sand due to the strong horizontal and vertical ground motion. Although the monitoring system was suspended immediately after the earthquake because of power outage, the system was restored 28 days after the earthquake.

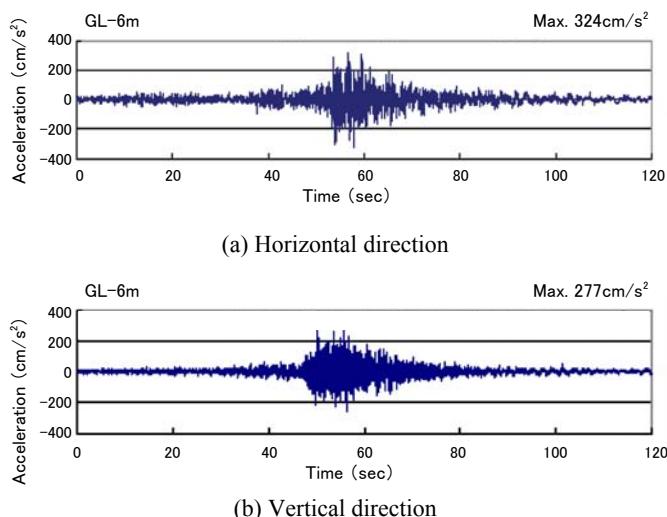
Figure 9 Time histories of accelerations at Tokai  
(Hashimura et al., 2011)

Hashimura et al. (2011) has reported about the response characteristics of a five-story base-isolated building located 0.4 km south from the hadron experimental hall. Figure 9 shows the time histories of accelerations observed at a depth of 6 m below the ground surface near the five-story building. The peak horizontal ground acceleration was  $3.24 \text{ m/s}^2$  and the peak vertical one was relatively large value of  $2.77 \text{ m/s}^2$ . Figure 10 shows the response spectra with a 5% damping ratio of the horizontal acceleration of the ground and that of the basement. It can be seen that the amplitudes of the short-period components are larger and the predominant period was around 0.2 s.

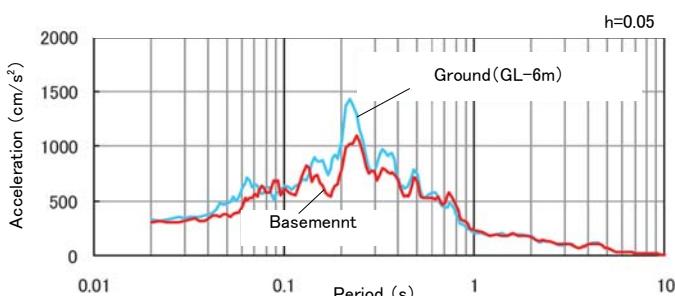
Figure 10 Response spectra of horizontal accelerations at Tokai  
(Hashimura et al., 2011)

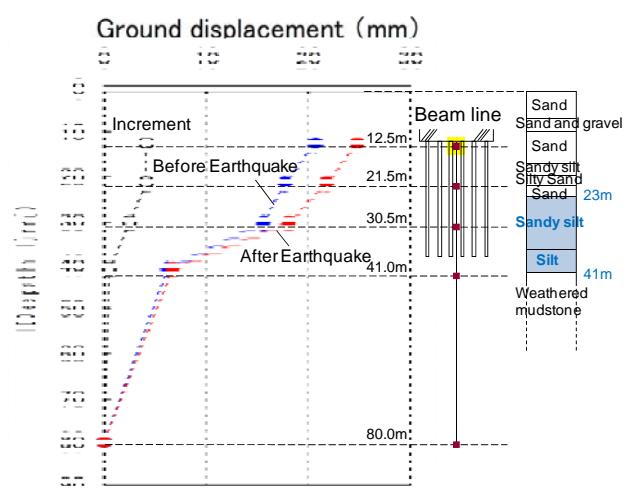
Figure 11 Profiles of vertical ground displacements

Figure 11 shows the profiles of the measured vertical ground displacements near the centre of the raft just before and after the earthquake, where the measured displacements were initialised just before the casting of the foundation mats. The foundation settlement increased by 4.1 mm from the pre-earthquake value of 20.7 to 24.8 mm 28 days after the earthquake. It can be seen that the increments in the ground displacements occurred mostly by the compression of the stiff silty soil layers between depths of 23 and 41 m. It is likely that the compression of the silty soil was caused by the vertical cyclic loading due to the inertial force acting on the structure, mostly via the pile group.
