# Tunnelling Induced Deformation of a Historic Building in Shanghai

**ABSTRACT:** Tunnelling induced deformations of a historic building, Chongsi Building, in Shanghai, China, are reported. The construction site located in Xuhui District, along the Metro line 11, and at the site the thickness of soft soil layer, soft clay and clayey silt, is about 30 m. The tunnelling method used is the earth pressure balance (EPB) shield tunnelling. The building with masonry structure was built about a century ago, and there were already considerable deformations. Considering this situation, the criteria for total and incremental deformations have been proposed; especially the twist criteria have been newly established and applied to the project. Controlling both the total and incremental deformations is called Dual-control criteria (DCC). The measured maximum settlement, differential settlement, and twist during tunnelling construction were 13.29 mm, 0.67 mm/m, and  $3.23 \times 10^{-5}$  rad/m respectively. Based on the monitoring results, the deformations of the historic building during and after tunnel construction were very small and, causing no serious damage to the building, and it is cons

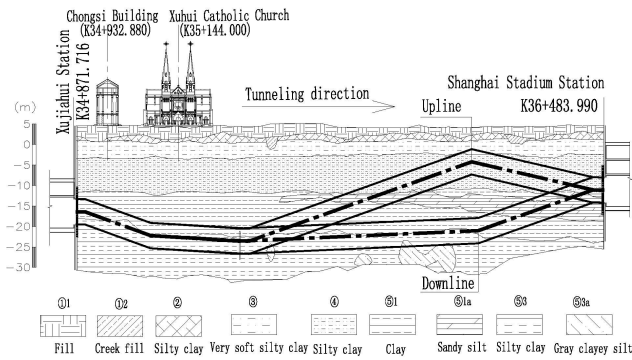
Figure 1 Soil profile and the location of tunnels

The historic building is located between Xujiahui Station and Shanghai Stadium Station of Metro line 11, Shanghai, China. The soil strata at the project site are shown in Figure 1 and the physical properties of the main soil layers are summarized in Table 1. The ground is mainly consisted of very soft silty clay (③ and ④), clay (⑤1), and silty clay (⑤3) (Figure 1).

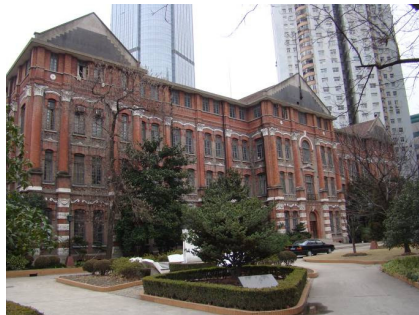
Figure 2 Chongsi Building

The both lines (up and down) of Metro line 11 are undercrossing Chongsi Building of Xuhui Middle School, which is a historical building and located at the right side of Xujiahui Station. Figure 2 is the picture of the building.

Four-story Chongsi Building was built in 1918. From the first to the fourth floor, the heights are 4.877 m, 4.267 m, 4.887 m, and 3.887 m respectively. The main structure of Chongsi Building was made of bricks with some concrete beams. The total length of the building axis in east-west direction is 66.140 m, and 25.144 m in south-north direction. The distance between the axis of the tunnel and ground surface is about 17.2 m, and the horizontal distance between the two axes of the tunnels is 18.4 m. The relative position of building and the tunnels is shown in Figure 3(a) and (b).

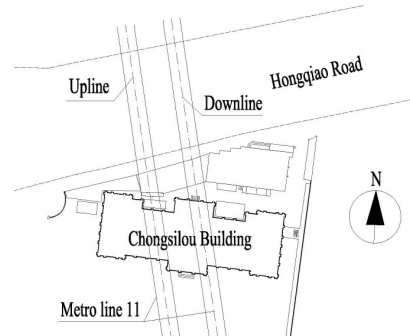
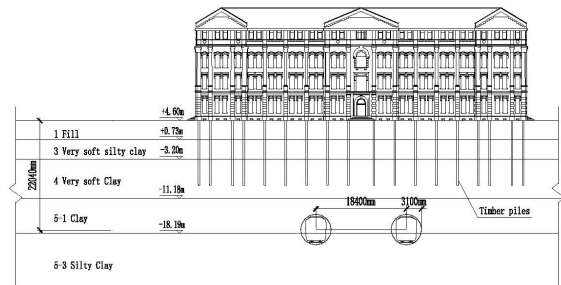
Figure 3 Schematic diagram of relative position of the building and the tunnels

(a) Plan view of the tunnels and Chongsi Building

(b) Cross-sectional view of the tunnels and Chongsi Building

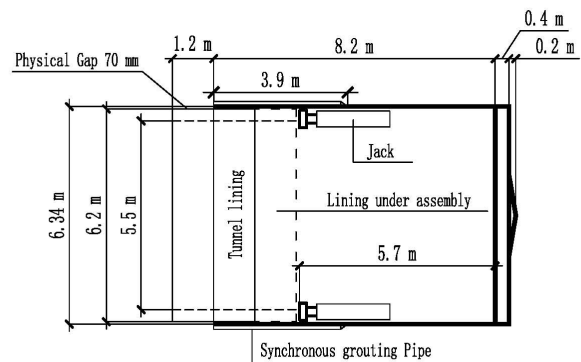
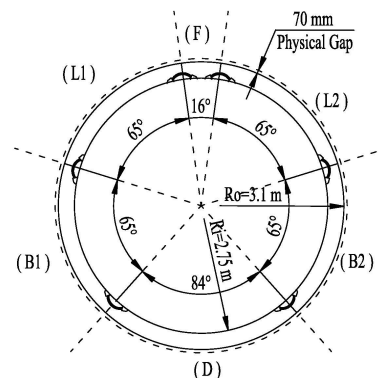
Figure 4 Earth pressure balance shield tunneling machine and Lining cross-section

The earth pressure balance (EPB) shield tunnelling method was used in this project. The shield body is 8.8 m in length and 6.34 m in diameter. The main properties/features of the EPB machines used for the project are listed in Table 2. A schematic diagram of the EPB shield is shown in Figure 4(a). The outer and inner diameter of the tunnel is 6.2 m and 5.5 m respectively as shown in Figure 4(b). The linings of the tunnels are made of reinforced concrete segments and the length of each ring is 1.2 m.

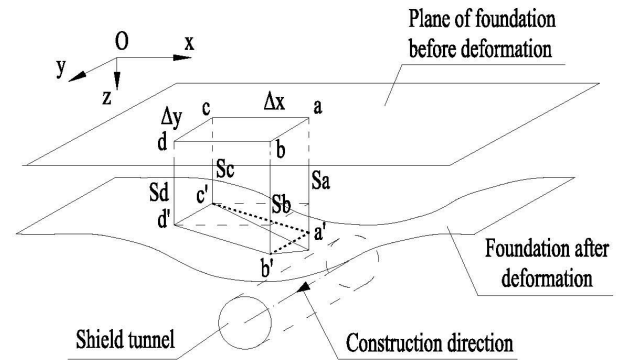
Figure 5 Twist of building foundation

Let's only consider the settlement ( $z$  direction) of a small (infinitesimal) area of a foundation,  $abcd$ , as shown in Figure 5, and its location after deformation is  $a'b'd'e'$ .

The settlement at points  $a$ ,  $b$ ,  $c$  and  $d$  are  $S_a$ ,  $S_b$ ,  $S_c$  and  $S_d$  respectively. The deformation of  $abcd$  can be divided into three parts, uniform settlement (or upheaval), rigid rotation and twist. As shown in Figure 5, there is only uniform settlement when it comes to the dashed line position and only rigid rotation from the dashed line to the dotted line position, and only twist from the dotted line position to the final position. Designating  $\overline{ac} = \overline{bd} = \Delta x$ , and  $\overline{ab} = \overline{cd} = \Delta y$ , the twist ( $T_w$ ) of  $abcd$  can be calculated as follows:

$$T_w = \frac{(S_a - S_b) - (S_c - S_d)}{\Delta x \cdot \Delta y} \quad (1)$$

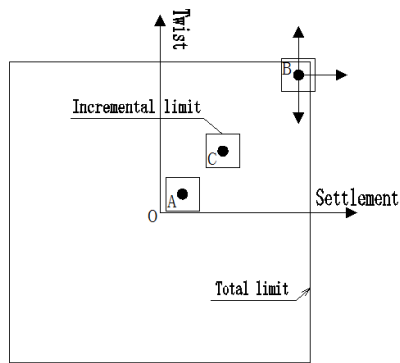
Figure 6 Concept diagram of the DCC method

The total deformation limit at a given point should be established by considering both total allowable absolute deformation and the allowable differential deformation. The incremental limit should be established by considering micro-disturbance due to construction as well as the total limit ( $T$ ). The concept of DCC (see Figure 6) is when the existing deformation plus the incremental limit is below the total limit, we control the incremental limit; and if it is over the total limit we control the total limit. To leave enough time to take countermeasures, generally the incremental limit ( $r$ ) should be smaller than the gap between the total limit ( $T$ ) and the existing deformation before the construction, such as the point A and C in Figure 6 (b). However, for a building and a given controlling item, only one incremental criterion is defined. There are locations at which existing deformation plus the incremental limit can over the total limit. In these locations, the controlling criterion will be the total one, such as the point B in Figure 6 (b).

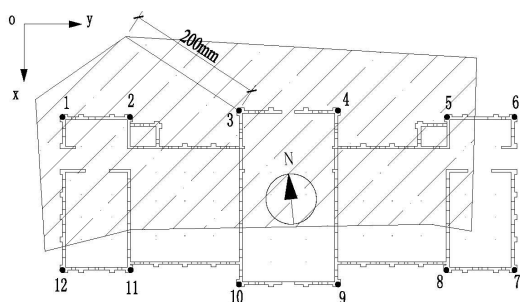
Figure 7 Comparison of the original building outline and the outline after deformation

The survey results about the façade tilting of the building are shown in Figure 7. The building tilted to north and west. The maximum tilt rate directing to north was 10 ‰ and to west was 15.3 ‰.

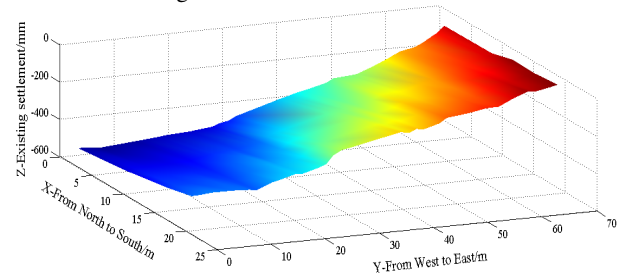
Figure 8 Relative height of bottom windowsill (unit: mm)

Relative heights of bottom windowsills are shown in Figure 8. The results indicate that the settlement was bigger in northwest and smaller in northeast, which coincides with the measured results of building façade tilt.

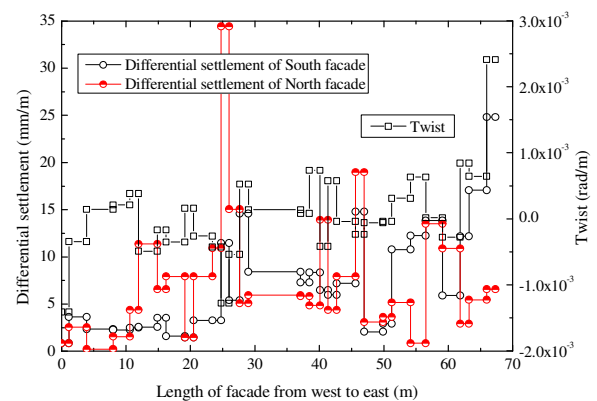
Figure 9 Original differential settlement and Twist of Chongsi Building

The original maximum twist of building before the tunnel construction was  $2.41 \times 10^{-3}$  rad/m and the original maximum differential settlement was 34.3 mm/m. The variations of the differential settlement and twist along west-east direction are shown in Figure 9.

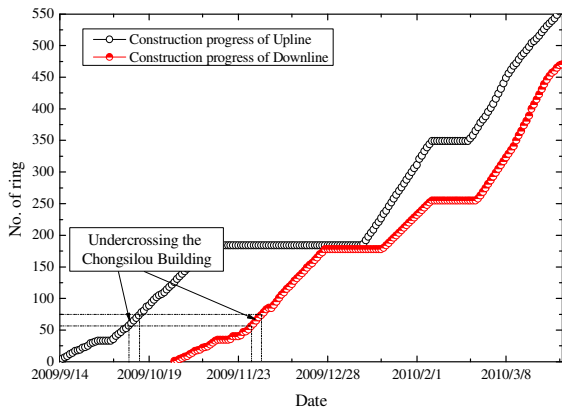
Figure 10 Construction progress of shield tunnels crossing historic buildings

The construction progress and the propulsion pressure of shield tunnels crossing the building are shown in Figure 10 and Figure 11. The vertical axis of the Figure 10 is the “Number of ring”, and the length of each ring is 1.2 m.

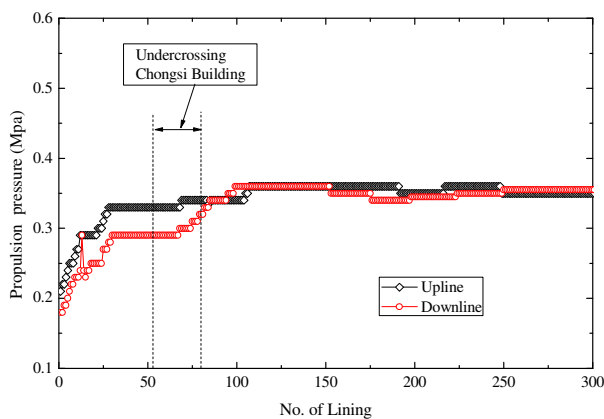
Figure 11 Propulsion pressure of shield tunnels crossing the historic building

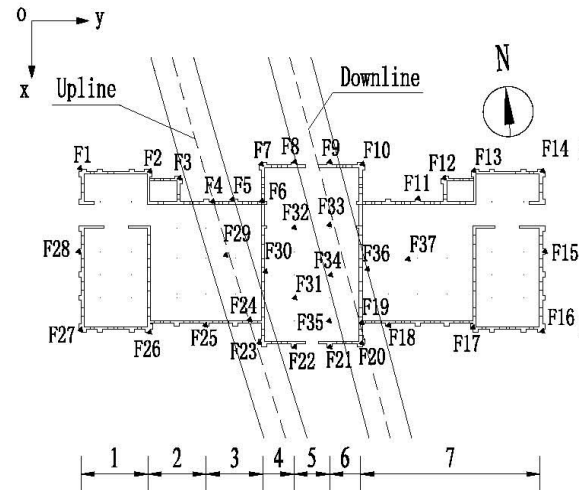
Figure 12 Plan of monitoring points of Chongsi Building

The deformation monitoring system had been installed around and on Chongsi Building before the tunnel construction. The plan view of the monitoring points is shown in Figure 12. The Arabic numbers indicate the building segments for twist calculation.

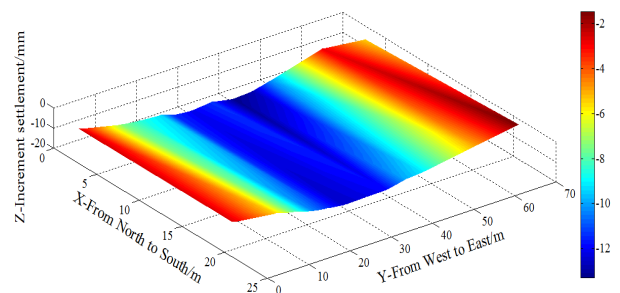
Figure 13 Contours of the settlements

The incremental settlements at the monitoring points of Chongsi Building during the tunnel construction are shown in Figure 13. The variations of the incremental settlements and the incremental twists of some key monitoring points are given in Figure 14 and Figure 15 respectively. Figure 16, Figure 17, and Figure 18 show the comparison of the existing, incremental and total differential settlements and twists. The maximum incremental settlement of the monitoring points was 13.29 mm, and the maximum incremental differential settlement was 0.67 mm/m, and the maximum incremental twist was  $3.23 \times 10^{-5}$  rad/m. It can be seen that the incremental twists were very small. In other words, the field data show that the tunnelling adopted induced deformation is not beyond the incremental limit, which indicate the construction of underground crossing is very successful and well controlled.

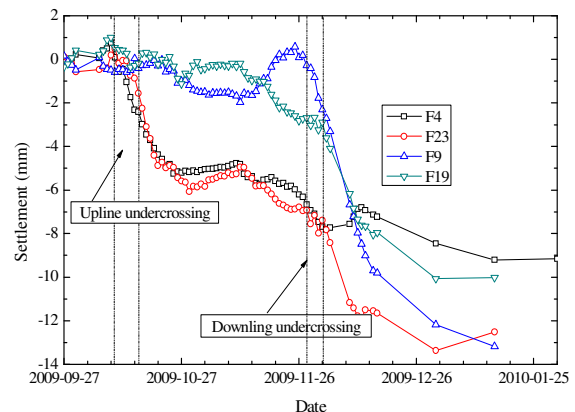
Figure 14 Settlement development with the construction process for some key measuring points

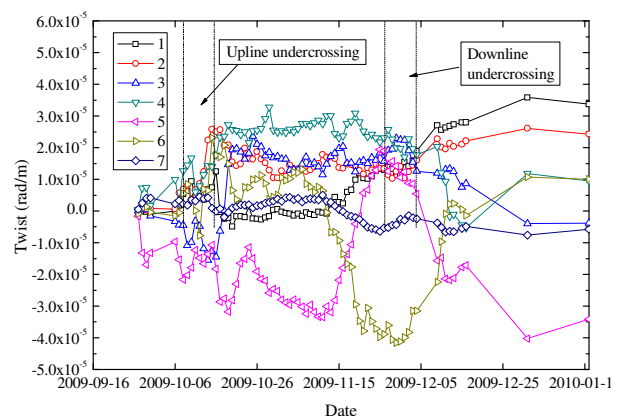
Figure 15 Development of twist with the construction process

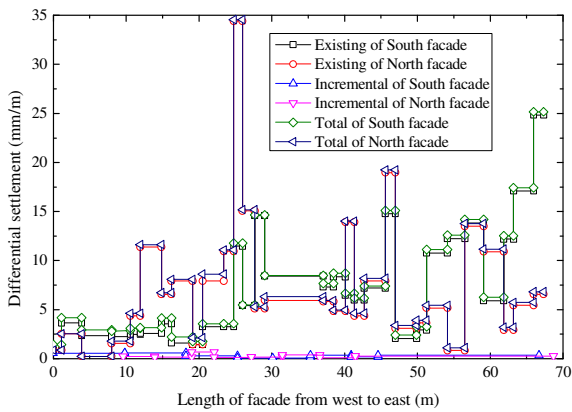
Figure 16 Comparison of existing, incremental and total differential settlements of Chongsi Building

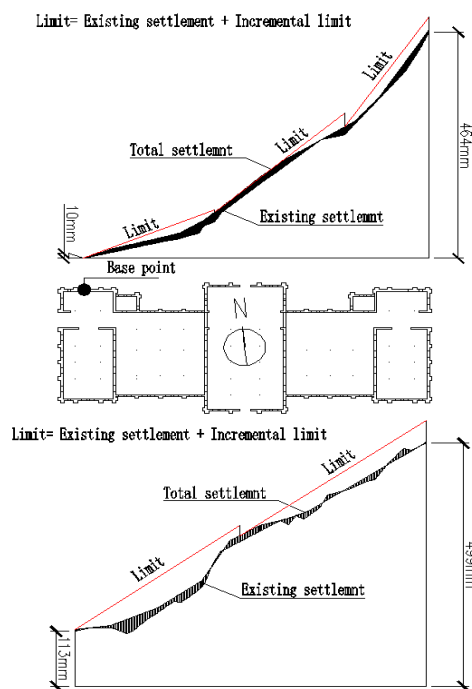
Figure 17 Comparison of existing, total settlements and incremental limit of Chongsi Building

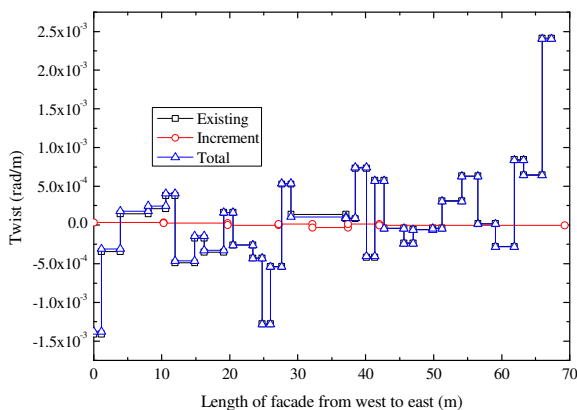
Figure 18 Comparison of existing, incremental and total twists of Chongsi Building
