KKU Engineering Journal

Public participation in erosion monitoring on Mekong mainstream

According to the construction of Xayaburi hydropower project in Laos, people along the Mekong River especially Thai people are worried about the impacts regarding to the development of hydropower projects on bank erosion. This research has an objective to create the procedure to observe the changing of river bank and increase scientific knowledge of local Thai people along the Mekong mainstream in order to adapt their livelihood. This research has provided the procedure of erosion monitoring through the forum among academic sector, governance sector and public sector in 32 villages of 8 provinces in Thailand along Mekong mainstream. Four rows of 4-inches wooden pegs were installed in pilot study areas at Songkram confluence in Chaiburi sub-district, Tha Uthen district, Nakhon Phanom province. This bank erosion changing was observed by a team that established from researchers and local people. From the observation, the vertical height of wooden pegs appears to present the values of the eroding and depositing which are occurred on the Mekong river bank. On November 24, 2015, it is found that the

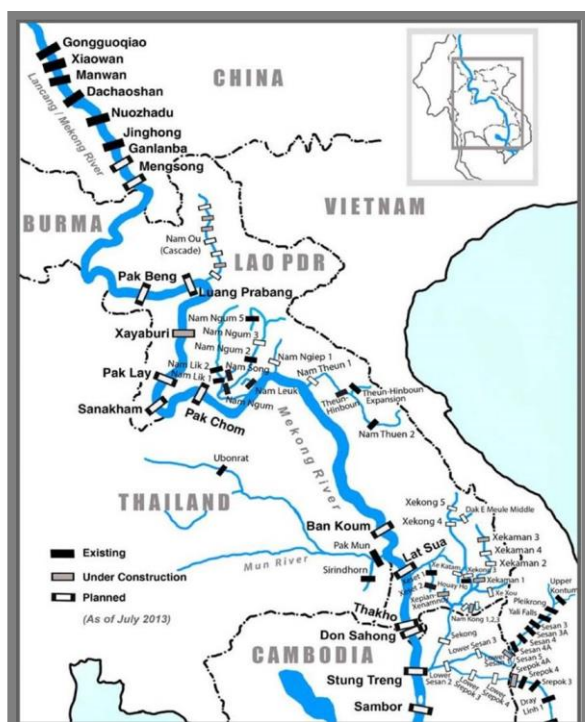
Figure 1 Proposed hydropower development project in Mekong mainstream [2]

Mekong River is one of great river in the world that has a lot of potential to develop hydropower project. Currently in the Upper-Mekong River especially in China, six hydropower dams; Xiaowan Dam, Jinghong Dam, Dachaoshan Dam, Manwan Dam, Nuozhadu Dam and Gongguoqiao Dam are operating while the first dam in Lower-Mekong River named Xayaburi Hydropower project in Laos is under construction and other 10 dams is on the plan as detailed in Figure 1 [1]. According to the construction of Xayaburi hydropower project in Laos, people along the Mekong River especially Thai people are worried both direct and indirect impacts regarding to the development of many hydropower projects on Mekong mainstream and its tributary that will effect to their livelihoods in terms of small-scaled fisheries, economic system, ecology system and so on.

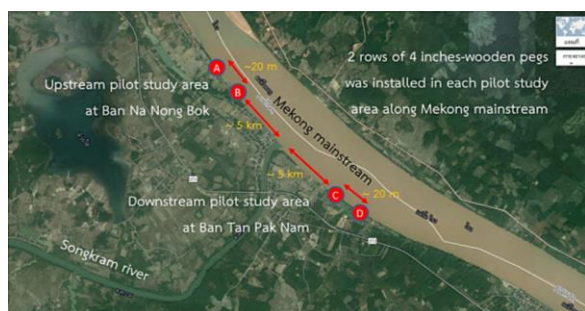
Figure 2 Two pilot study areas along Mekong mainstream

knowledge in order to adapt their livelihood according to the development of those 11 hydropower projects in Lower Mekong River that will be operate in the next few years. Therefore the erosion and deposit monitoring procedure has to be created by public sector collaborations. The pilot study areas for this study covered the area of Songkram confluence along the Mekong mainstream as illustrated in Figure 2.

The team has chosen 2 pilot study areas that located on upstream and downstream of Songkram confluence which are situated at Chaiburi sub-district, Tha Uthen district, Nakhon Phanom Province. The first pilot study area is located at Ban Na Nong Bok, and the second pilot study area is located at Ban Tan Pak Nam, as shown in Figure 2.

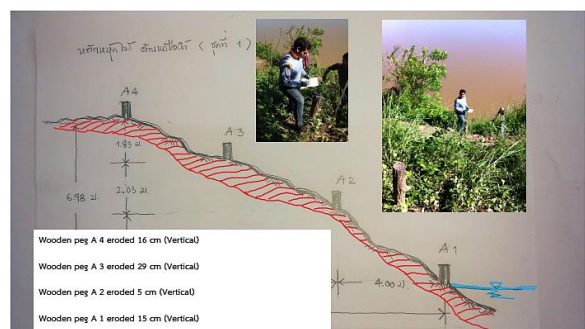
Figure 3 5th Monitoring of wooden peg in Line A at Ban Na Nong Bok (upstream)

5th Monitoring: On November 24, 2015, the team has observe and survey at site, and found that all wooden pegs are above the water due to the coming of dry season, the level of Mekong River is back to the lowest level. Additional, the team has found that at toe slope in row D, the wooden peg is tilting about 30 degree from vertical, and the measured vertical height of this wooden peg is about 120 cm, therefore the team observe that this peg is eroded 70 cm (120 cm – 50 cm) and the team has concluded that this is the highest risk case of erosion in this study as shown in Figure 3 to 6.

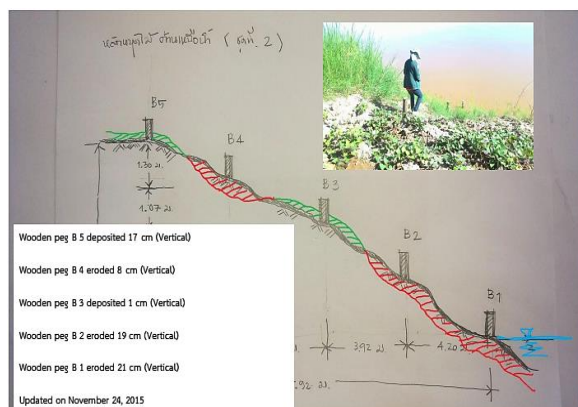
Figure 4 5th Monitoring of wooden peg in Line B at Ban Na Nong Bok (upstream)

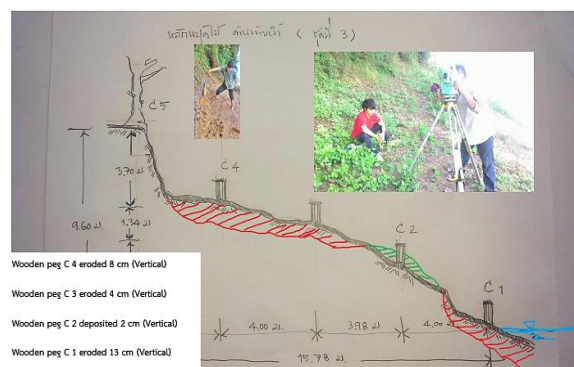
Figure 5 5th Monitoring of wooden peg in Line C at Ban Tan Pak Nam (downstream)

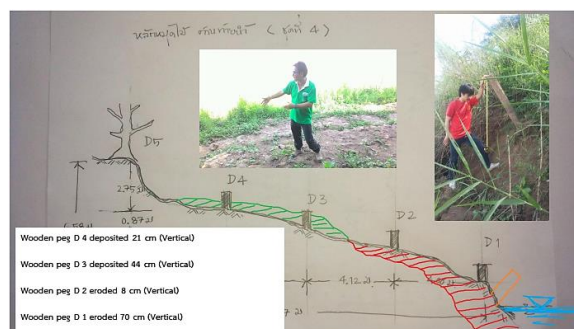
Figure 6 5th Monitoring of wooden peg in Line D at Ban Tan Pak Nam (downstream)
