## Tsunami risk assessment of the 2004 Indian Ocean tsunami in Kamala beach Phuket

Piyawat Foytong<sup>\*1)</sup> and Anat Ruangrassamee<sup>2)</sup>

**Keywords:** Tsunami risk assessment, Fragility curves, Reinforced-concrete building

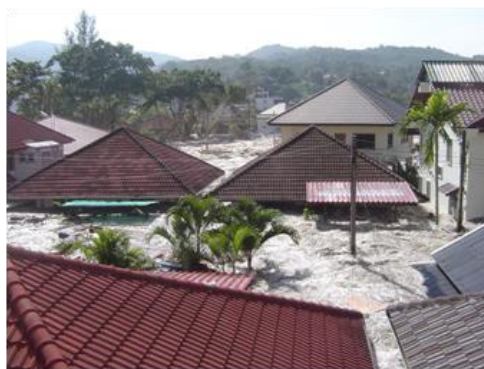
(a) The inundation height was about 3 m

**Figure 1** Damaged at Kamala Beach, Phuket due to the December 26th, 2004 tsunami (Courtesy of Mr. Paisan Pongnaritson)

From the observed database [2], the December 26th, 2004 tsunami caused the inundation height of about 3 m. which caused damage to many buildings in Kamala beach Phuket, Thailand as shown in Figure 1. Building damage data is distinguished into 5 zones. Zones are branched following the local road. Table 1 shows the number of damaged buildings in each zone for one-story buildings and buildings taller than one story. There are 62 observed damaged buildings in this area. 9 buildings suffered no damage, 31 buildings were damaged in secondary members, 19 buildings were damaged in primary members and 3 buildings collapsed. The distribution of 4 damage levels in this area for reinforced-concrete buildings is shown as Figure 2. From the observed damaged buildings, the average inundation heights and the probability of damage levels 0, 1, 2 and 3, which are average overall damage of buildings, of each zone for one-story buildings and buildings taller than one story are shown in Table 2. Most damage for one-story buildings is the damage level 2 and most damage for buildings taller than one story is the damage level 1. For zones 4 and 5, the probability of damage for one-story buildings is 100% because there are a small number of buildings in these zones.

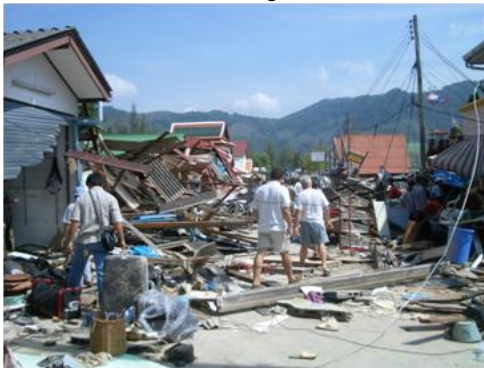
(b) Damage of residences and shops

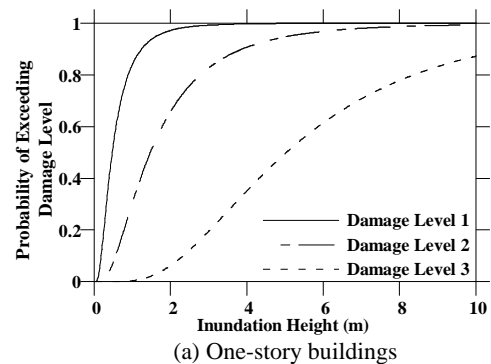
(a) One-story buildings

**Figure 3** Tsunami fragility curves of reinforced-concrete buildings [1]

The proposed tsunami fragility curves, which are used to evaluate the residential damage, are established from the building damage database in the December 26<sup>th</sup>, 2004 Indian Ocean tsunami [1]. The proposed tsunami fragility curves are considered only reinforced-concrete buildings. The fragility curves are developed using a maximum likelihood method and describe the damage probability corresponding to a specific damage level for different inundation heights. The damage levels are classified into 4 damage levels ranging from no damage to collapse; 1) no damage (DL0), 2) damage in secondary members only (DL1), 3) damage in primary members (DL2) and 4) collapse (DL3). The tsunami fragility curves for reinforced-concrete buildings are classified into two types: one-story buildings and buildings taller than one story as shown in Figure 3(a) and Figure 3(b), respectively.
