POTENTIAL DEVELOPMENT OF SACRIFICIAL ANODE CATHODIC PROTECTION APPLIED FOR SEVERELY DAMAGED RC BEAMS AGED 44 YEARS

Two specimens of 44-year-old severely damaged RC beams having a span of 2400 mm and 200x300 mm cross-section, both suffering from chloride-induced corrosion of the reinforcement are prepared as "RC1" and "RC2" marking. The polymer modified mortar as the material of patch repair section is applied to the middle tension area in the dimension of 70x150x800mm. Four cylindrical sacrificial zinc anodes with 30 mm diameter and 130 mm length installed in the parent concrete by LiOH cementitious coating material. Corrosion inhibitor applied to the tension steel bar surface of the patch repair section in RC2, since the natural macro-cell corrosion was naturally occurred before the repair. Half-cell potential test of rebar by silver/silver chloride reference electrode (SSE) in every 5 cm on the side section of specimen's surface, and the current density of sacrificial zinc anodes are measured regularly on 0, 7, 14, 21, and 32-days presented in this paper.

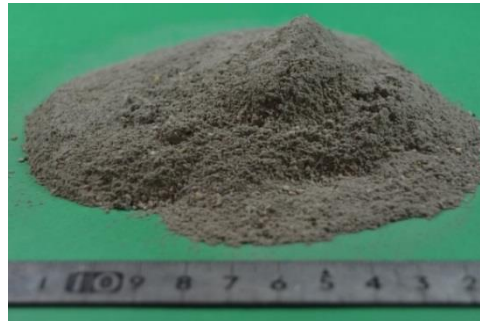
Figure 2 Polymer modified cement for mortar

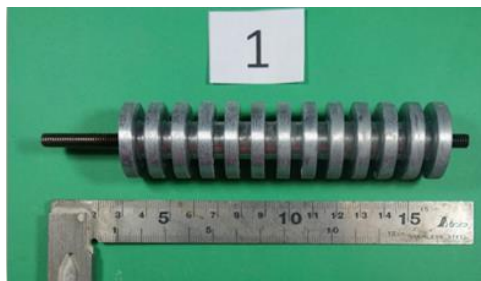
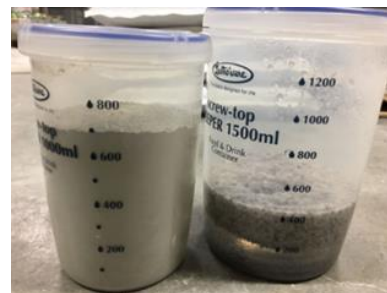
Figure 3 (a) Sacrificial Zinc Anode (b) Cementitious anode coating material mixed with LiOH

sacrificial zinc anode (Figure 3(a)) with a diameter of 30 mm, a length of 139 mm and an approximate weight of 417 grams were installed in pre-drilled holes of 40 mm diameter in parent concrete and cementitious coating material with LiOH (Figure 3(b)) was used to cover the anodes after settling

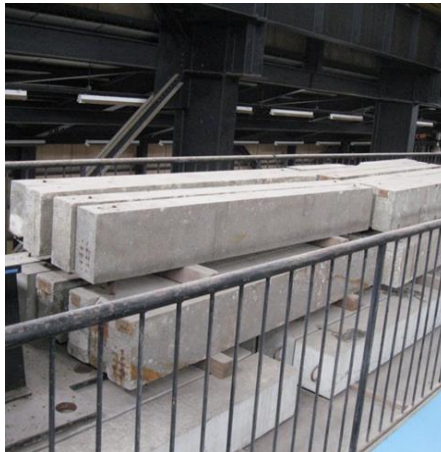
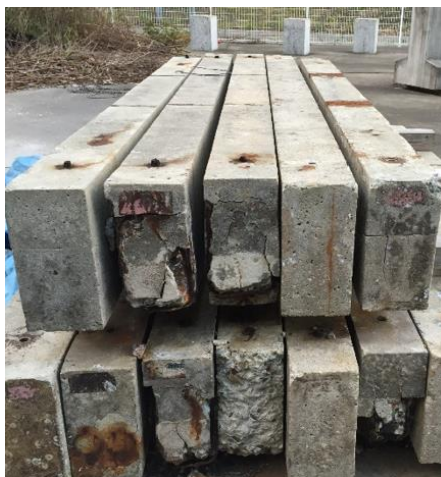
Figure 4 Exposure condition at (a) Sakata Port (1975-1995)[7], (b) PARI Laboratory (1995-2010), (c) Kyushu University (2010-2018)

The two specimens repaired were exposed to the natural marine environment for 20 years (1975-1995) at Sakata Port as shown in Figure 4(a) [5, 7-10], hereinafter Figure 4(b) showed it sheltered from the rain at the Port and Airport Research Institute (PARI) laboratory in Yokosuka, Japan (1995-2010), furthermore the RC beams were moved and stored at the outside exposure field in Kyushu University Ito Campus, Fukuoka, Japan (2010-2018). After the repair process, the specimens were kept for two days' wet condition by tap water followed by the five days' dry condition in the laboratory air.

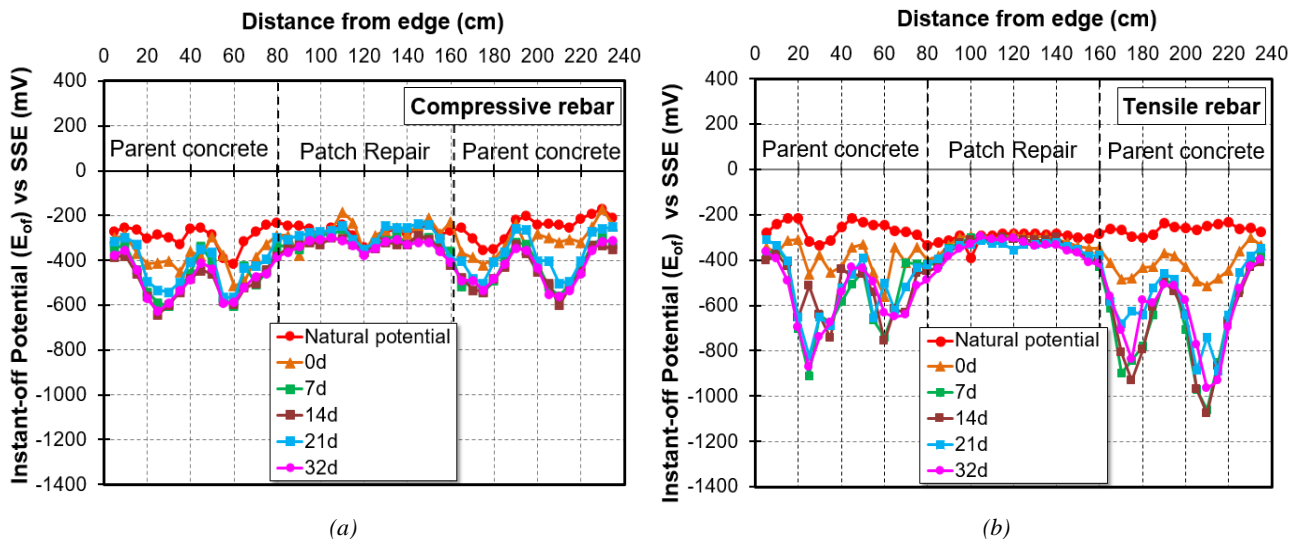
Figure 7 Natural and instant-off potential of (a) compressive rebar and (b) tensile rebar on RC1

This study focuses on the performance of sacrificial zinc anodes to deliver protection current embedded in the parent concrete, especially to the tensile rebar which is the most severely damaged condition. Potential shift of rebar was observed during 32-days after the installation of the anodes. Figure 7 and 8 present the instant-off potential of compressive and tensile rebar, measured at the position of 15 cm and 5 cm vertical distance from the anode position. The polarization of the tensile rebar is larger than that of the compressive rebar due to its closer position to the anode. The polarization is found in the parent concrete, but it is not found in the patch repaired position, because of the inherent differences in properties between patch repair material and parent concrete. In this case, the potential shift is almost limited to the distance of approximately 200 mm away from the anodes position.

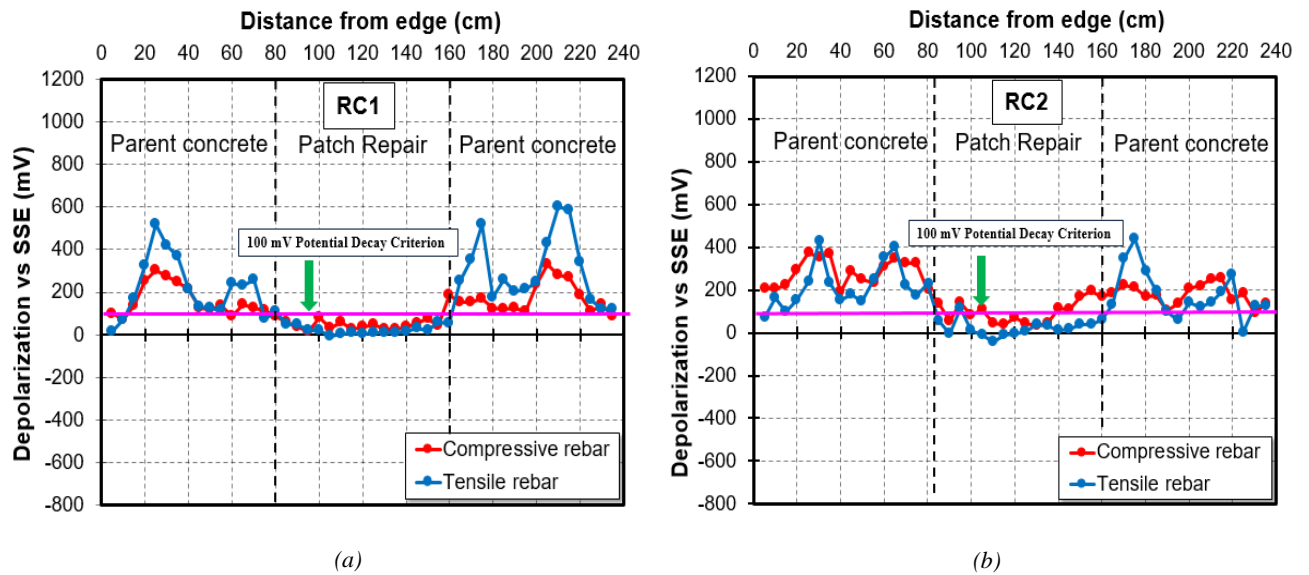
Figure 9 Depolarization of rebar on (a) RC1 and (b) RC2 at 32 days

Depolarization test of rebar was done at 24-hours after the disconnection of anode. Normally, potential decay criterion of 100 mV is adopted for assessing the performance of sacrificial zinc anodes. Figure 9 presents the depolarization value after 32-days of the connection. It can be seen that in the RC1, the protection zone was in parent concrete, both of compressive and tensile rebar, but the patch repair area is non-protection zone. Compared to the RC1, depolarization value of RC2 in patch repair section is slightly higher. It may be due to the application of corrosion inhibitor in the tensile rebar. Nevertheless, the corrosion inhibitor applied in the patch repair cannot be evaluated “effective” against the corrosion of rebar at the only 32-days.
