# The Strategic Design Approaches for Chittagong Hill Areas to Reduce Risks of Landslides and Exploring the Opportunity of Tourism Development

**Syed Monirul Islam\* / Maher Niger\*\***

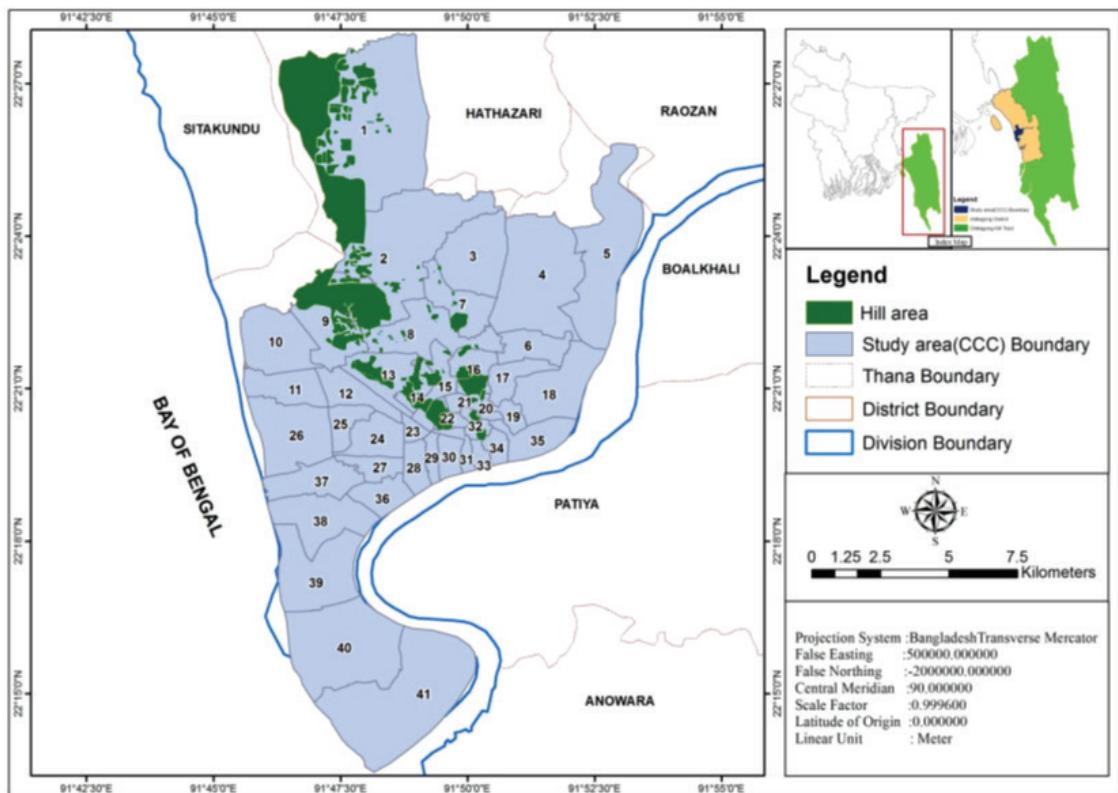
Figure 2:  
Existing Hilly Area in Chittagong City Corporation (CCC)  
(Source: Chittagong Development Authority)

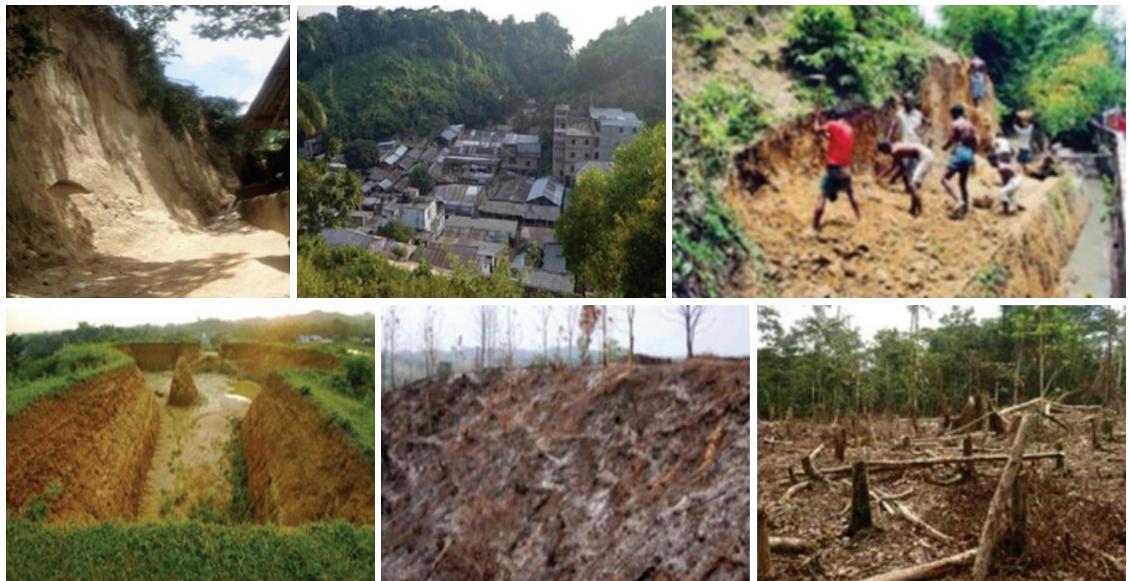
Figure 3:  
Features of landslide area of Chittagong city

**De-vegetation and deforestation:** In the hilly areas de-vegetation and deforestation means cutting small plants and forests. In the study area, de-vegetation and deforestation was reported by 75% and 63% respectively. Prior to a few decades ago enriched vegetation cover was a prominent feature of the hilly areas. Vegetation protects the soil and makes slopes stable which reduces the risk of landslides. Large trees provided strong structures in the earth that anchored the soil and protected it from any erosion (Sultana, 2013). The de-vegetation and deforestation is increasing day by day due to various human interventions. A number of hills in the study area were found with no vegetation coverage. (Figure 3)

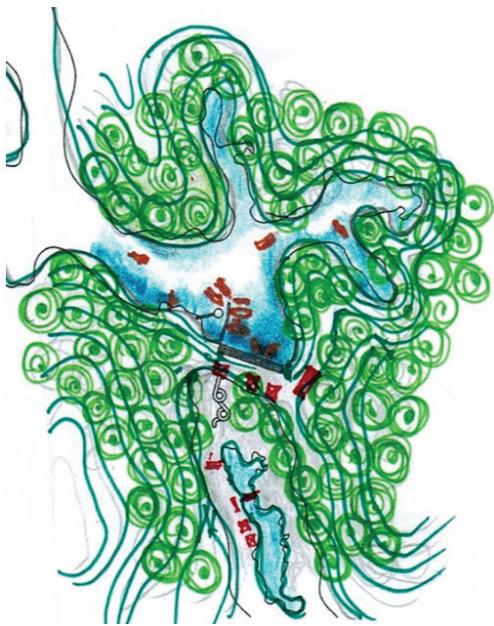
Figure 4:  
Site plan of Foy's Lake with amusement facilities.

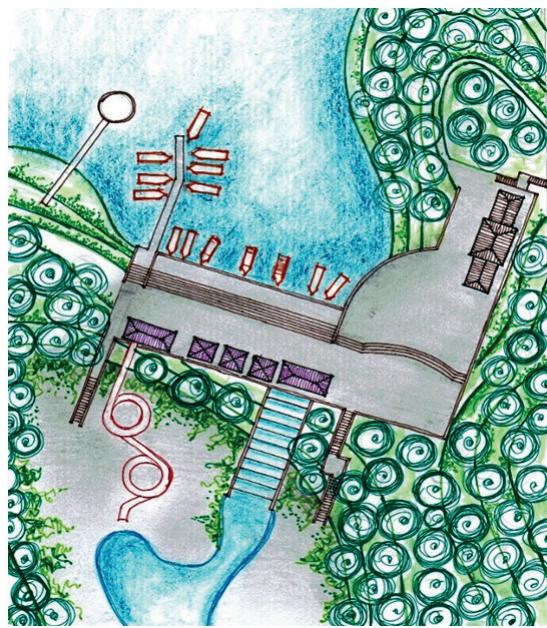
Figure 5:  
Amusement facilities on a platform between hills.

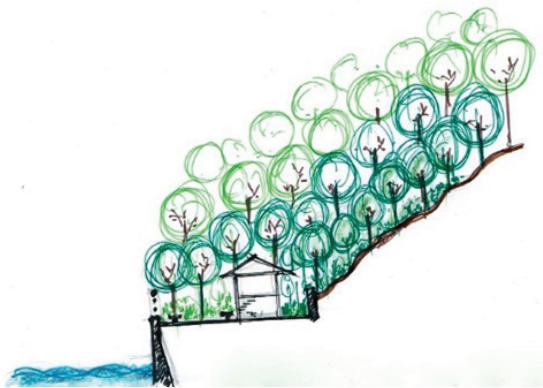
Figure 6:  
Retaining wall has been constructed to protect foothill.

- The trees, shrubs, bushes and grass on hill slopes grab the soil creating stability of hill slopes and reduce the scope of landslide.
- Retaining walls have been constructed at critical positions in the hills and contribute to landscaping works such as walkways, a fountain, steps and a platform on the lake. There are also some buildings which are very close to the foothills that are constructed with the support of retaining walls.

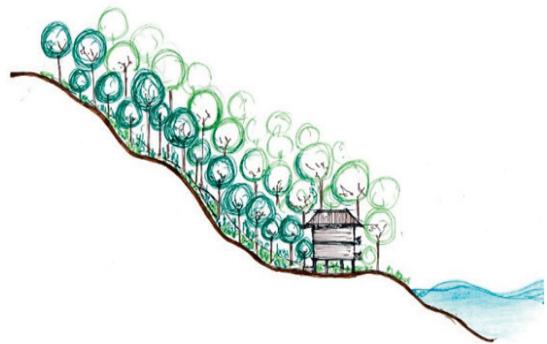
Figure 7:  
Slope of hill is remain untouched and building has been constructed on flat land keeping a distance from foothill.

- Almost all buildings (used as restaurant, shops, cottage and resorts) have been constructed on flat land, maintaining a distance from the foot hills and on the platform between the hills without disturbing hill slopes' stability.

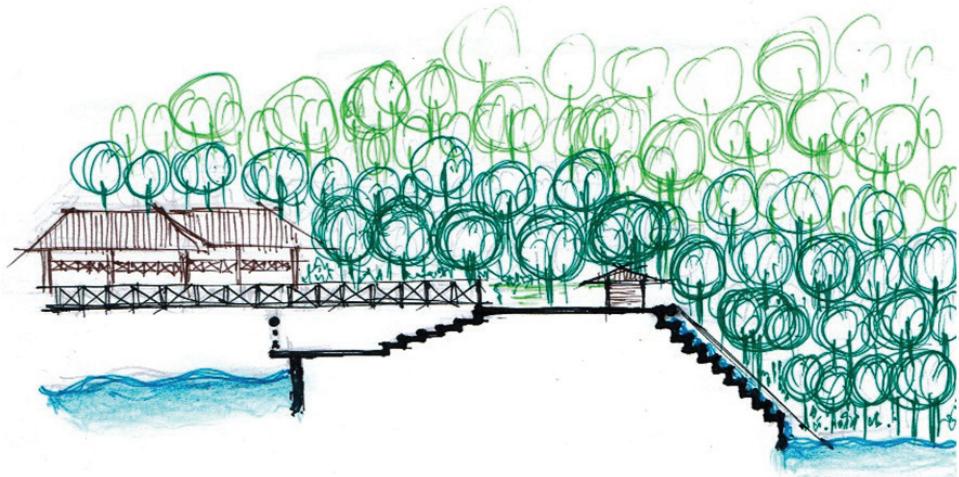
Figure 8:  
Slope of hill and bank of lake has been utilized and protected with steps and fountain.

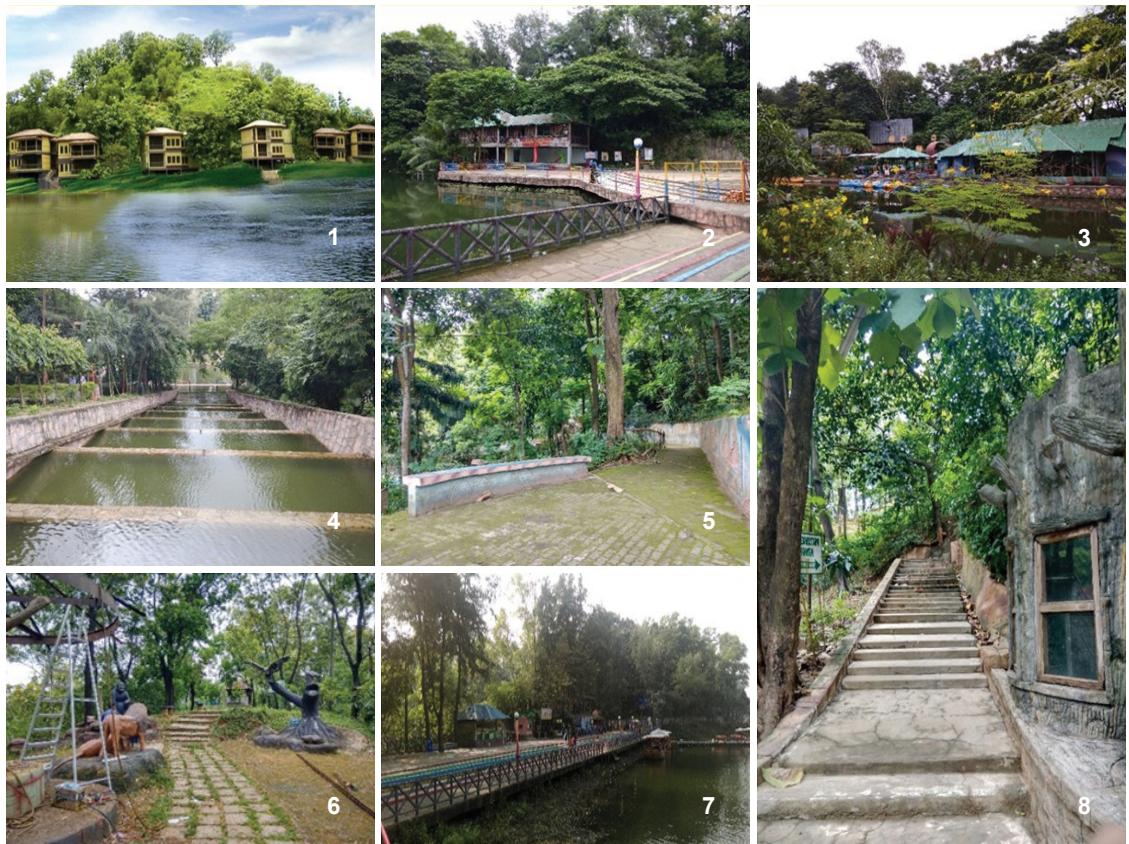
Figure 9:  
Images of Foys lake area.

1. Slope of hill is remain untouched and resort has been constructed on flat land keeping a distance from foothill.
2. & 3. Recreational facilities
- 4, 5, 6, 7 & 8. Slope of hill and bank of lake has been utilized and protected with steps and fountain.

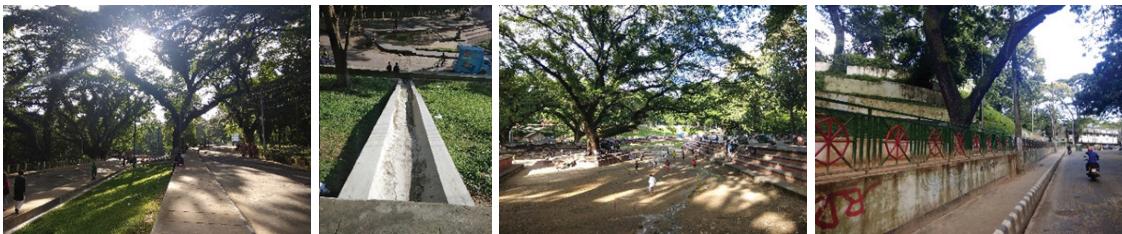
Figure 10:  
Hill protection measures in CRB hill area and DC hill area.

In figure 10 Additional details also show where hills are protected through some measures and provide recreation facilities in those places.

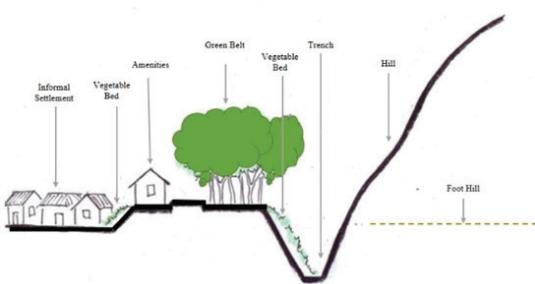
Figure 11:  
Strategic design for intact or little modified hill

As hill types and level of damage varies two types of strategic designs are proposed. One is for the hills which are intact or have slightly modified foot hills. Another proposal is for those which have sustained massive hill cutting. In case of intact hill toe, a drainage trench is proposed which will elongate the hill slope downward and contain landslide debris during a disaster. On the other hand, in a deformed hill part of the hill will be restrained with proper structural measures and then the trench will be placed. In this case, immediate flat land of the restored part will be restricted for any type of human intervention but reforestation. (Figure 11 & Figure 12)

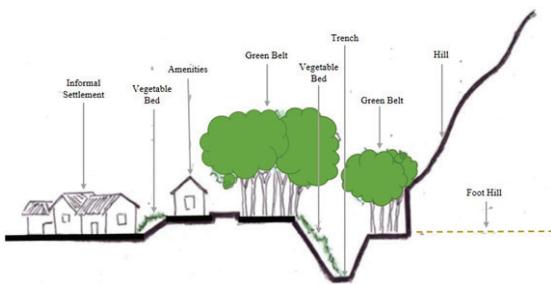
Figure 12:  
Strategic design for deformed hill
