Historic Preservation and Disaster Risk Preparedness: Critical Approaches in Managing Cultural Heritage in Indonesia

CASE STUDIES: The Historic Campus of ITB

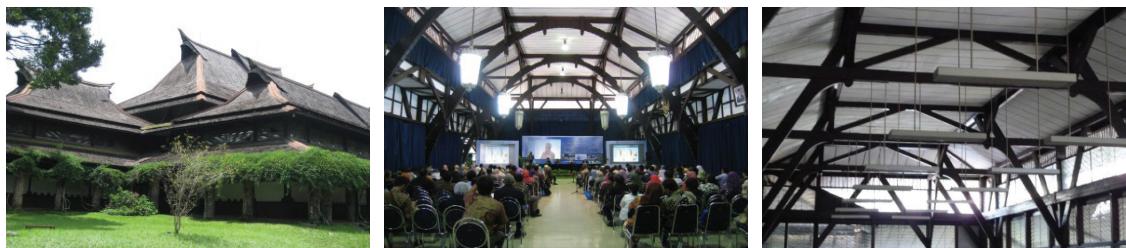
Figure 2a:
West Assembly Hall, view from outside and inside the building.
Source: L. Tambunan (2013) and W. Martokusumo (2013)

The buildings of West and East Assembly Hall have an unusual appearance, especially the form of the roofs, which dominate the buildings' silhouettes. The new compound of the buildings' complex, which was also dominated by the row of columns made from local stones, plus the unique roofs' form was conceived as an expression of hybrid architecture that was influenced by traditional/local building archetype. All of that was reported meticulously in the local newspaper Preangerbode of 24th July 1920 (van Leerdam, 1995). Local materials, such as natural stone and construction timber, are used for these two buildings. It is the first wide span building, built at the beginning of the 20th century in the Netherlands Indie. The renowned Dutch architect, H.P. Berlage, also praised the building when he visited the country in the early 1920s. He observed that there had already been two leading streams in the architecture on Java; the first stream was vigorously influenced by the European tradition of building design from the 19th century with less influence from the local building tradition, while the other stream was developed from the local, original Javanese (regional) building culture. The architect Maclaine Pont belongs to the second stream. Through his long experiment with Javanese traditional architecture, he developed a unique hybrid architecture, that is commonly known as the Indisch architecture. (Fig. 2a and Fig. 3a)

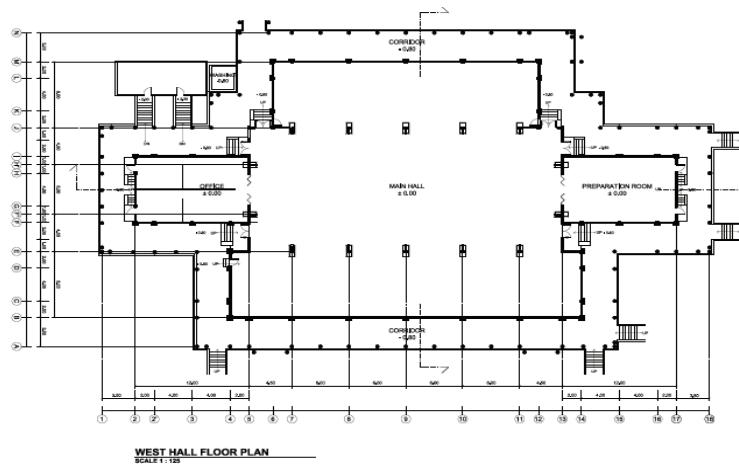
Figure 2b:
Ground floor of West Assembly Hall
Source: Measured drawing (2013)

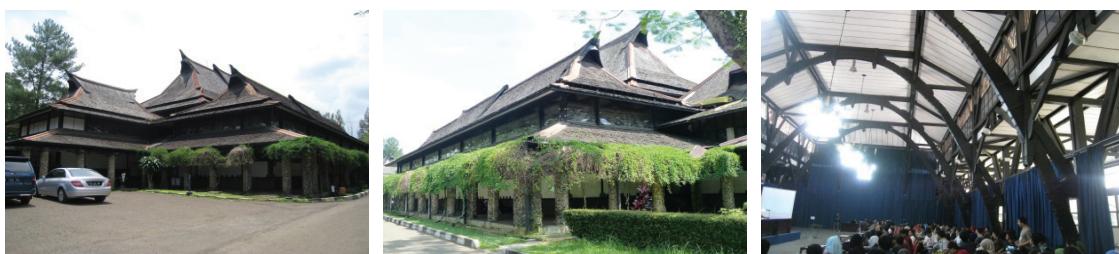
Figure 3a:
East Assembly Hall, view from outside and inside the building
Source: W. Martokusumo (2013) and L. Tambunan (2013)

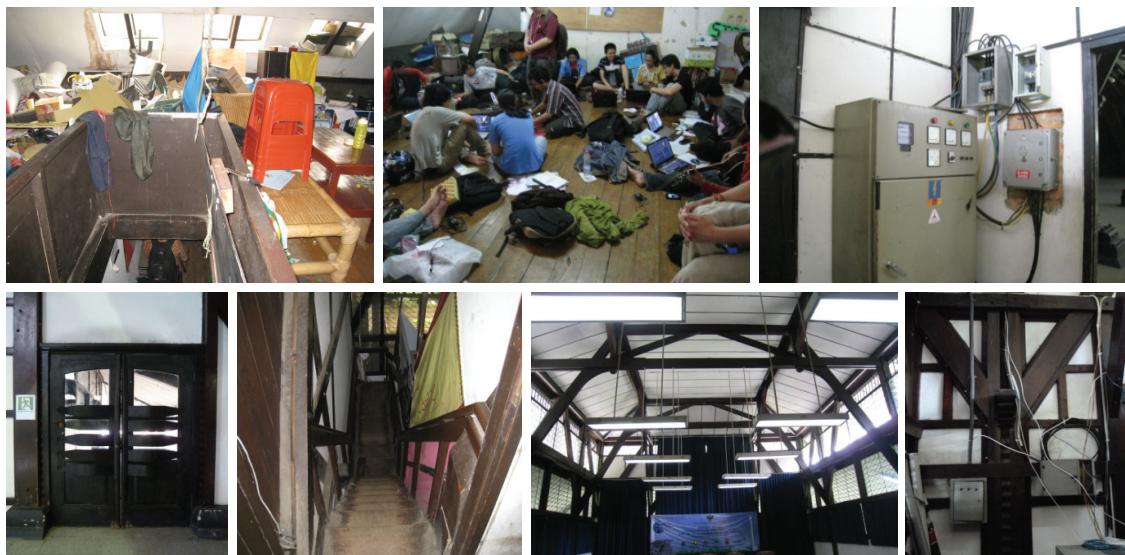
Figure 4: Combustible materials, inappropriate students' activities, insufficient emergency exit, lack of detection system and sprinkler, insufficient exit signage and lack of maintenance of electrical installation/wiring in the Assembly Halls
Source: L. Tambunan (2013)

The case studies reveal that the West and East Assembly Halls are already more than 90 years old, while the Faculty House Kerkhoven is presently 87 years old. They have been places for many activities, and are mostly used to accommodate seminars, symposium, exhibition, discussion, musical performances, ceremony of ITB's anniversaries and other special events. As mentioned, there is a lack of regulation nationwide regarding disaster mitigation. According to Adhisakti (2011) and Martokusumo (2012) the national building regulation to some extent is very generic; it is focused on the post-catastrophes, and is by nature prescriptive. Historic buildings have certain characteristics that cannot be assessed by such regulation. In case of fire, the rehabilitation of artifacts would be very difficult, since the loss due to fire could be very destructive. There is no appropriate building mitigation regulation, especially when it deals with historic and heritage buildings. Thus, protection for historic buildings against human-induced hazards (arson) and natural-caused disaster is not prepared yet (Fig. 4).

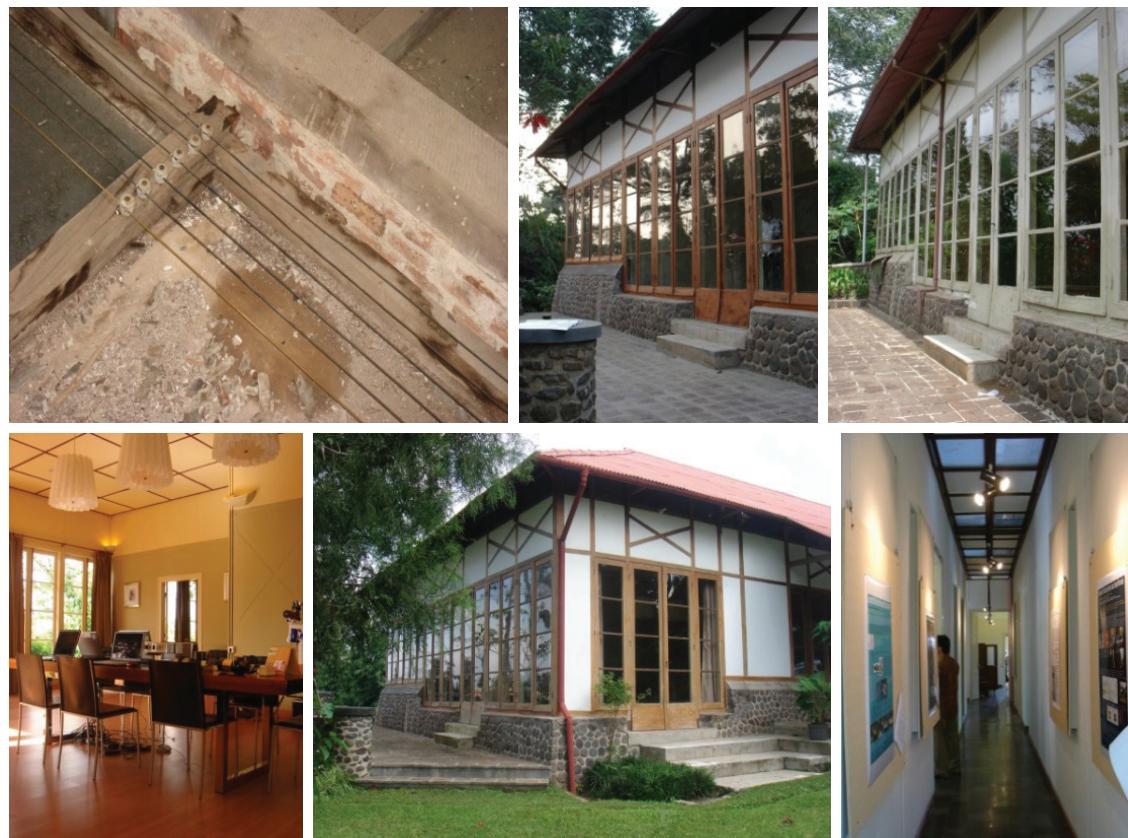
Figure 5a:
The Faculty House Kerkhoven, Bosscha Observatory Lembang
Source: W. Martokusumo (2007)

During the rehabilitation work, landslides and earthquakes, already damaged the part of the building. [happened while restoring or during restoration damage was discovered?] Parts of the building, especially the timber structures, were deteriorated due to the high impact of humidity. The timber is therefore very vulnerable to high humidity. Due to a limited budget, the repairs mainly focused on the severely damaged parts of the building. A preventive approach was implemented due to scope of work and the priority of repairs. Not all of the targeted repairs were successfully achieved. During the rehabilitation, the exact dimension of the work was sometimes hard to predict and determine. This

is actually quite common in rehabilitation/renovation work. A new plumbing system, due to the functional requirements, and the mechanical/electrical system and their components were respectively installed (Fig. 5a and 5b).
