Proposing a Conservation Management Plan for Bara Katra

Shirajom Monira Khondker* / Mehnaz Tabassum**

* Faculty of Architecture, Ahsanullah University of Science and Technology, Bangladesh

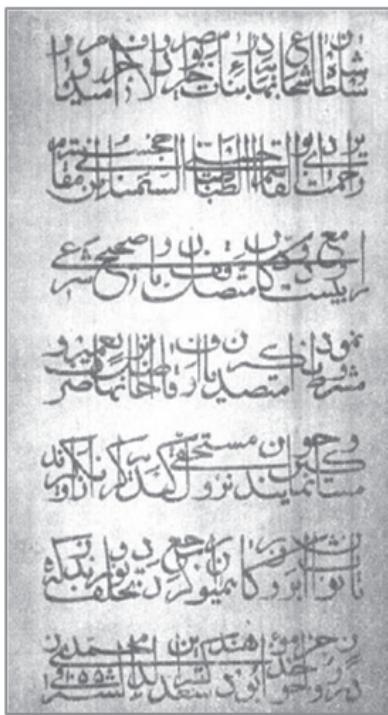
Figure 6:
Inscriptions on the northern gateway of Bara katra (now lost). (Source: Hossain, M.S., 2006)

The Bara Katra contains two inscriptions (Figure 6) in Persian: one records that it was built in 1053 AH (1643-44AD) and the other contains the date 1055 AH (1645-46AD) and confirms that Shah Shuja gave the building to Mir Abul Qasim, who built it, to be used as a Katra on the condition that the officials in charge of the endowments (*waqf*) should not take any rent from any deserving person alighting therein. Twenty-two shops were *waqf* to defray the expenses

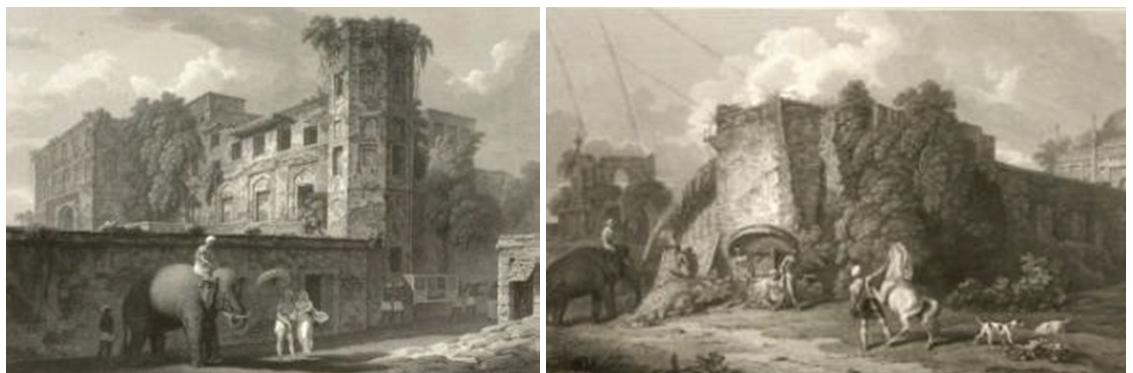
Figure 7:
Southern wing of Bara Katra (left) and ruin of northern gate (right). (Source: Painting of D'Oyly, 1823).

In this research paper, the authors studied the status of Baro Katra from Historic Documents and their virtual reconstruction are stated below with photographic documentations (Figure 7, Figure 8 & Figure 9).

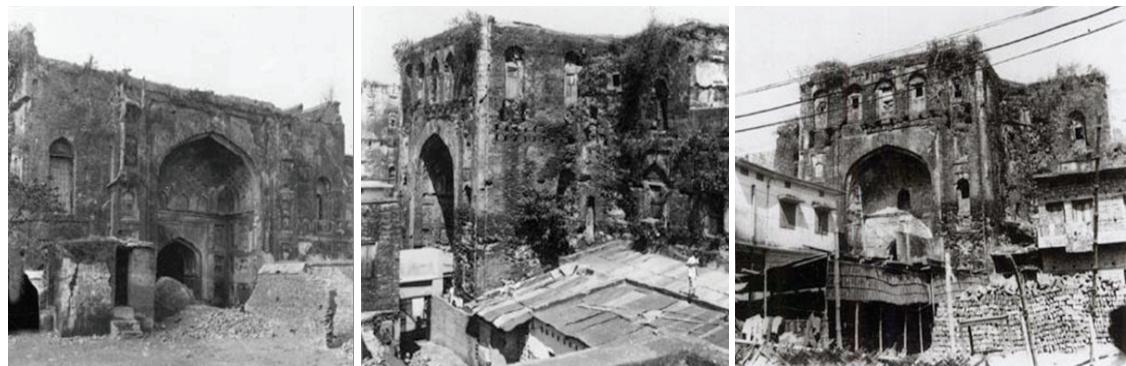
Figure 9:
Entrance, south wing from the courtyard.1950 (left); Entrance, south wing, 1964 (middle); Entrance, south wing from the courtyard.1950 (left).

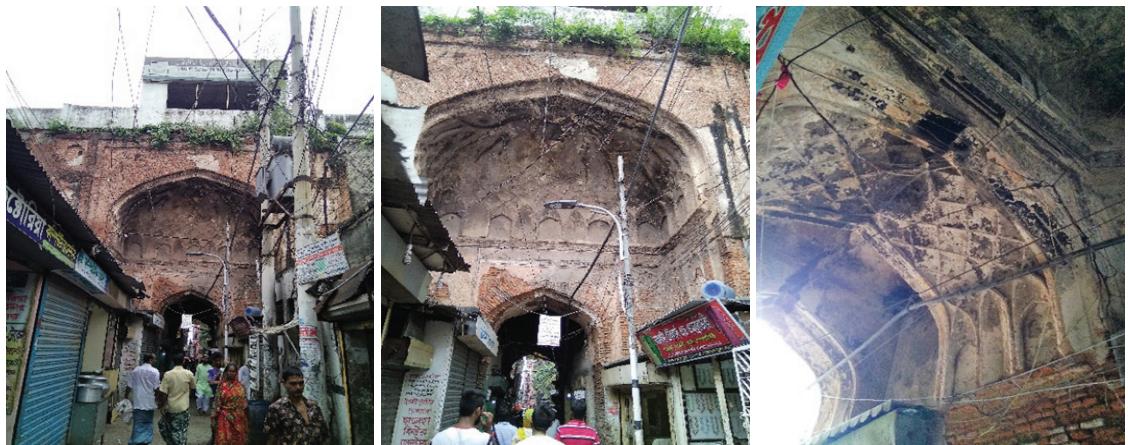
Figure 10:
Access pathway to southern entrance (left); Southern entrance of Bara Katra (middle); Inside the gateway with plaster details (right). (Source: Photographs taken by the authors).

Baro Katra in their present state are in a serious identity crisis due to new settlements within and adjacent to the sites. The dense settlement in and around the artifacts is creating visual obstacles. The visual obstacles are more prominent in all the gateways (Figure 10). Moreover, there are several damaged walls, roof, floor, staircases, and corner turrets needing proper initiatives for repair and improvement (Figure 11 & Figure 12). The present use of Baro Katra and its surrounding areas is a great threat for its physical and visual existence. Open courts are occupied by incompatible functions (Figure 11). (Shaikh and Mowla, 2009)

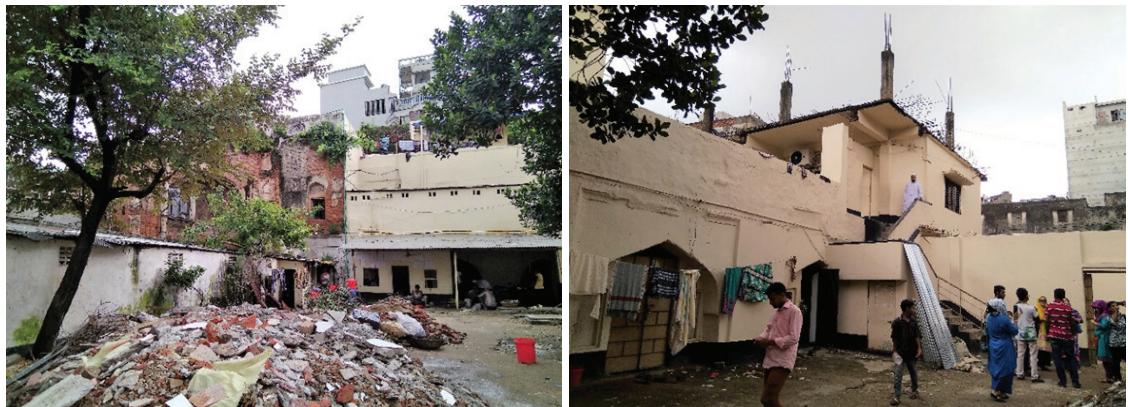
Figure 11:
Existing situation inside the courtyard (left); Ruin condition of the staircase of 1st & 2nd floor of the artifact (right). (Source: Photographs taken by the authors).

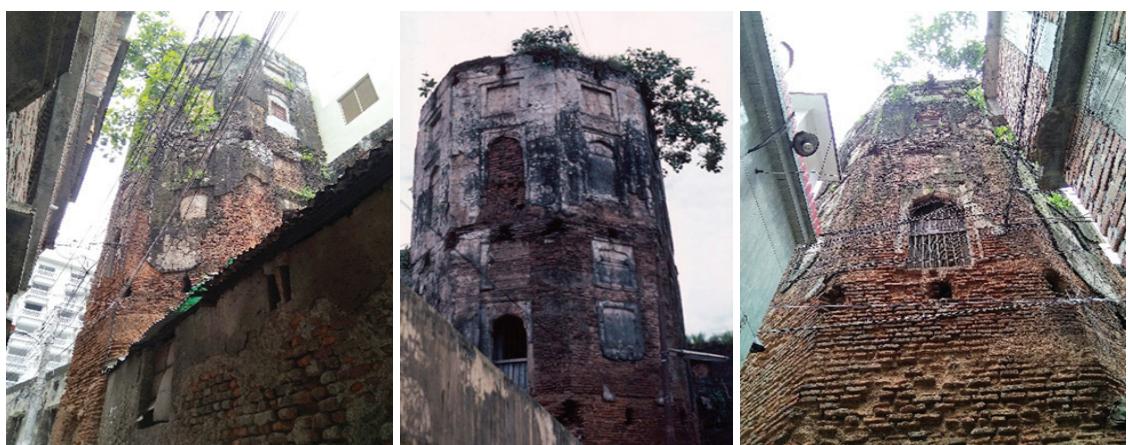
Figure 12:
Existing situation of the corner octagonal turrets (hollowed tower) of Bara Katra. (Source: Photographs taken by the authors).

5). The three storied corner towers were hollow and could be approached from the subsidiary structures. Following the traditional pattern of the *caravan-sarai* of Central Asia, the Bara Katra was highly fortified and was embellished with all the features of the imperial Mughal style. In 1765 Nayab –e Nazim of Dhaka used the building as his residence. (Hossain, 2006)

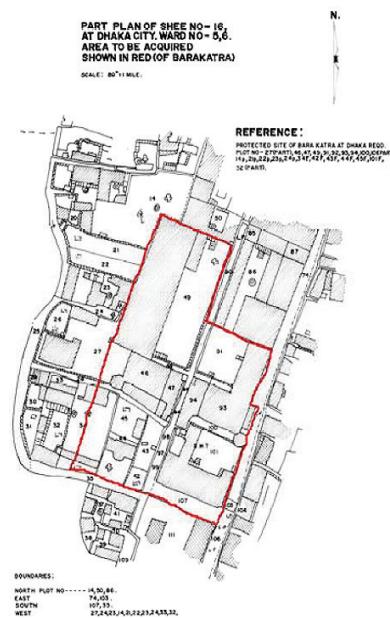
Figure 13:
Area occupied by the artifact Bara Katra shown in red (part plan of shee no.-16, at Dhaka city, ward no.-5 & 6).

The Figure 13 describes the physical footprints of Baro Katra which can still be seen on the Ward map but the plots are used by newly constructed *pucca* or semi- *pucca* constructions which are obviously illegal as it is a large *waqf* property. (Shaikh and Mowla, 2009)

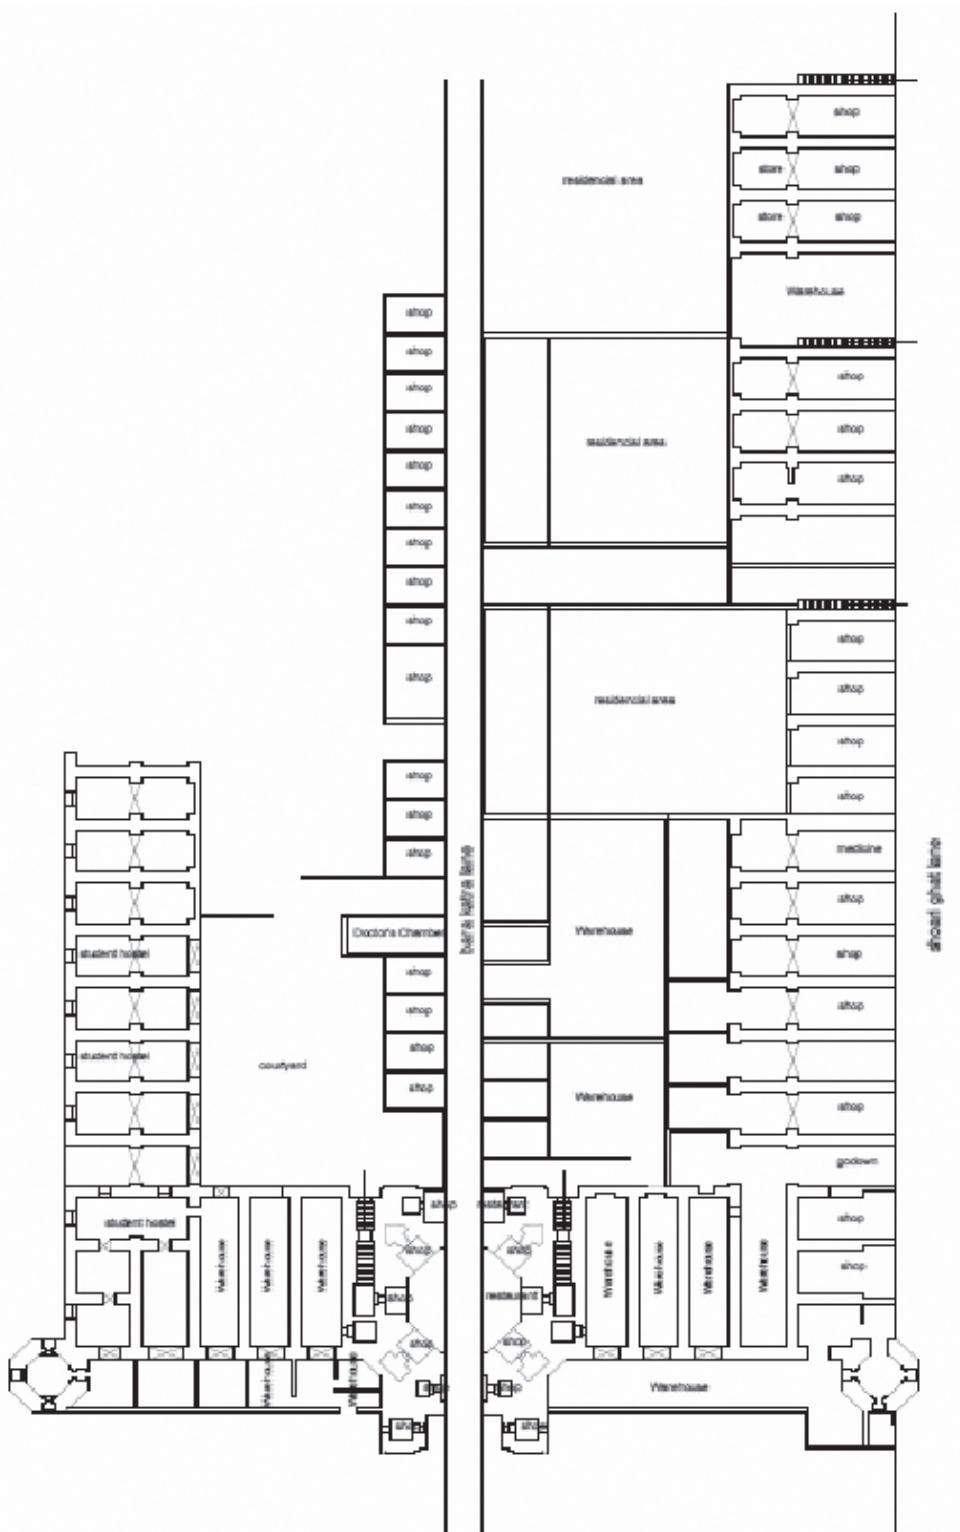
Figure 14:
Existing ground floor plan with use pattern of Bara Katra.
(Source: Field Survey, 2010, Department of Archaeology, Bangladesh).

The Figure 14 describes the surviving structures of the artifact Bara Katra with present activities which are elaborately explained here. Except for the Southern wing with a gateway and some portions of the east and west wings, all other parts of Bara Katra have almost disappeared. There are traces of walls and foundations of east and west wings standing with the newly built residences (colonial structure) in the east and *madrasa* in the west side. The wings with entrance on north side have completely disappeared but the southern wings still exist as ruins. In the entrance hall there are so many incompatible additions of shops of different categories that they impede the visual quality. The additions of a newly built toilet and ablution spaces on the terrace of first floor have been made. Some tin shaded structures are also added on the terrace of second floor. Though the building has small openings in the traditional Mughal style entrance, ample natural lighting was ensured by windows. But currently on the ground floor and staircases most of the openings are sealed preventing the usual penetration of light. (Shaikh and Mowla, 2009)

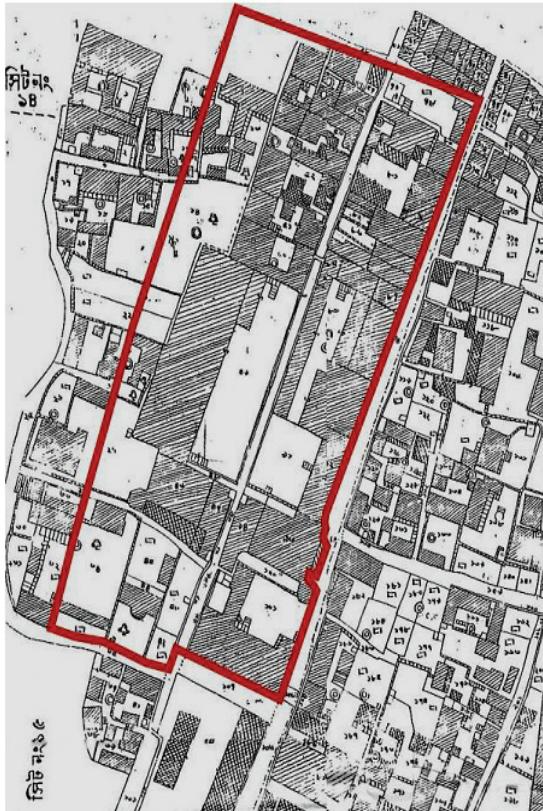
Figure 15:
Area to be acquired for katras shown in red, 1958.
(Source: Department of Archaeology; Reference- Mouza Shahar Dacca, Ward No: 5 & 6, Sheet No-16, C.S map 1912-1915; Protected site of Bara Katra at Dacca required plot no: 27 (part), 46,47,49,91,92,93, 94,100,101 (part), 14p, 21p, 22p, 23p, 24p, 34, 42, 43, 44, 45, 101, 32p.)

The Figure 15 describes the existing drawings of Bara Katra including areas to be acquired for the artifact. Areas to be acquired are those areas

which are currently illegally occupied. These illegal structures should be demolished as part of the restoration and conservation process of the artifact.

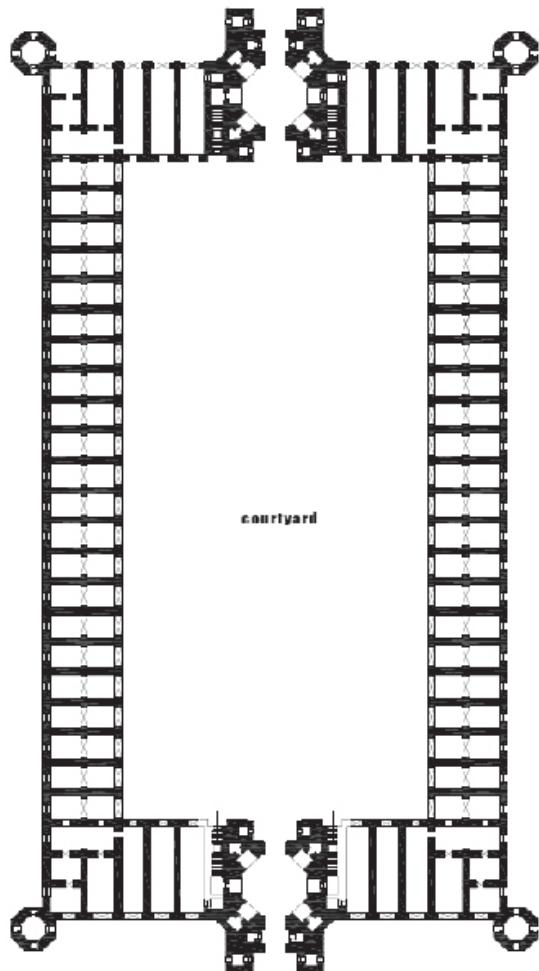
Figure 16:
Conjectural Drawing of ground floor of Bara Katra.
(Source: Department of Archaeology, Bangladesh)

Conjectural drawing of ground floor plan, conjectural drawing of first floor plan, conjectural drawing of second floor plan, river front elevation of south wing, and sectional elevation of south wing (north elevation of south wing) have been shown below in Figure 16, Figure 17, Figure 18, Figure 19, & Figure 20.

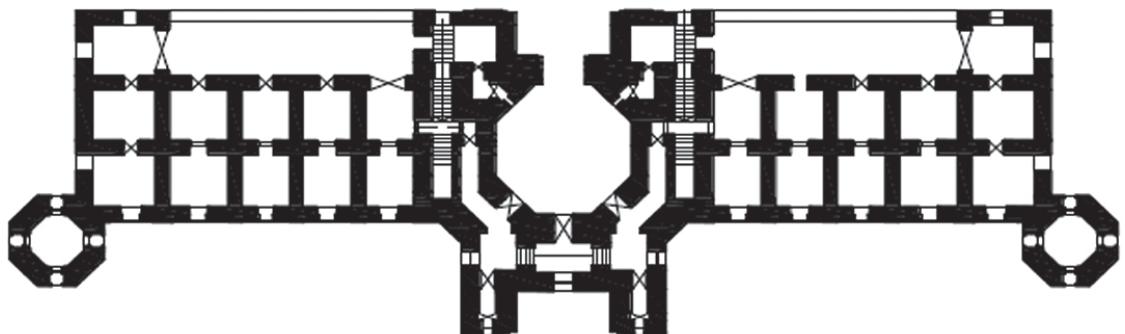
Figure 17:
Conjectural Drawing of first floor plan of Bara Katra.
(Source: Department of Archaeology, Bangladesh, 1981).

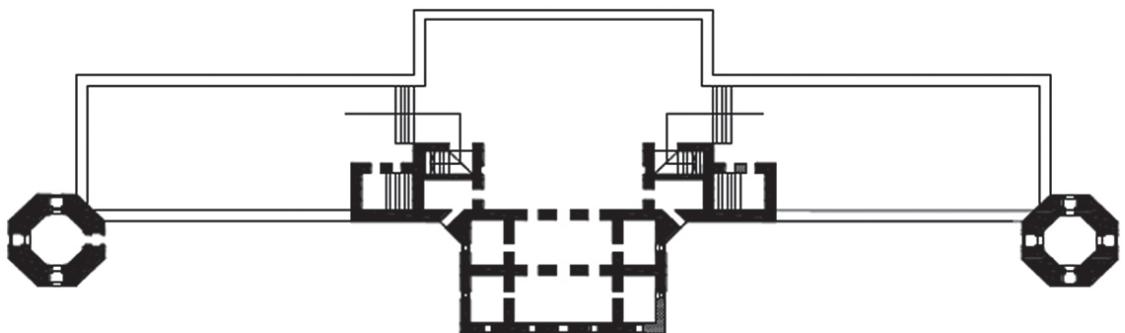
Figure 18:
Conjectural Drawing of second floor plan of Bara Katra.
(Source: Department of Archaeology, Bangladesh, 1981).

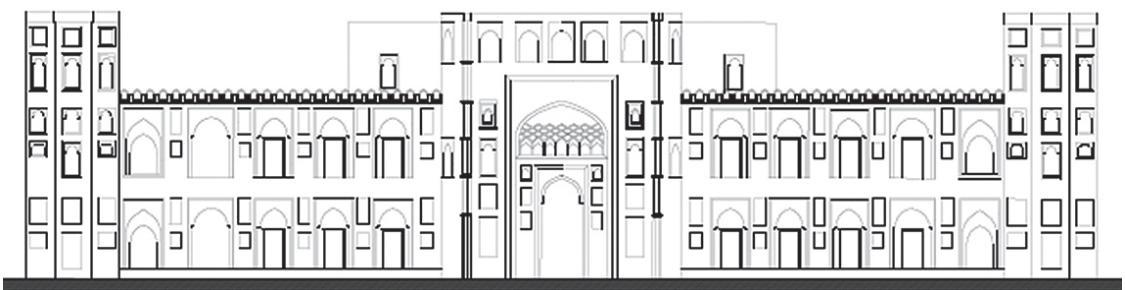
Figure 19:
River front elevation of south wing of Bara Katra.
(Source: Department of Archaeology, Bangladesh, 1981).

and western wings of the building, staircase, especially the stairs at the terrace of the 2nd floor (Figure 19), door and windows (Figure 25), walls, parapets, etc. can be done on the basis of existing ruin, archaeological evidences, and authentic documentation with detail drawings and photographs.

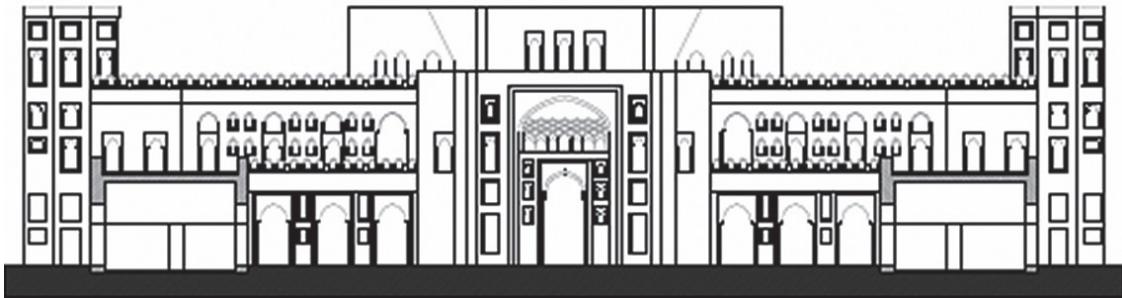
Figure 20:
Sectional elevation of south wing of Bara Katra (north elevation of south wing).
(Source: Department of Archaeology, Bangladesh, 1981).

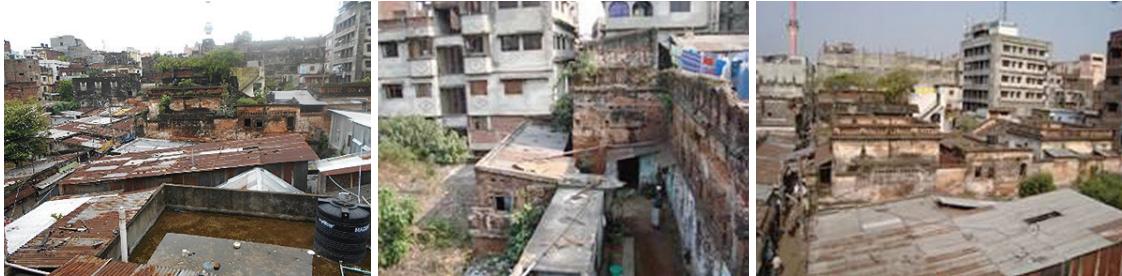
Figure 21:
Existing situation of the dense settlements around the artifact.
(Source: Hossain, M. S., 2006).

Figure 21. describes how the newly built structures are creating visual obstacles as well as more complicity for the artifact.

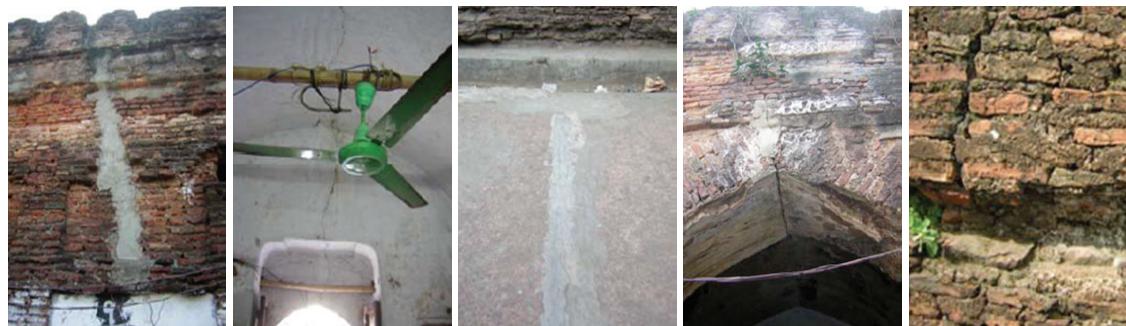
Figure 22:
Major cracks on exterior, interior, arch in the artifact, Bara Katra.
(Source: Hossain, M. S., 2006).

- v Necessary repair works includes; cracks and damages of structural elements like load bearing brick walls that are partly destroyed, arches, vault roofs that are damaged by leakage and could possibly collapse. These repairs may be carried out to protect the monument (Figure 22).

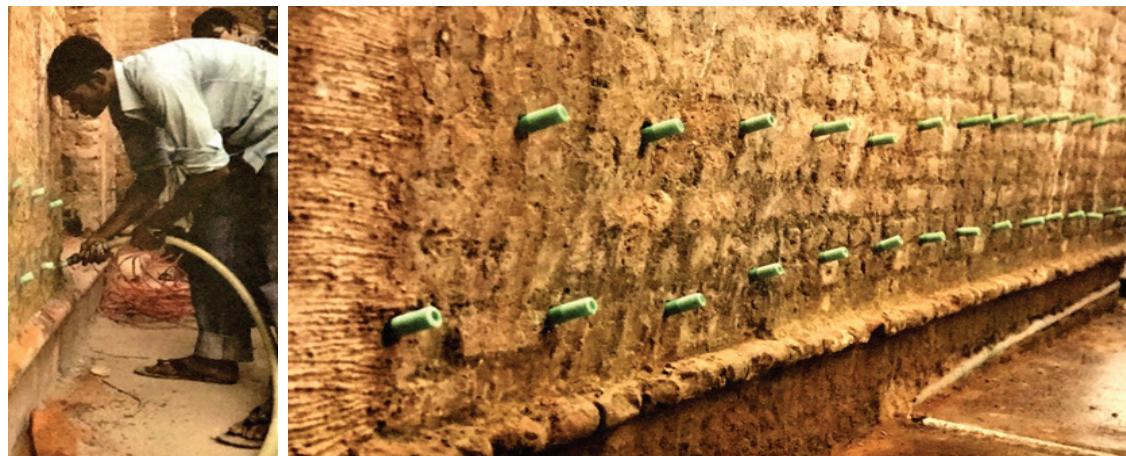
Figure 23:
An example of insertion of damp proof course (DPC) into the existing wall.
(Source: Ahmed, "Unfolding the past: Conservation of Baro Sardar Bari", Published in 2015).

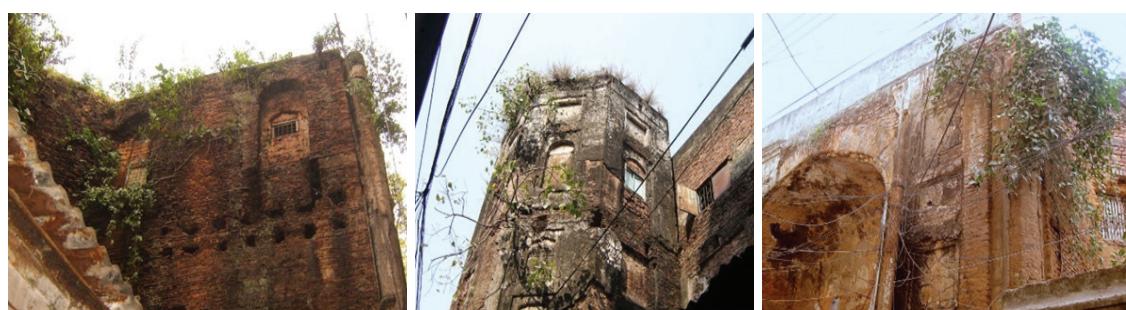
Figure 24:
Biological growth of several strangler figs in the artifact, Bara Katra.
(Source: Photographs taken by the authors).

- vii The growth of several strangler figs and vegetation on the exterior and interior masonry walls and other parts of the building, (Figure 24) should be removed properly as well as very sensibly.

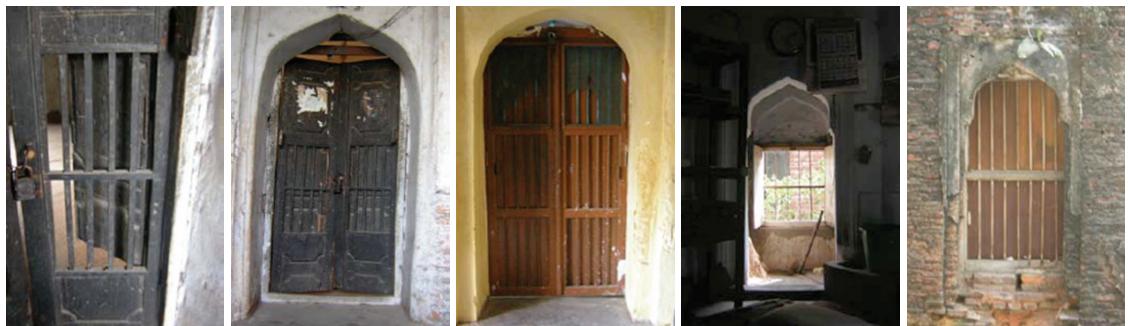
Figure 25:
Existing door-window analyses for restoration work in the artifact, Bara Katra.
(Source: Hossain, M. S., 2006).

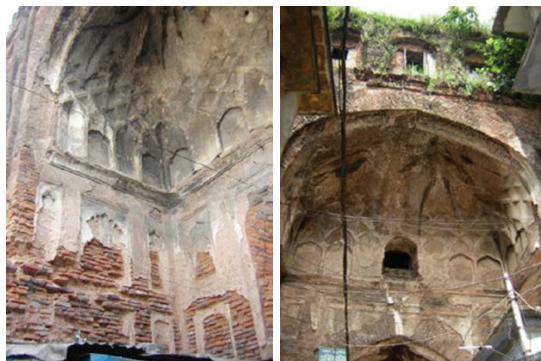
Figure 26:
Damage of plaster detail on the southern gateway of the artifact. (Source: Hossain, M. S., 2006).

- xii Necessary repair work and reconstruction work to recover missing ornamentation as well as decoration details on the plaster at the outer and inner walls should be carefully handled by the proper investigation from the historical evidences (Figure 26).
- xii Electrical wiring, fittings like switch sockets, fans, and lights should be properly checked and replacements of defected fittings and entire wirings are recommended to ensure safety.

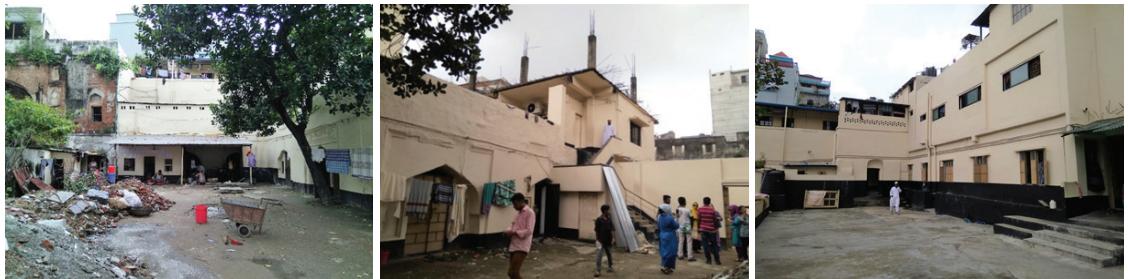
Figure 27:
Present conditions of some alterations, as a ruin, and the additions of newly built structures in Bara Katra.
(Source: Photographs taken by the authors).

Bara Katra's present condition of some of the alterations, as a ruin, and the additions of newly built structures are shown in the following Figure 27.

Currently, Bara Katra is still in use. But the way the artifact is being used, is very unsympathetic and hazardous to the building's physical and visual existence. Unaware of the value of the building, the users are frequently demolishing the walls to build new structures. They also add new floors ignoring the building morphology and structural safety. The eastern and western wings are either demolished or altered in a manner that makes it beyond recognition of its historic past. The boundaries are occupied by small factories which are harmful to the brick wall of Bara Katra. The only surviving southern gateway is fully occupied by shops (Figure 28). Bara Katra is listed as national antiquities of Bangladesh. But this Mughal edifice is in a terrible condition and is also in danger of extinction due to the lack of care by the authorities.

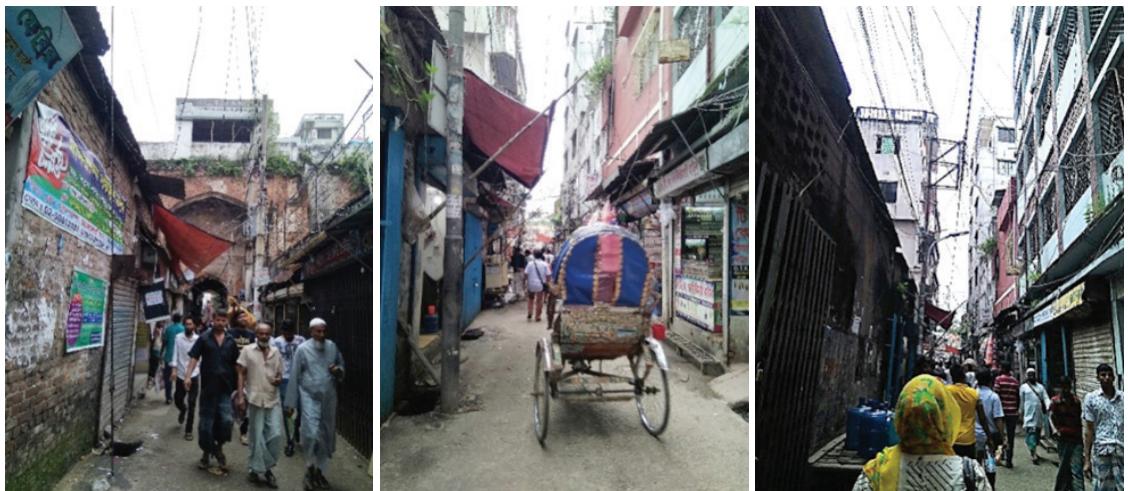
Figure 28:
The artifact is fully occupied by shops, factories, warehouses in the dense settlements of Chowk Bazar, old Dhaka.
(Source: Photographs taken by the authors).
