Tabo Monastery (996 CE) A Vernacular Architecture of Lahaul and Spiti Region of Himachal Pradesh, India: A Preliminary Investigation of Deterioration and Conservation of Murals of gSer-Khang Gompa

Archeological Survey of India, Puratattva Bhawan, India

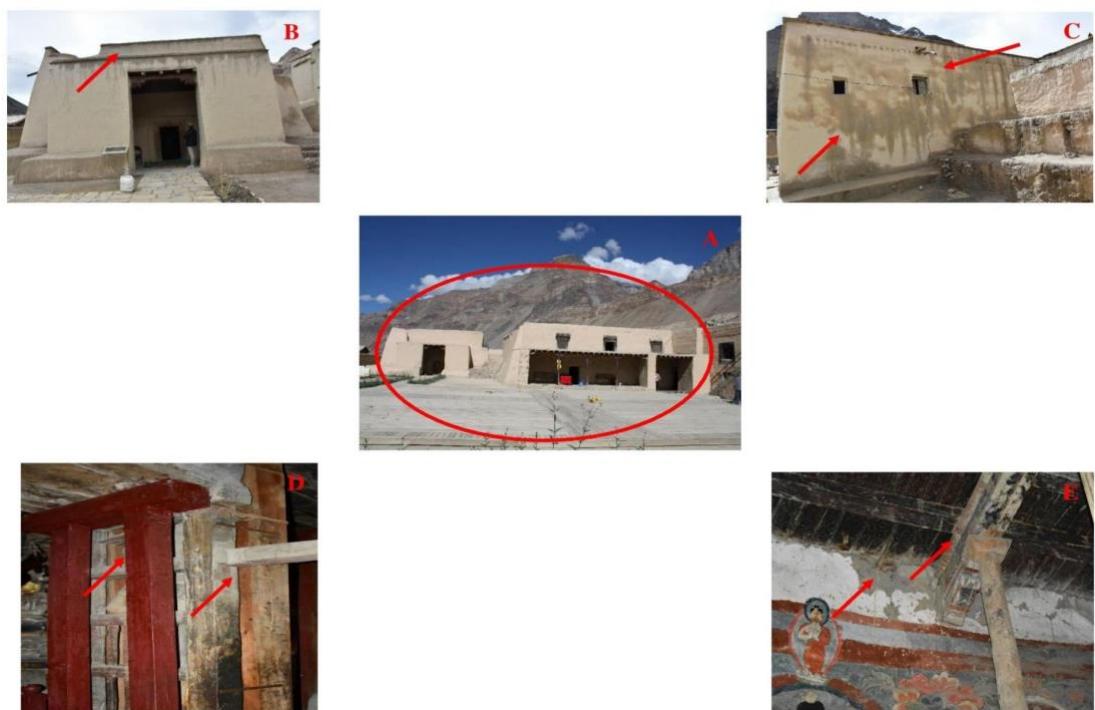
Figure 4*Structural Deterioration Problems in gSer-khang Gumphu, Tabo*

summer are greatly influencing the overall environmental conditions of the region. Also, the percolation of water through the carrier wall of murals (Figure 4B, 4C), which is due to melting of snow and rainwater, causes fluctuations in humidity and changes in the micro-climate (Becherini et al., 2010). Moreover, the dampness trapped within the carrier wall has adverse effects; the painted plaster loses its hold on the wall due to resulting weakness of the binding agent, and pigments of murals showed a tendency towards fragmentation, powdery appearance, and loss of color (Coccato et al., 2017; Saunders & Kirby, 2004).

earthquakes per day) is 1-2 events at stations Tabo, Lalaung, and Rangrik, while it is one event per two days at Mikkim (Geological Survey of India [GIS], 2013). As per the information reported by the National Disaster Reduction Control Portal, Himachal Pradesh, between 1800 and 2008, 553 earthquakes were recorded in the State. Out of these, about 99 were observed in the valley, which comprises 17.90 % of total reported in Himachal Pradesh in the same time period (National Disaster Risk Reduction Portal [NIDRM], 2010). The disaster risk profile of the districts of Himachal Pradesh reveals that, of the total area of 13,841 km² of the Lahaul and Spiti region, 747 km² is classified as Earthquake Hazard Zone V, while 13,094 km² is classified as Earthquake Hazard Zone IV (National Disaster Management Authority [NDMA], 2019). The frequent seismic movement causes sudden stresses that spread in the system from load-bearing members to foundation (Dandona, 2006; Mydin et al., 2012). These sudden loads result in additional loads and some lateral forces for which the walls are not necessarily designed. For these structural systems, the result over time when progressively subjected to these types of forces, is loss of strength of structural members, which causes detachment of large chunks of painted plaster, vertical cracks from top to bottom of murals, tilting of walls, etc. (Figure 4E).

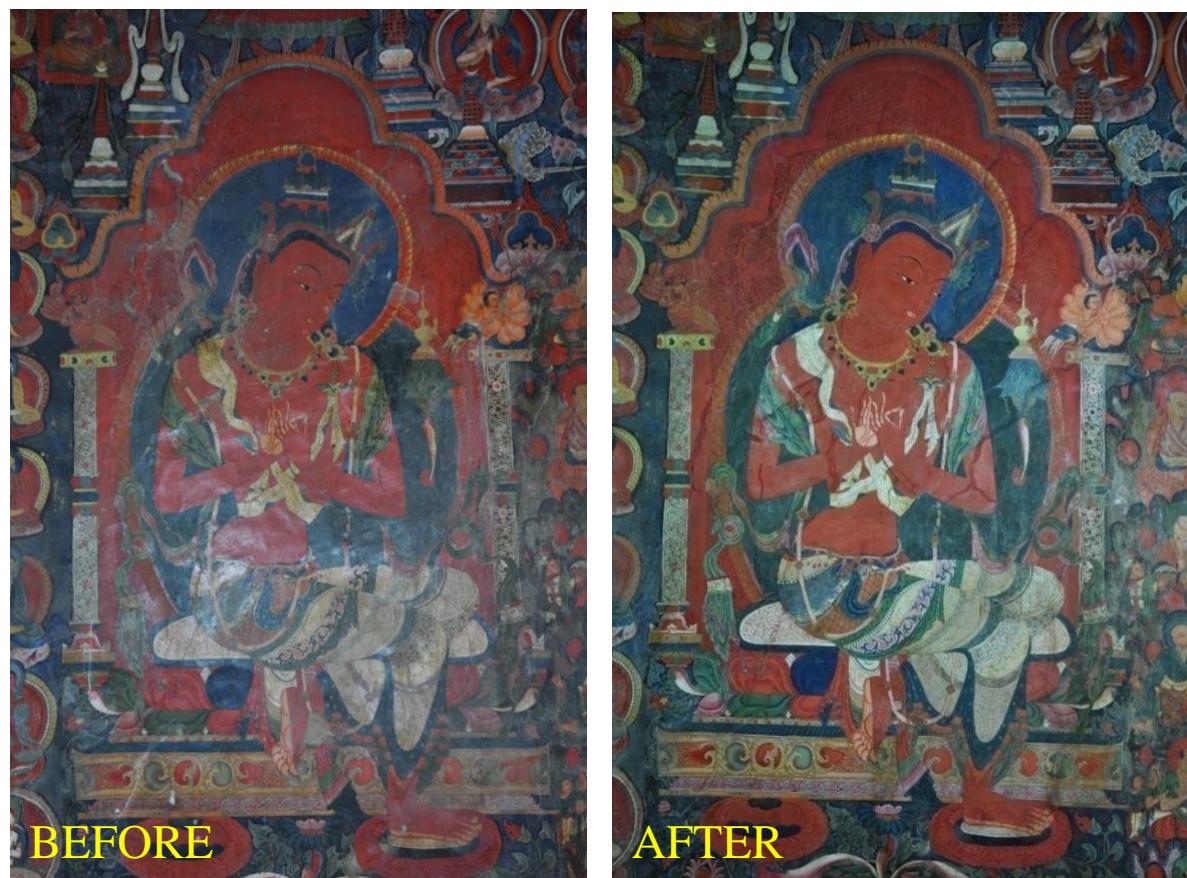
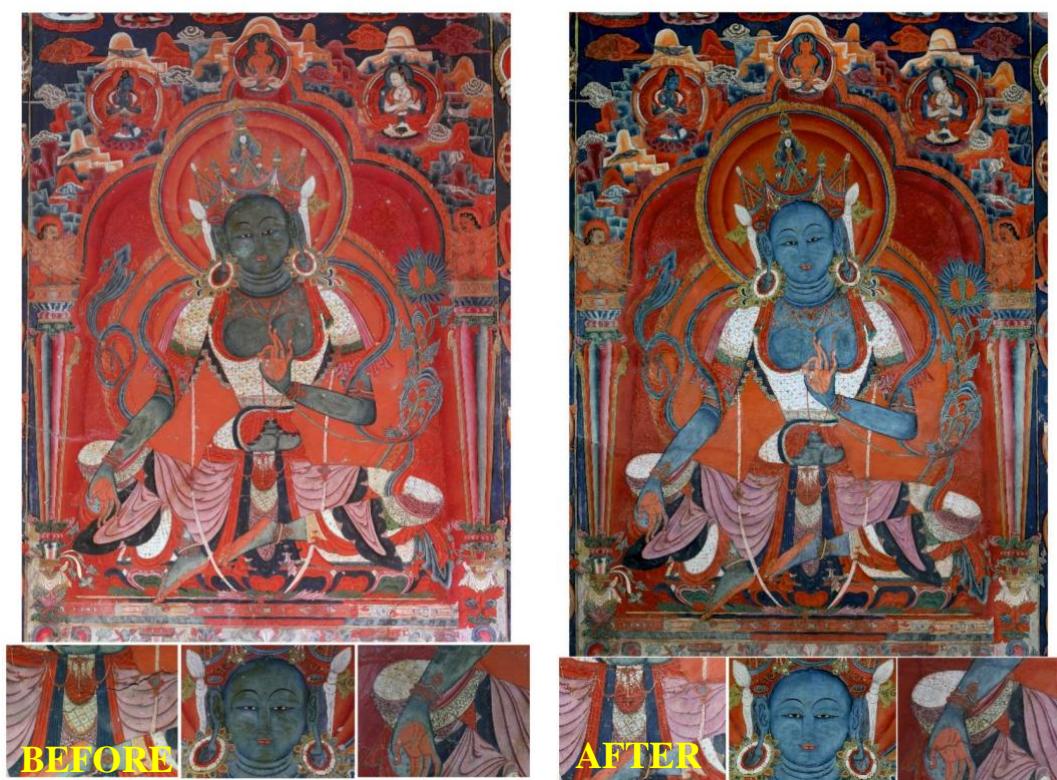
very thin coat of reversible preservative coating to preserve them from any further loss (Figure 8, Figure 9, and Figure 10).

Conservation of Murals at gSer-khang Gumpha, Tabo

Conservation of Murals at gSer-khang Gumpa, Tabo
