Failure Mode for Creep Area of High Open-pit Slope Under the Influence of Underground Mining

Wang Ning[1], Zhou Xiaolong[2], Zhu Dengyuan[1]

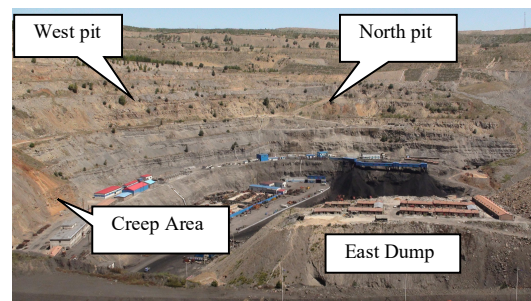
Figure 1   Full views of the open-pit mine

Northwest pit of Antaibao open-pit mine is mainly covered by Quaternary system loess, as shown in Figure 1. The maximum height of the slope from bottom to the top is about 258m, and the pit includes several steps about per 30m from bottom to the top, with step width about 40m.

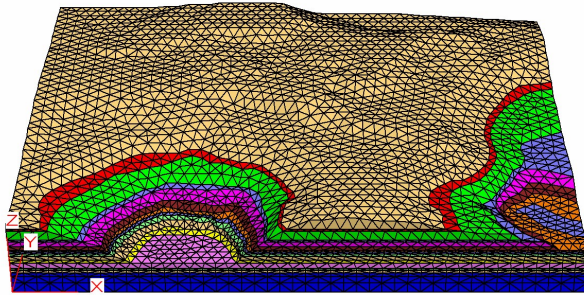
(a)   3D model of the slope

At present, there are a lot of penetrated cracks in the third-level platform, while only the lower part of the northwest pit has been protected by shotcreting, and drainage system has not been established in the upper slope. For the emphasized protection of creep area where a large-scale landslide happened, six boreholes along two survey lines were chosen to get the profiles and soil properties of creep area, as shown in Figure 2, and Table 1 shows the physico-mechanical parameters of 3 soil layers and 5 rock layers in the area.

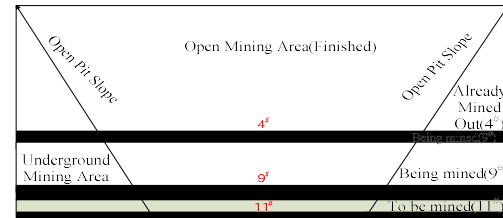
Figure 3   Underground mining conditions

Underground mining induces caving of overlying rock seams inner slope and tensile cracks on the slope surface, with slope rock mass integrity destroyed and the original rock strength decreasing. Slope stability is determined by slope deformation status, under the combined influence of underground mining and open-pit mining, leading to interacting mining effects, and it is a complex dynamic system. Layout of minable seams is shown in Figure 3.

The mining work-face in NO.9 coal seam is much broader than gobs in NO.4 coal seam, but they are far away from the slope, mainly causing ground subsidence. As shown in Figure 3, there are five gobs in No.4 coal seam. Only gob 1 and gob 2 are linked together, causing obvious surface subsidence, while gob 4 and gob 5 are nearer to the slope surface, and play an important role in slope deformation and crack development. In this paper, only gob 5 of No.4 coal seam was concerned with the deformation and stability of creep area. At the same time, 3 typical sections of the slope are chosen for analysis, as shown in Figure 4.

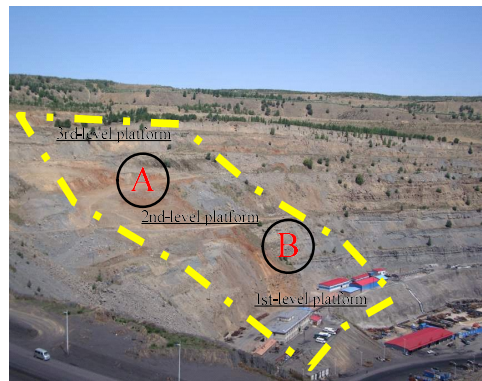
(a) Dangerous area

Under the influence of open-pit excavation and underground mining, lots of cracks occurred on the third-level platform, about 100m from the bottom, which provided penetrating channel for surface water, especially the rainwater. At the same time, rainwater penetrating will promote the continuous development of cracks. Through investigation, it is found that the surface is covered with red clay in the area. Red clay is highly plastic clay, with high porosity and significant shrinkage, and it can easily become a gathering place of water. Therefore, this region is very likely to form a wedge sliding body, shown in Figure 5.

At present, several wedge-shaped sliding bodies have been formed from the third-level platform, at the same time, the accumulation of rainwater and groundwater will erode the bedrock at the bottom of the slope, which will aggravate the failure of the slope. Roughly, there are potential sliding zone A and potential sliding zone B, and several monitoring points were located in the dangerous area.

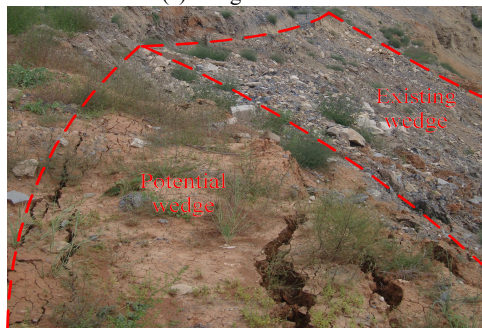
(b)   Cracks on the third-level platform

Creep area is located in the southwest of the slope, under the third-level platform, with a large number of tensile cracks on the upper third-level platform. Under the creep area lies Gob 5 of NO.4 coal seam, and natural exposure of upper soil leads to loosening of the surface soil and continuous deformation. At the beginning of this century, the creep area occurred an overall landslide with an earthwork of about 80,000 m^3, while soil instant slipped nearly 60m. Since then, the creep area has been closely monitored, especially the development of surface deformation, and the creep area is continuous moving, and a huge potential sliding body with length over 100 m has been formed, which is a potential threat.

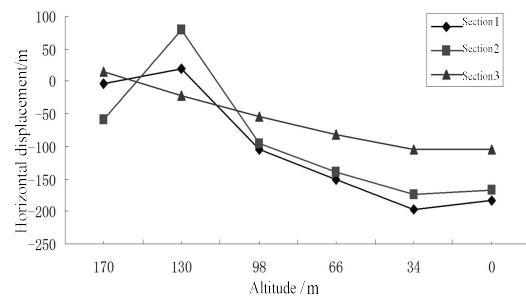
Figure 6   Horizontal displacement of monitoring points with altitude changes after underground mining

Taking the three sections of the slope as example, as shown in Figure 4, positive horizontal displacement is defined as horizontal displacement away from the goaf side, and Figure 6 shows the horizontal displacement of each section with altitude changing, the extracted data at 170m and 130m of section 1 shows a displacement deformation towards goaf side, while other points towards outside. Section 2 and section 3 also produce a horizontal displacement to the goaf side at the two measuring points with high altitude, and other three monitoring points away from the goaf side. Although the points near the top of the slope produce a large retraction displacement towards goaf side, this deformation is beneficial for the overall stability of the slope, therefore, after extraction, the deformation of the overall slope is substantially stable. With the stopping face progressing of No.9 coal, the ground subsidence center will be transferred to the above of No.9 coal stopping faces, but slope deformation will not be obvious influenced because they are far away from the slope. Under the influence of coal stopping, the deformation response of high slope will enhance, vertical displacement will increase, and the development trend away from the goaf side will be more obvious.

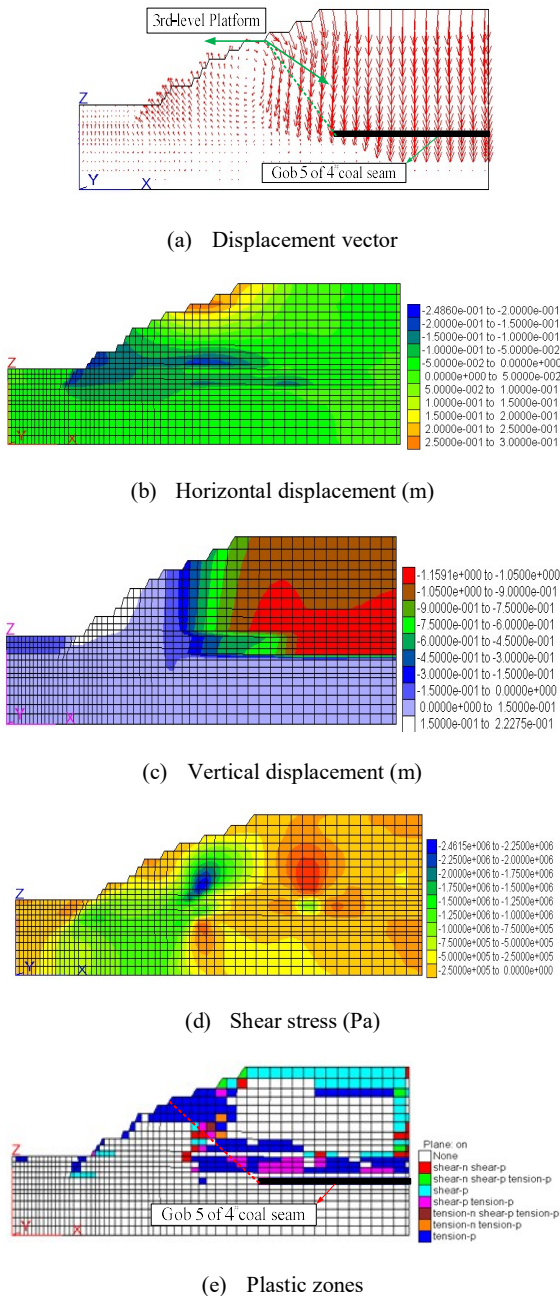
Figure 7   Deformation characteristics after underground mining

Figure 7 shows the deformation characteristics of section 1 after underground mining. The displacement vector changed obviously, and the slope has a tendency of deformation towards both apart and towards the gobs. On the top of the slope, the deformation is mainly vertical displacement towards underground mining gobs, while on the bottom the deformation is mainly horizontal displacement away from the gobs, resulting in shear stress concentration and widespread tensile plastic zones on the top of creep area, on the edge of the influence zone of underground mining. At the same time, a small number of shear failure zones appeared at the bottom of the

slope. The opposite horizontal deformation direction of upper area and lower area leads to shear failure zones of the slope and ground subsidence. As a result, underground mining induces tensile cracks on the middle platforms of the high slope, almost the third-level platform in fact, with slope rock mass integrity destroyed and the original rock strength decreasing. After excavation, slope deformation is affected by complex underground mining and former open-pit mining, and latter underground mining will play a continuous impact on slope deformation development. Although mining activities do not occur near the creep area any more, slope deformation would go on changing.

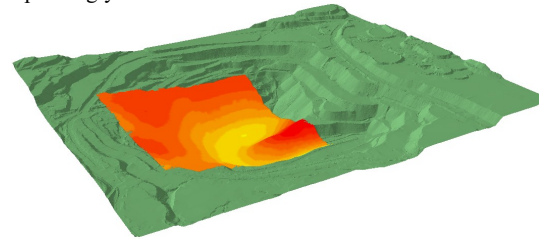
Figure 8   Spatial distribution of displacement reclassification value

It can be seen from Figure 8 that the classification value of the upper part of the slope and the creep area are larger, and with the increase of slope and elevation, the displacement will increase correspondingly.

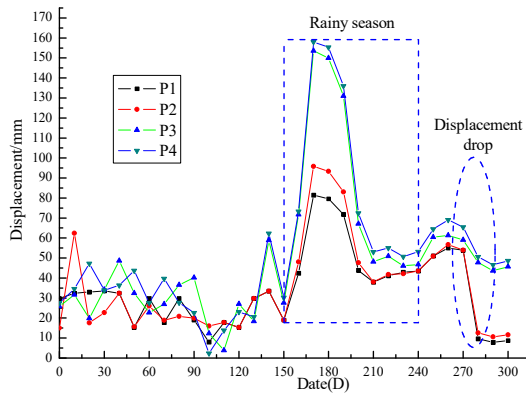
Figure 9   Displacement trend of 4 monitoring points

Displacement trend of four displacement monitoring points with time is shown in Figure 9. NO.1 point and NO.2 point were located on the second-level platform of the creep area, and NO.3 point and NO.4 point were located on the upper third-level platform of the creep area. As can be seen, the displacement development of the slope is substantially stable at present, but in the rainy season, slope

surface deformation increased accordingly, and at the end of the rainy season displacement value would fall.

Displacement response during rainy season indicated that the rainwater penetrating would promote the development of slope displacement periodically, and the rainy season was the most intense period of deformation development. Though the lower part of the northwest slope had been reinforced by shotcreting, which lowered the influence of rainwater, and in other cases, the slope is not stable under the effect of combined factors, and an abnormal amount of rainfall during rainy season could be a great risk to slope stability, when creep deformation would be fully developed. Therefore, we must closely monitor in the area and take necessary reinforcement measures.

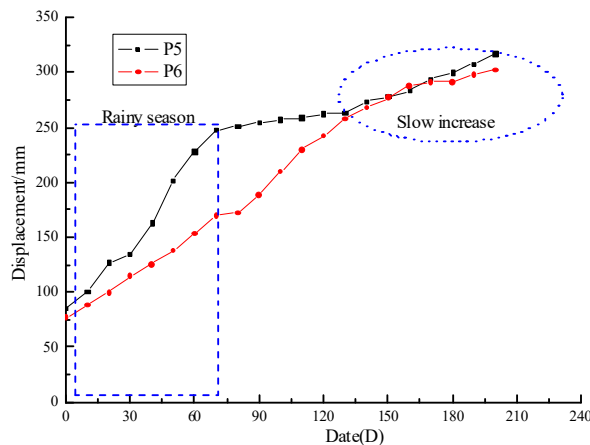
Figure 10   Displacement trend of 2 monitoring points

The east dump is merely influenced by underground mining, and it is composed by single fill soil. For comparison, displacement trend of two displacement monitoring points located on the east fill dump is shown in Figure 10. NO.5 point was located in the upper part of east dump, and NO.6 point was located in the upper part of east dump. As can be seen from Figure 10, the displacements increased continuously in the rainy season, about 50 mm per month, corresponding with the rainy season in the region. After the rainy season, the monitoring displacement continued to increase, but the growth rate was obviously reduced. At the same time, the deformation response of dump slope to the rainfall was obviously real-time compared with the open-pit slope formed by open excavation.

It is worth noting that the resilience of displacement is an evidence of the failure possibility, showing that the creep area is linked as a whole with overall failure risks. Under the influence of rainy water or earthquakes, slope deformation would be obviously developed, however, when the deformation is not sufficient for a sudden landslide, there will be a resilience or spring-back of the whole sliding mass.

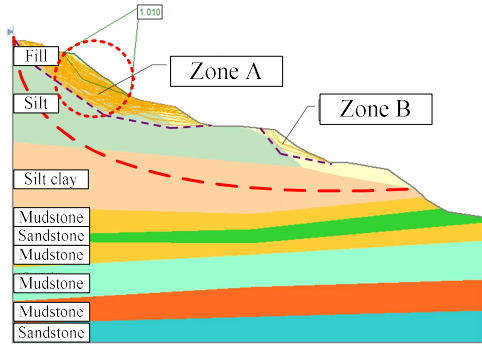
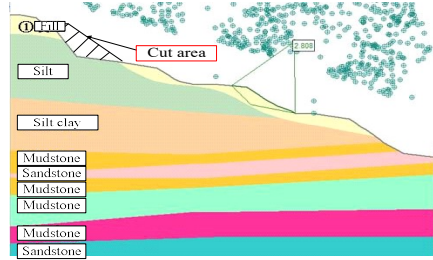
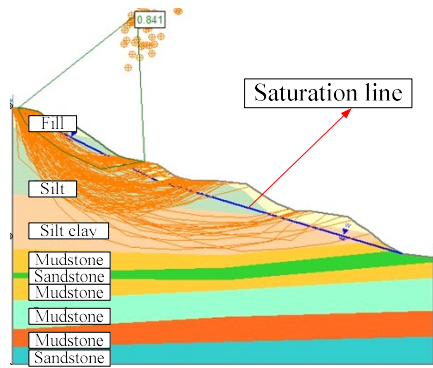
Figure 11   Sliding surfaces under different conditions

The results show that the safety factor under saturated water condition is about 0.841 and the most dangerous sliding surface is located in the upper slope, passing through the upper soil and silty soil, including potential sliding zone A and potential sliding zone B. While the slope stability coefficient under the unsaturated condition is 1.010, and the slope is basically in limit equilibrium state, and the most dangerous sliding surface is still located in the upper slope, only part of potential sliding zone A, whereas sliding zone is obviously reduced compared to saturated condition and sliding surface is also decreased. Figure 11 shows dangerous zones under unsaturated condition, the green line represents the most dangerous sliding surface, while the yellow lines show sliding surfaces with Fs less than 1.30. Under water-saturated condition, the most dangerous sliding surface are represented by the red line, with a tendency of potential sliding zone A and B connected together.

Under the water-saturated condition, the dangerous sliding surface increases obviously, and the potential sliding zone A and potential sliding zone B are connected, namely that the Fs of whole failure is less than 1, and local slip may develop into overall failure in the role of heavy rainfall.

Under the assumed slope cutting condition, the Fs of sliding surfaces increases obviously and the most dangerous sliding surface is transferred to zone B. The Fs is about 2.808, and the stability of both local zones and overall area are obvious enhanced .

For important projects in China, Fs should be more than 1.30, and by reasonable slope cutting of potential sliding zone A, the stability of both potential sliding zone A and whole creep area could be improved.

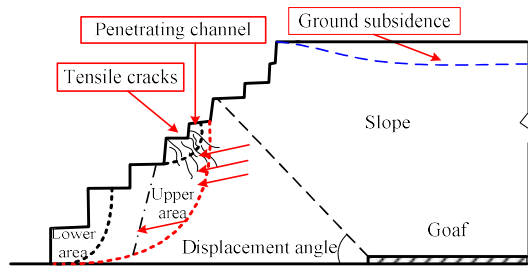
Figure 12   Overall failure mode of creep area

The two kinds of opposite horizontal deformation tendencies induce tensile cracks on the third-level platform of the slope, which became penetrating channel of rainwater, and an abnormal amount of rainfall during rainy season can be a great risk for slope stability. In the creep area, there is a red clay layer in the overlying soil, and the permeability of the clay is low, while the relatively gentle inclination of the bedrock layers creates the catchment surface, and along with the shear stress concentration in slope foot, the whole landslide of the creep area is prone to happen.

Tensile cracks in the third-level platform of the slope caused by underground mining, historical landslides and rainwater infiltration constitute the three elements of the overall slope failure, and determine the formation of the ever-expanding slip surface and landslide cycle, and the shear stress concentration in slope foot along the horizontal bedrock layer create the condition for creep-tension-shearing mode of a landslide. With the soaking and penetrating effect of rainwater continuously weakening the physical and mechanical properties of rock and soil, the anti-sliding force of the potential wedge-shaped sliding body is reduced and the sliding force is increased considering water wedge effect under certain rainfall conditions. The potential wedge would exert an increasing downward thrust on the front body and keep developing. The expanding sliding surface and the decreasing soil and rock properties decrease the anti-sliding force of the slope, and the overall failure is likely to happen again under the influence of the increasing rainfall or the continuous deformation development. The overall failure mode of the creep area is shown in Figure 12, while the displacement angle represents the range influenced by underground mining.
