Causes of Damage of Rural Road in Coastal Areas of Bangladesh

Md. Jahangir Alam¹, Mohammed Emdadul Karim², and Md. Shamsul Hoque¹

This paper focuses on the causes of rural road damage in coastal areas of Bangladesh.

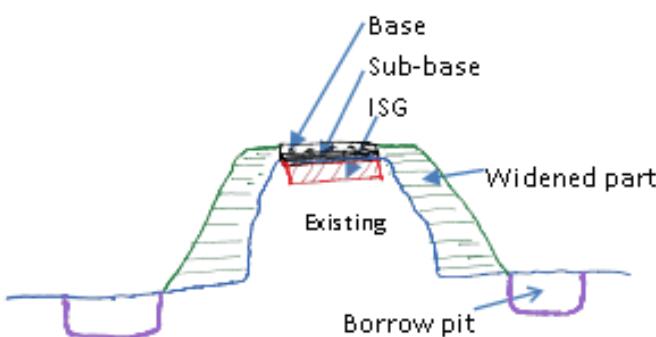
During site visits, authors observed that existing earthen roads are upgraded as shown in Figure 2. Earthen roads are widened using borrow pit soil from nearby land. 300 mm thick Improved Subgrade (ISG) is prepared using available local sand filling into box cut on top of the existing road. 150 mm thick sub-base is prepared using available local sand and brick chips mixed in 1:1 ratio. Then 150 mm thick base is prepared using brick chips only. 25 mm thick bituminous carpeting is done on base.

Figure 2 Typical rural road widening.

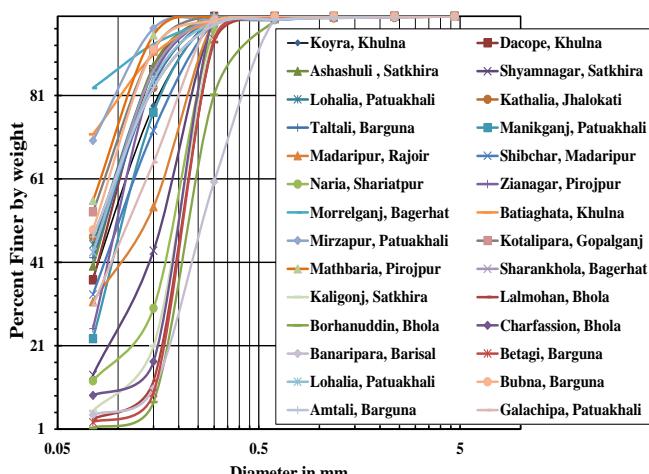
Among the 28 sand samples, 5 samples are poorly graded sand, 5 samples are sandy silt and other 18 samples were silty sand as per the Unified Soil Classification System (USCS) (Figure 4). The Fineness Modulus (FM) of 4 samples are more than 0.80, 2 samples between 0.50 and 0.80. Other samples have the FM ranged from 0.00 to 0.50. As per AASTHO, 14 samples are of group A-4, 7 samples of A-3 and of A-2-4 group 6 samples. Fines content of the sandy soil varied from 0 to 82%. Most of the sand samples did not meet the requirement of LGED specification. Due to unavailability of specified sand of FM greater than 0.80, contractors frequently use locally available very fine sand, silty sand and sandy silt in ISG and sub-base with poor compaction control. This is one of the reasons of unsustainable rural roads in Bangladesh.

Figure 3 Grain size distribution of sands used for ISG and subbase in coastal districts of Bangladesh.

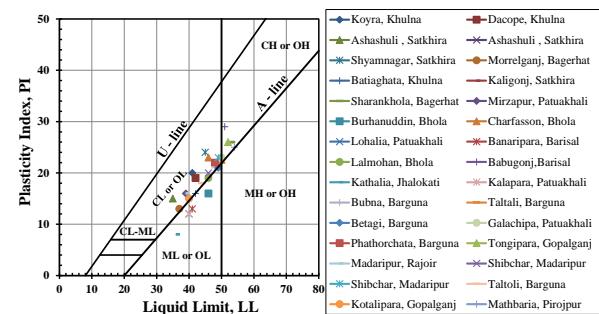
Among 28 borrow pit samples, 6 samples were silt, 6 samples were fat clay and 18 samples were lean clay (as per USCS) (Figure 4). These soils are used in widened part and shoulder of embankment without compaction. Widened part is not integrated with existing embankment by benching and layer by layer compaction. As a result, shoulder and widened part of embankment is soft where vehicle runs frequently during passing over.

Figure 4 Position of borrow pit soil samples of coastal districts in the plasticity chart.

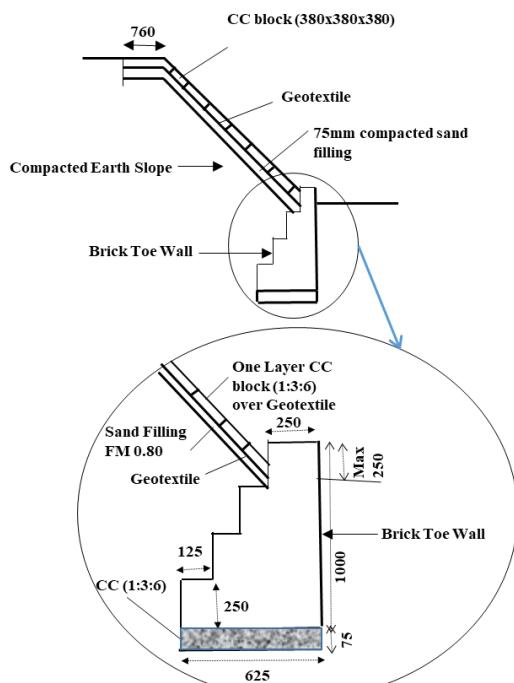
Some rural roads run along the bank of river or khal (Figure 10). This kind of road needs slope protection works for sustainable road construction. Sometimes, slope protection work is done using CC block revetment as shown in Figure 12. This is a typical design which is followed everywhere without any slope stability analysis. That is why sometimes slope failures are observed as shown in Figure 10(b) and Figure 12. Limited fund of rural road construction is a reason of not doing any proper slope protection design. If the slope protection is designed properly, construction cost of project will be more than the estimated budget.

Figure 11 Schematic diagram of designed slope protection.

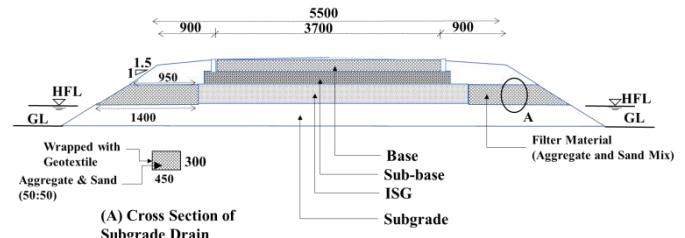
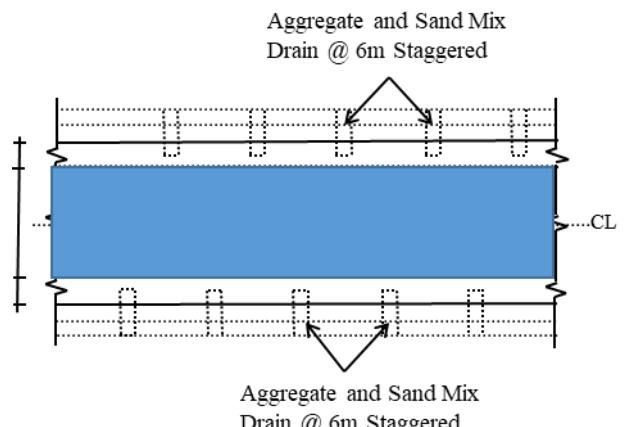
Authors observed a subsurface drainage path is installed in some recently completed rural roads. In the both sides of subgrade layer aggregate and sand wrapped with geo-textile are installed. The cross section of this modified road is shown in Figure 15 (a). This wrapped aggregate and sand mixture would work as a drain line through subgrade of the road. Here, the water inlet and outlet are placed in a zigzag pattern that is illustrated in Figure 15(b). Subgrade drain is 450 mm wide and 300 mm thick (Figure 15(a)). The center to center distance of subgrade drain is 6 m. However, in the rainy season it was found that the soils above the subgrade drains were washed away (the dashed oval marked portions in Figure 16). In Figure 16 (a) two photographs are exhibited where this type of erosion observed.

Figure 15 Modified design of road; (a) typical cross section of road with subgrade drain and (b) plan of subgrade drain.

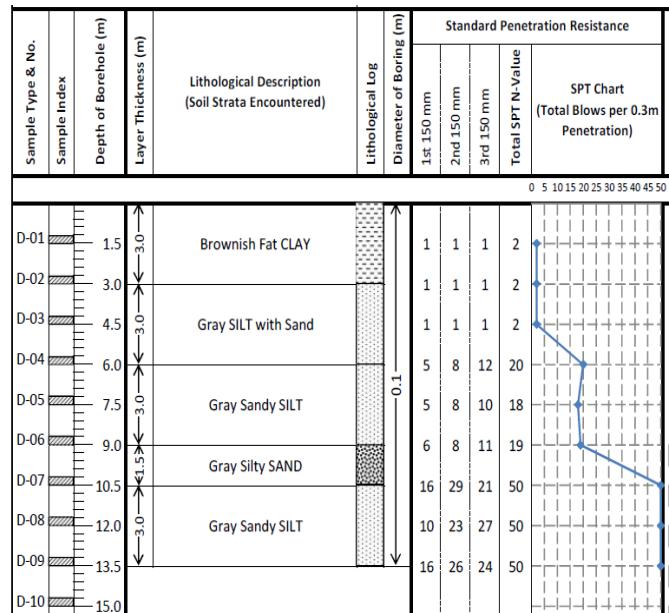
Nearly 85 percent of Bangladesh is underlain by deltaic and alluvial deposits of Ganges, Brahmaputra, and Meghna river systems (Alam et al, 1990). In the previous studies of the coastal region of Bangladesh, it was found that the sub-surface soil is soft (Kabir et al, 2000; Nath et al, 2017). At least 4-8 m soft clay exists at top layer of subsoil in coastal districts. Figure 22 shows a bore log of plot for Civil Surgeon office, Gopalganj. In another research report on "Ground Improvement on Khulna Soft Soil" revealed that more than 15 m soft clay layer exist at top of subsoil in Khulna region (AsCAP final report, 2017). The soft soils consist of silt or clay. Besides, in that region, in some places, an organic clay layer of 3-5m thickness was found. This organic layer was formed from the decomposition of mangrove vegetation of the largest mangrove forest of Bangladesh (Kabir et al, 2000). As the soils of the coastal area are soft and sometimes those are organic, settlement of the newly constructed road or widened or elevated road continues more than 10 years. This settlement is not uniform along longitudinal direction of road.

Figure 22 A subsoil bore log at Civil Surgeon Office, Gopalganj, Dhaka

When roads are constructed on this subsoil, consolidation and squeeze out of soft clay cause subsidence, cracking and rutting of constructed road. Subsoil investigation should be mandatory for road project in coastal areas. Special attention should be given in the planning and design phase of road projects. Geotechnical Engineers should be involved in the design phase. Figure 23 shows the settlement of road on soft soil. In the both sides of the road fish farm is full of water.

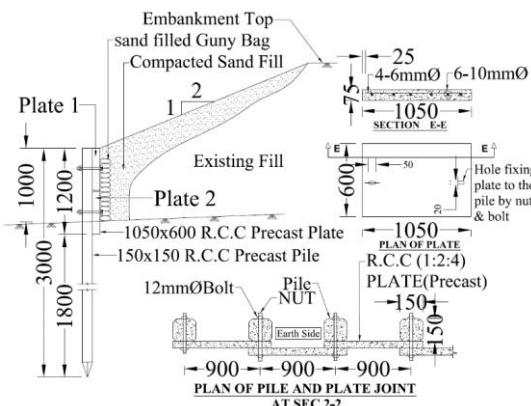
Palisading is done to stabilize the slope of the road along the pond, khal and river. In most of the cases palisading does not work properly. Figure 24 shows the design of palisading followed by LGED. Firstly the precast piles of 3 m length are driven into the existing soft soil at a c/c distance of 0.90 m. Thereafter the RCC precast plates are hooked using nuts and bolts. After one or two years of construction the nuts and bolts become corroded and slipped from hooked piles (see Figure 25(a)). Besides, in between two vertical RCC plates small gap exist through which the soil washed away day by day and erode the slope (Figure 25(b)). Later this design is modified by LGED. They used cast in place plates instead of precast plates. However, this system is not stable in many soil conditions of coastal districts. The posts are inserted within the soft soil layer. Failure of palisading is observed in Kajiarchor, Shariatpur (Figure 26). Existing typical design and construction methodology of palisading need to be revised. Palisading design need to be modified with proper stability analysis by Geotechnical Expert.

Figure 24 A typical design of palisading implemented by LGED.

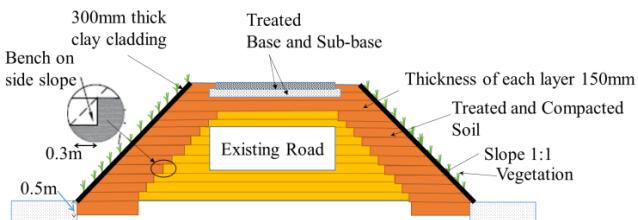
Figure 33 Proposed method of rural road widening.

Major problems identified in rural road construction are improper methodology of construction and unavailability of suitable material. Recommended method of road widening and elevating is shown in Figure 33. Benching at existing side slopes, layer by layer compaction and keeping required distance between borrow pit and toe should be done for making sustainable rural roads. Compaction of soil at widened part of embankment is difficult due to two reasons. One reason is high moisture content in borrow pit soil and another reason is roller cannot move in muddy land. 4% lime treated clay can be used for filling widened part of embankment (Abdi, 2011; Osinubi, 2006). Addition of lime reduces the water content due to hydration and reaction with clay and it will increase the workability, such as easy compaction. Compaction must be done using diesel operated plate compactor. After accomplishing the road construction work, a 150 mm thick clay cladding may be used on lime treated clay slope for growing vegetation. Besides, by treating the soil it is possible construct the rural road at steep slope (1H:1V) which will be also reduce the cost. Lime treatment may increase the budget of the project but considering the steep slope and life-cycle cost it is more economical. The borrow-pit location should 3m or
