Anchors of Anchored Slopes in Taiwan

ABSTRACT: A catastrophic failure of an anchored cut slope at the national expressway in 2010 uncovered the status quo of tie-back anchors in Taiwan. Serious corrosion of anchor components due to poor corrosion protection was found to be the most obvious factor contributing to this landslide among other factors. After an extensive island-wide investigation on the existing anchored slopes, similar corrosion problem was found in many other anchored slopes. After the investigation, the construction and maintenance practice of anchored slopes had been fundamentally changed in Taiwan. This paper covers the inspection results on anchored slopes and also the measures taken to improve the corrosion protection of existing anchors and new anchors. Based on the problems found from the existing anchored slopes, some modifications on anchor tendon assembly and cement grouting practice had been developed to upgrade the corrosion protection of the new anchors and to monitor the long-term anchor load change as well.

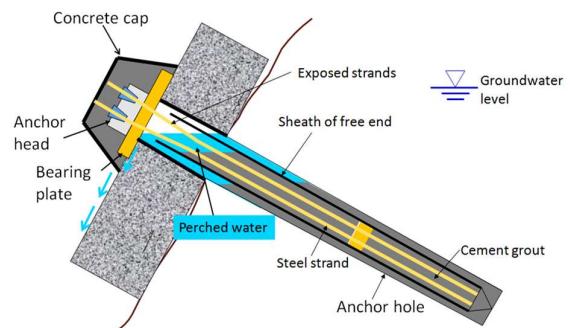
Figure 5 Schematic diagram of ground anchor installed in the slope

Figure 5 illustrates the ungrouted void under the anchor head due to improper anchor hole grouting. When anchor is inclined downward, the void and the ungrouted annular space outside the plastic sheath can easily become a storage space for the perched groundwater in slope. Having the perched water in the anchor hole, the unprotected steel strands are constantly exposed to or submerged by groundwater. Not for long, the steel components of anchor become corroded quickly. The corrosion of steel strands can be inspected by the endoscope images taken when inspecting the portion of steel strands under anchor head.

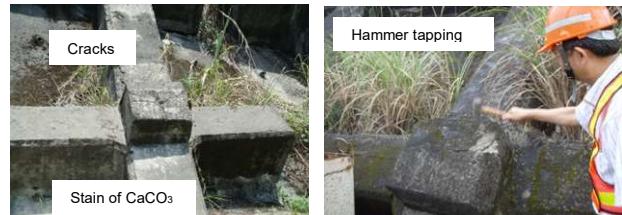
Figure 7 Visual inspection and hammer tapping on the concrete cap of anchor

protection cap of anchors (Figure 7): The integrity of concrete cap can be easily detected by hammer tapping. Special attention should be paid to the cracks on concrete cap and the sign of groundwater leaking out from the concrete cap. If there is a constant water flow from within the anchor hole, calcium carbonate (white stain CaCO_3) will deposit under the concrete cap and can be easily spotted.

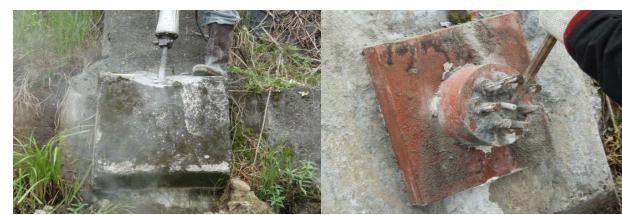
Figure 8 Remove the concrete protection cap of anchor head

If the integrity of concrete cap is good, normally the appearance of steel strands and wedges also look good. Otherwise, a clear sign of corrosion can be observed on the strands and wedges.

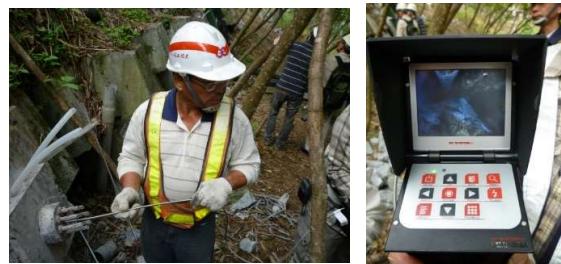
Figure 9 Use endoscope to inspect steel strands under anchor head

(3) **Use endoscope to inspect the condition of steel strands beneath the anchor head (Figure 9):** Usually, the appearance of anchor head components does not necessarily correspond to the extent of corrosion on steel strands beneath the anchor head. So it is necessary to use endoscope to do a close up inspection on the corrosion condition of steel strands under the anchor head.

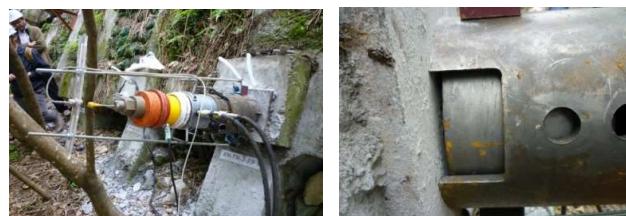
Figure 10 Lift off test for determining the residual anchor load

(4) **Carry out the lift off test to determine the residual anchor load (Figure 10):** It is normal to have a residual anchor load varied within $\pm 20\%$ range of design load. For those anchors suffering serious strands corrosion problem, extra caution must be exercised to avoid breaking the rusty steel strands during lift off test. If the residual anchor load goes beyond 130% of design load, it is an indication of slope displacement. Immediate measures must be taken to resume the stability of slope. If the anchor load falls below 80% of design load, it may be resulted by problems associated with fixed end, free end, and anchor head; or simply a load redistribution of the anchored slope. The real causes should be observed and verified from the timely slope inspection work carried out afterward.
