Forensic Investigation of A Subway Tunnel Construction Failure

ABSTRACT: In this paper, the forensic evidences and investigation of a subway tunnel construction failure occurred in Kaohsiung, Taiwan are presented. The studied construction failure occurred during a cross passage excavation of a shield tunnel construction work of the Kaohsiung Mass Rapid Transit System, and resulted in severe tunnel collapse and extensive ground failure that even reached to ground surface 30m above the tunnel depth. Valuable photo images obtained during and post event, as well as results of special geophysical testing methods were presented and compared to verify proposed failure scenario. Information presented in this paper is hoped to be helpful to improve engineers' knowledge for preventing similar construction risks.

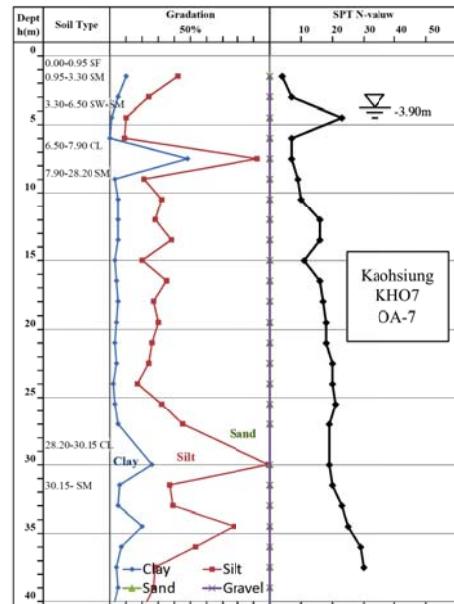
Figure 4 Typical soil profile with gradation data at the site after collapse

Figure 4 also shows a typical soil profile of the studied site after failure with gradation characteristics. As shown in the figure, silty sand deposit at the studied site contains 20% to 35% fines with no plasticity. This silty sand deposit was later studied and confirmed as very sensitive to internal erosion and disturbance (Chen 2012). Ground water table of the studied site is closed to 2~3m below the ground surface. The hydrostatic pressure at the depth where construction failure occurred is over 2.7 kg/cm^2 . Prior to the crosspassage excavation work, soil surrounding the excavation area where the failed crosspassage was located had been stabilized by means of the jet grouting for the purposes of both strengthening the soil and providing water tightness.

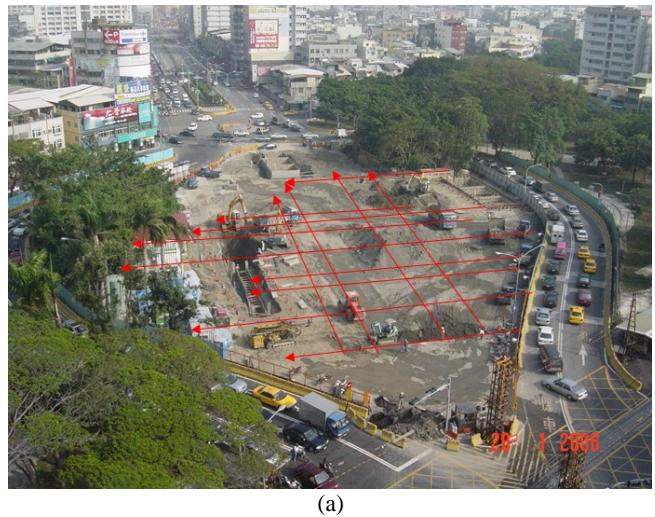
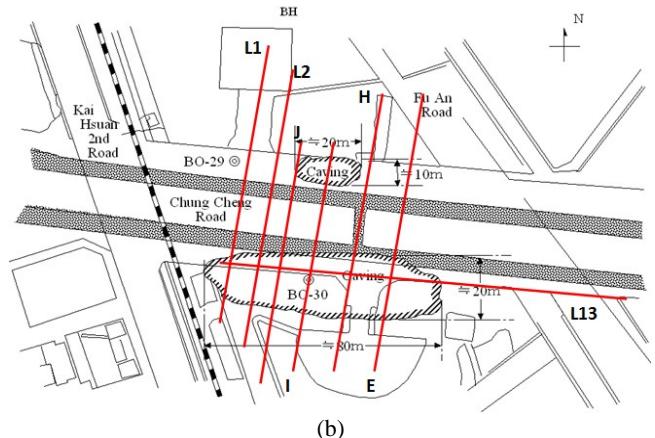
Figure 21 Layout of 2D RIP tests

RIP surveys were conducted. Optimization of sensor layouts and calibrations of the analytical models were the most challenging issues of this forensic RIP testing (Lee and Ishihara, 2008a). Figure 21(a) shows the layout of the 2D RIP testing. As depicted in the figure, total four longitudinal (east-west direction) and nine transverse (north-south direction) survey lines were conducted in an attempt to cover the damaged area. Moreover, Figure 22 shows the top view and the cross section schematic drawings of the 3D RIP testing. Total six boreholes were drilled to a depth of 40m. This 3D RIP survey was in an effort to assess the damage condition of the cross passage and the up-track shield tunnel.
