Case Study of Renovation on Alishan Route 18 after Typhoon Morakot

Kung-Tai Chou¹, Wen-Long Wu², Chiao-An Hsiao³, Kun-Hsien Chou⁴
CECI Engineering Consultants, Inc., Taiwan

KEYWORDS: Typhoon Morakot, Road, Slope, Disaster, Remediation measures

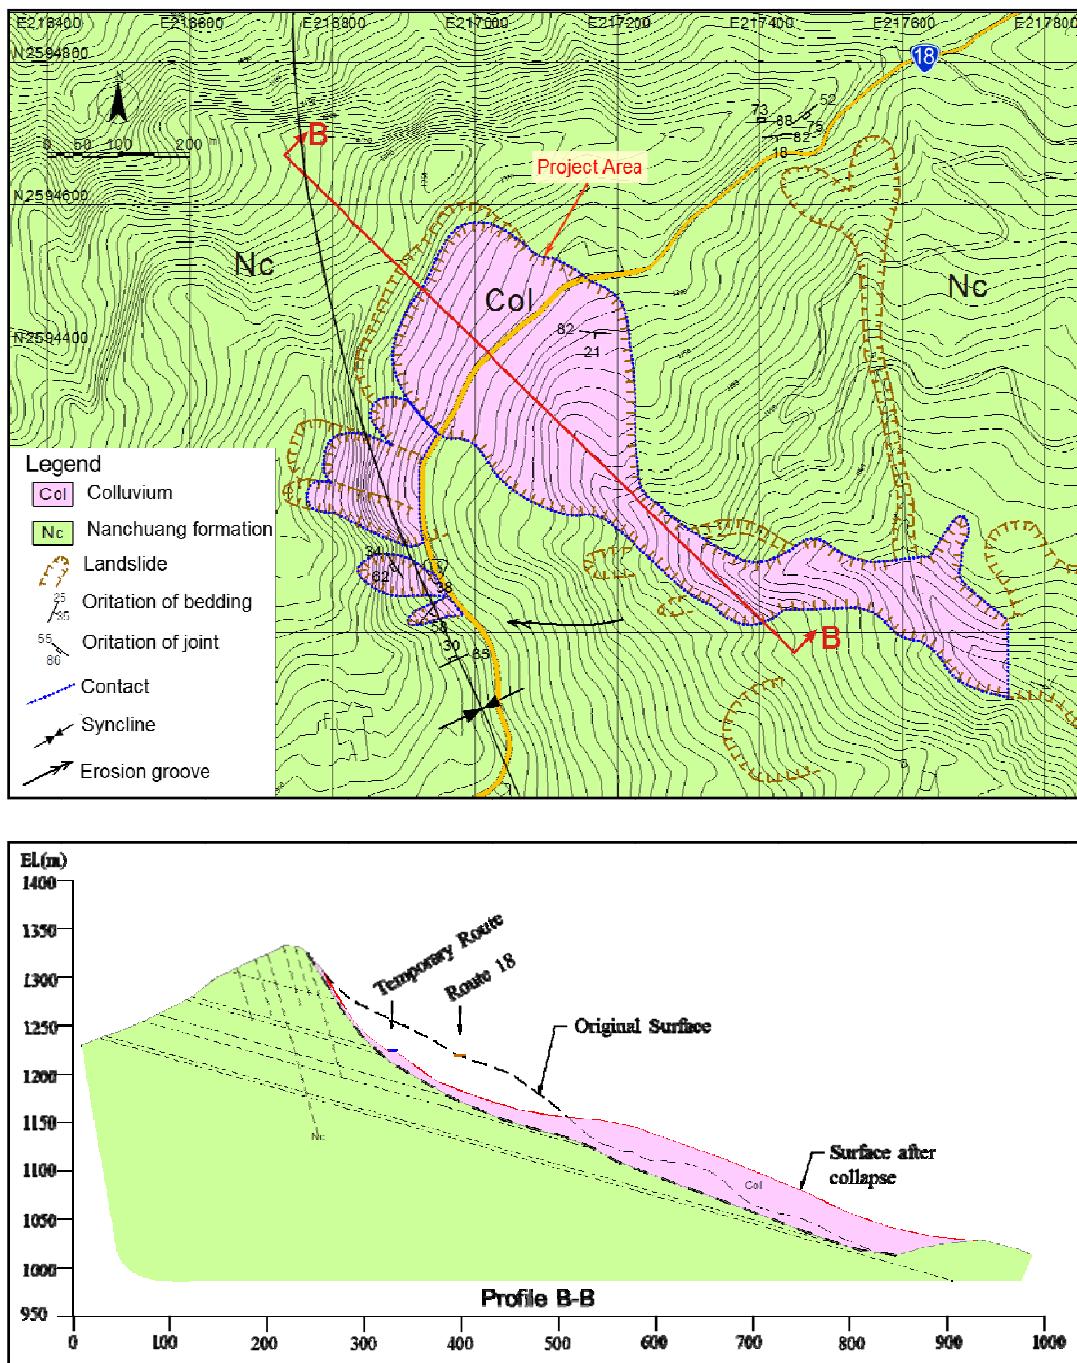
Figure 7 Geological plan and section at mileage 59.1k.

59.1k	<ul style="list-style-type: none"> Runoff erosion due to heavy rain No vertical and horizontal cut-off drainage facilities in slopes Formation steep, more broken joints in the upper shale slope, lots of rain infiltration in joints increase tension cracks. Rainwater infiltration in colluvium deposits at lower slopes soften soil strength and lead to slope failure 	<ul style="list-style-type: none"> Topping failure due to the crest rock with high angle joints, the slopes in vicinity of tunnel belong to dip slope plane slide. Other sections are classified as circular landslide

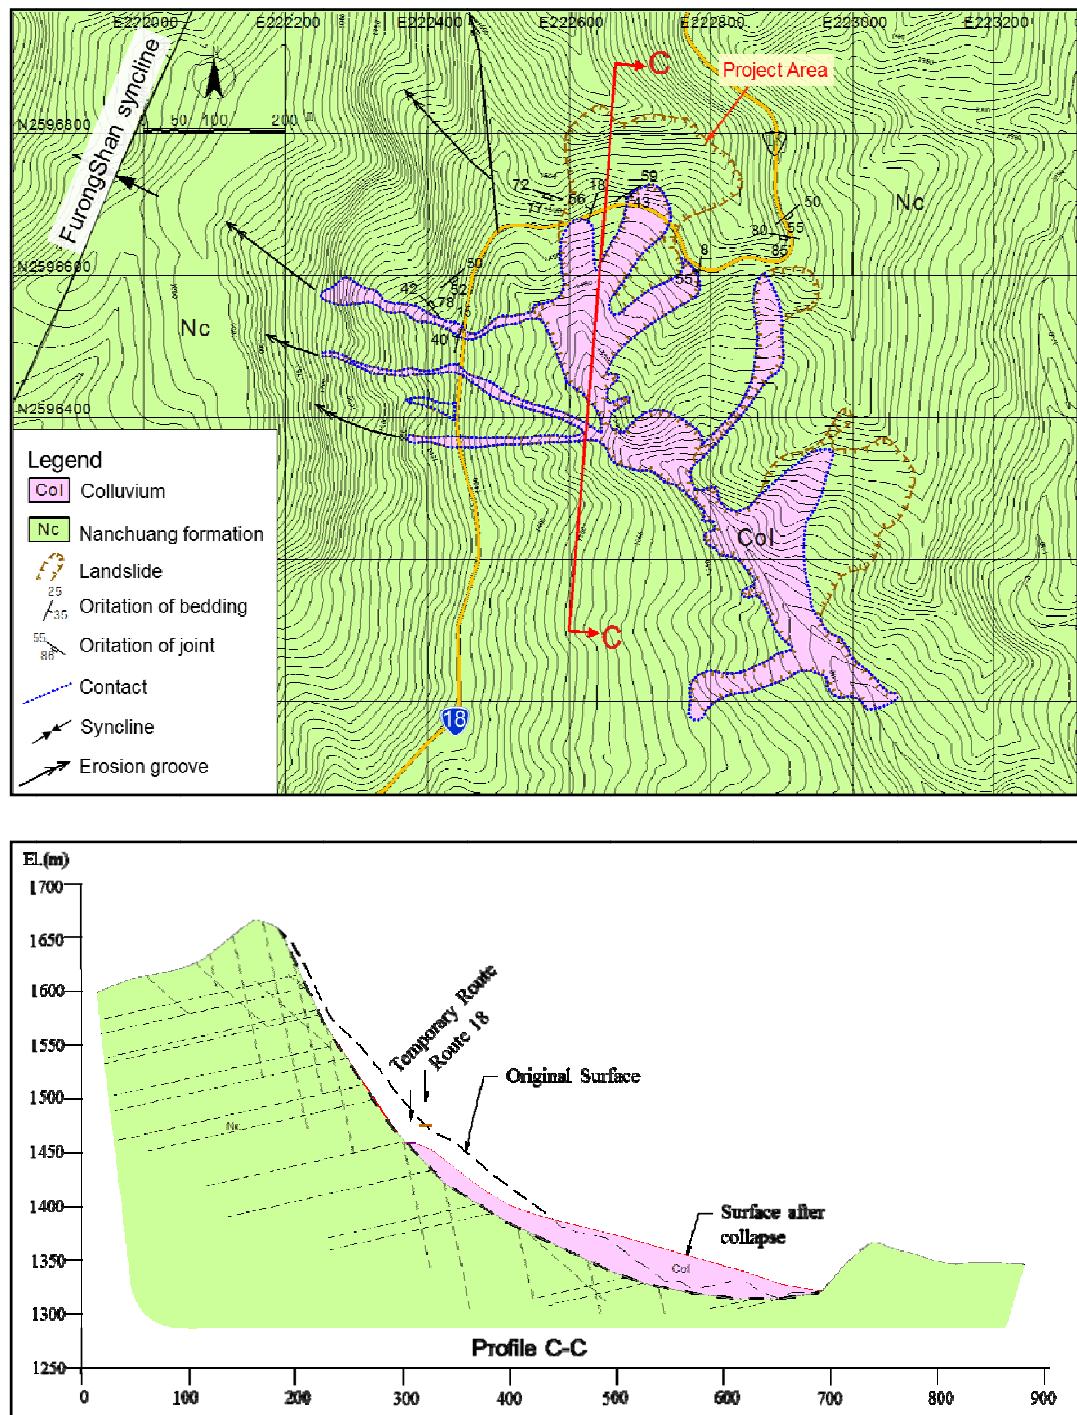
Figure 8 Geological plan and section at mileage 71.1k

71.1k	<ul style="list-style-type: none"> Runoff erosion due to heavy rain After rock crushing and highly weathered, the rain infiltration in rock cracks increase water pressure and soften soil strength. This road section includes streams through, runoff flow wash out slope and rock rushed shift which results in steep terrain in some sections. In the upper slope of road, the heavy rainfalls leads to the broken rocks fall and accumulate on the roadbed. In the lower slope of road, the exposed toe of dip slope leads to landslide and the loss of roadbed. 	<ul style="list-style-type: none"> The upper slopes are classified as circular failure, the upper broken rocks fall and accumulate on the roadbed. The lower slope valleys are wash out by rains, the exposed toe of dip slope lead to landslide in the lower slope.
