## DAMAGE OF PUNCH/DIE TOOLS IN STEEL WIRE ROD SHEAR CUTTING

*In this research work, damage of punch/die tools in a steel wire rod shear cutting was investigated. The tools (punch and die) used in a steel wire rod (JIS SCM420) cutting ranging from 50,000 to 150,000 cutting shots were collected for the investigation. Experimental results showed that the main damage of the tools at the sheared zone was tool edge chipping. The edge of the die was chipped severely when passing 150,000 cutting shots. To investigate the cutting characteristics of the wire rod by the damaged tools, the tools were applied for a shear cutting test using a developed shear cutting tool holder. It was found that the damage of the tools did not remarkably affect the cutting load resistance of the wire rod. However, when cutting the wire rod with the higher-cutting-shot tools, the quality of the sheared edge deteriorated. Namely, the sizes of the rollover and the burr at the sheared edges of the wire rod tended to increase.*

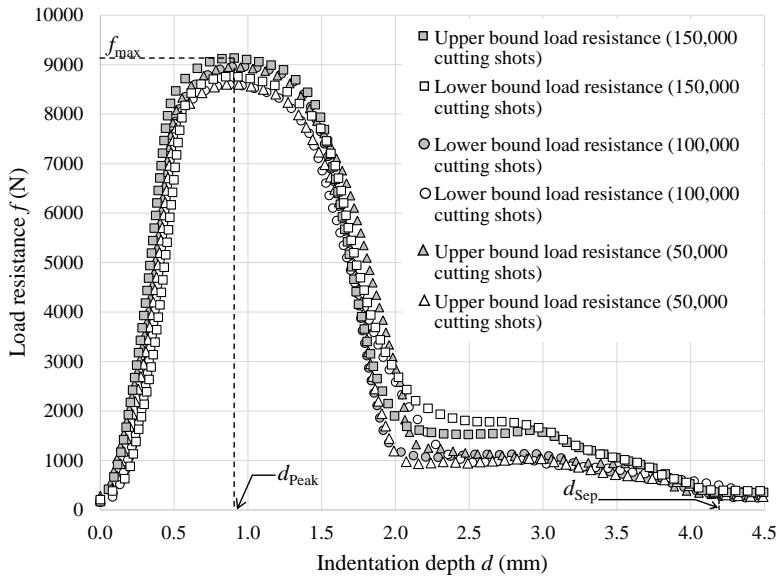
**Fig. 7.** Relationship between indentation depth of punch and cutting load resistance of wire rod.

In steel wire rod shearing industry, punch and die are impossible to be replaced, suddenly after their damage. Due to the high productivity of the shear cutting process, a lot of wire rods are cut by the damaged tools. In order to identify the acceptance damage level of the tools to obtain satisfy shear cutting results, the understanding of the cutting characteristics of the wire rod by the damaged tools is crucial. Thus, the authors used the damaged tools (50,000, 100,000 and 150,000 cutting shots) for the wire rod shear cutting test and investigated. Figure 7 shows the cutting load resistance of the 50,000, 100,000 and 150,000 cutting shot tools. Here, it was found that the load resistance of the wire rod was not significantly different when varying the tool cutting shots. In addition, considering the peak point of the load ( $f_{\max}$ ) and the peak position ( $d_{\text{peak}}$ ) which typically correspond to the crack initiation state of wire rod, they were not noticeably affected by the tool damage. Also, the final separation position of the wire rod ( $d_{\text{sep}}$ ) was similar for all cutting shot tools.
