FAILURE ANALYSIS OF A HERRINGBONE GEAR IN 2-HI PINION GEARBOX USED IN HOT STEEL MILL

ABSTRACT

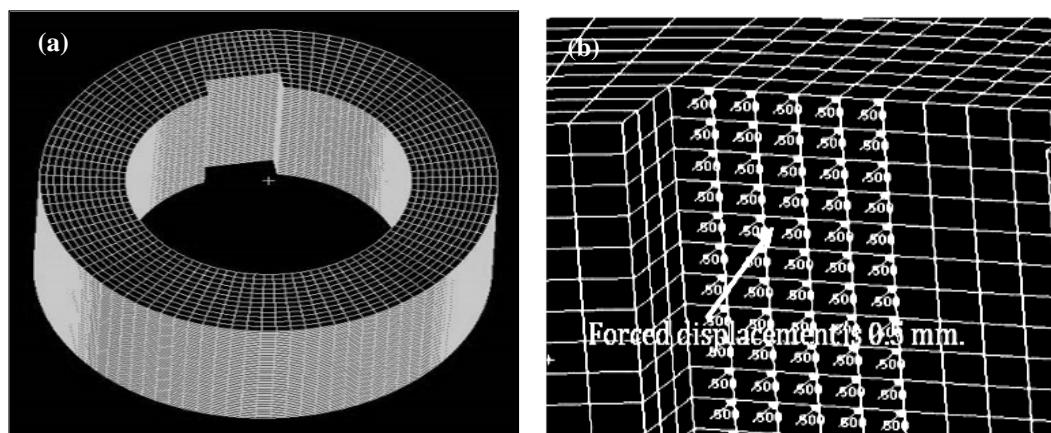
There are 4 boundary conditions to constrain the model. (i) To simulate the deformation of the keyway due to the installation of the over-sized key, the nodes in the contact area are applied with a forced displacement of 0.5 mm, as shown in Figure 2b.

A contact area is the area which the keyway surface shows damages due to the interference as rubbing wear. (ii) To simulate an abutment between the bore of the gear and

Figure 2 Simplify the FE model of gear (a) Forced displacement on the keyway (b)

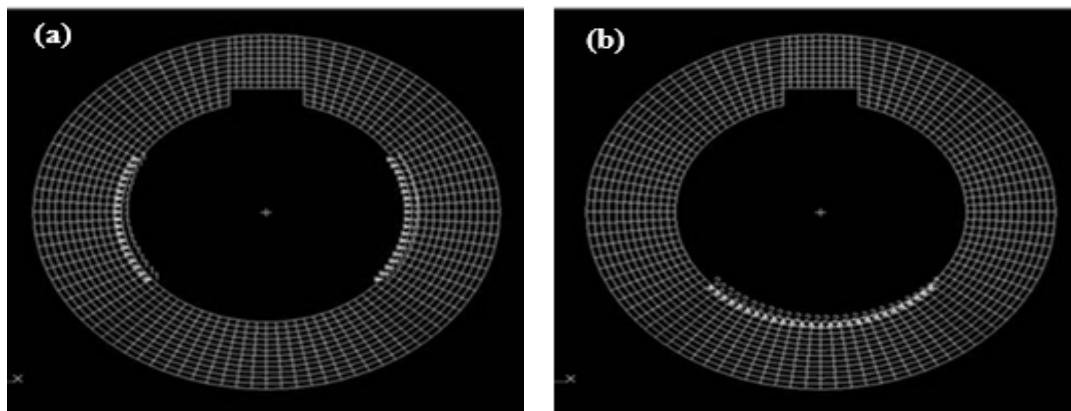
the shaft, the nodes at both sides of the bore are constrained in X translation because inside bore diameter of the gear cannot become smaller, as shown Figure 3a. (iii) To simulate another abutment contact between the shaft and the inside bore diameter of the gear, the nodes at the bottom of the inside bore diameter of the gear are constrained in Y translation, as shown in Figure 3b. (iv) There is one node which has been constrained in Y translation, this node is also constrained in all DOFs to locate the model in the space and to make the analysis runs.

Figure 3 Constrained in X translation (a) Constrained Y translation (b)
