MAINTENANCE PROCESS FOR TRANSMISSION TOWERS

Prachoom Khamput¹

ABSTRACT

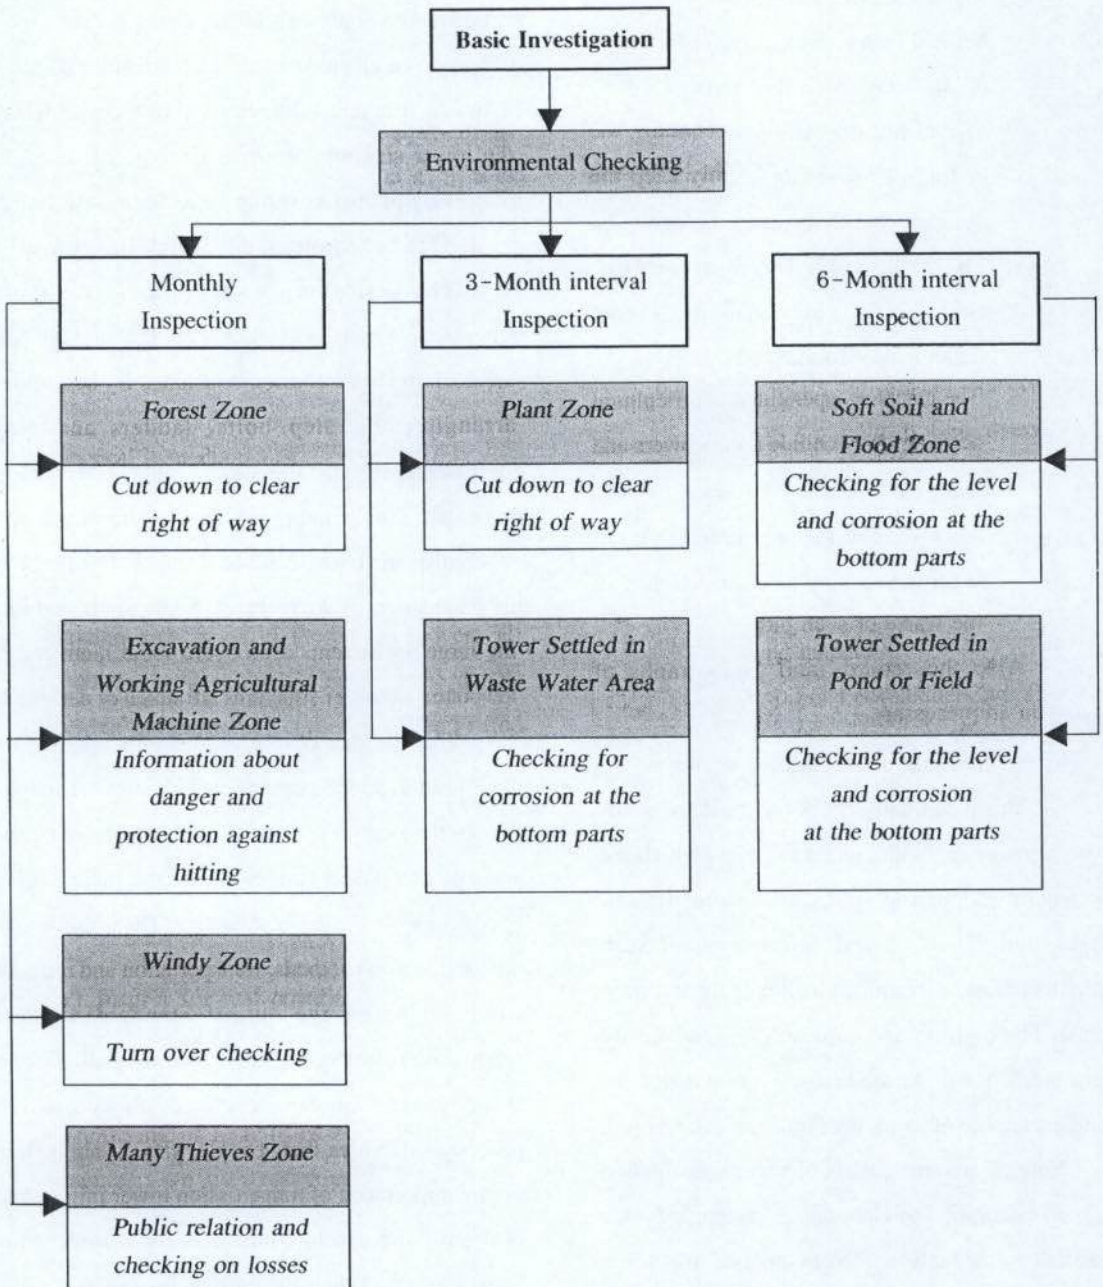
Fig. 2 Chart for Presenting the Basic investigation

- Figure 2 has shown the chart of basic investigation.
- Figure 3 has shown the chart of elaborating investigation.
- Figure 4 has shown the chart of operation system for elaborating investigation.

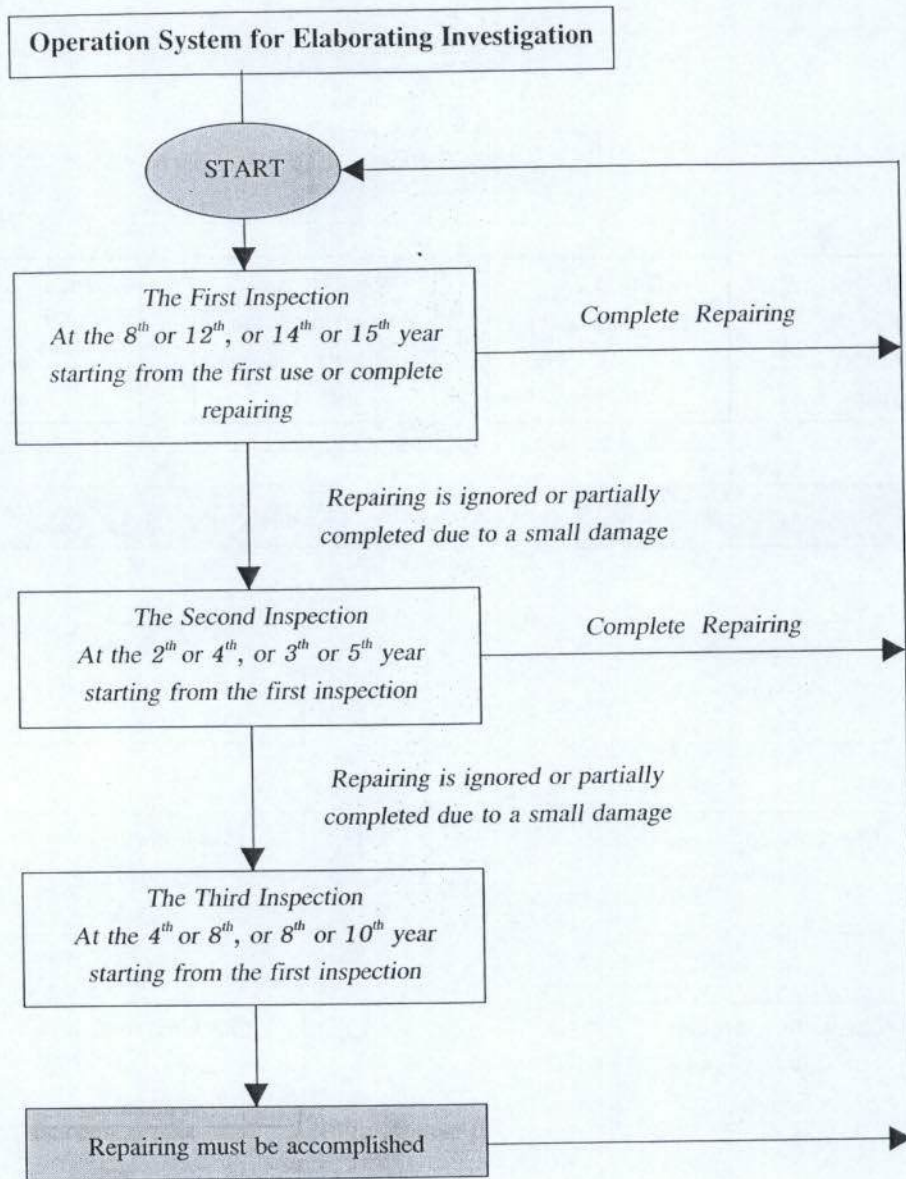
Fig. 4 Chart for Presenting the Operation System of Elaborating investigation

Consider on the figure 4, the order of checking period is presented as follows: industrial, city, rural-II and rural-I area, respectively.

From the above information, the operation system for the elaborating investigation has been begun from the checking cycle at the 8 or 12 or 14 or 15 year for industrial area, city area, rural-II area and rural-I area respectively that is started from the first use of tower or the last complete repairing.
