Geometry and Roughness Effect at the RCC Interface-Earth Dam Causing Leakage in Mae Suai Composite Dam, Thailand

ABSTRACT: Mae Suai Dam is an earth zone dam with RCC section in the center of downstream slope located at Mae Suai district, Chiang Rai, Thailand. The differential settlement at the joint between RCC spillway and the earth-filled section caused leakage near the crest of the dam. This unusual settlement is the result of a joint where materials of different stiffness are connected; the settlement pattern depends on the shape and interface shear strength of the contact area. In this paper, non-uniform settlement of Mae Suai Dam was investigated by 2D & 3D FEM using MIDAS GTS for Fully Coupled Stress-Seepage analyses. The results of finite element analyses were verified with the geodetic measurements data and observation in rehabilitation processes of Mae Suai Dam. Roughness and taper effects were studied by analyzing the settlement along the dam crest using 2D FEM analysis by varying the interface stiffness between the earth dam and RCC spillway to characterize the settlement of each condition and verified with the geodetic measurements. The analysis revealed that the effe

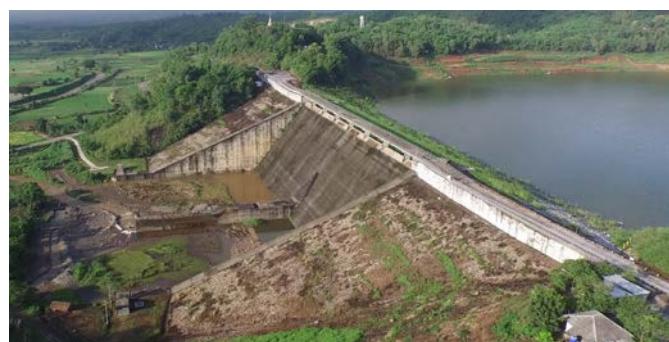
Mae Suai Dam is a 59 m high structure with 400 m crest length and having a reservoir capacity of 73 million cubic meters (Figure 1). The dam has been in operation since 2003. The RCC section is used as an overflow spillway and was designed for 500 years return period of the flood. The RCC material is a low-paste RCC covered with conventional concrete (CVC). Figure 2 shows the longitudinal and transverse sections of the dam. The RCC structure is laid upon sound rock foundation. Sandy material in the riverbed has been removed to prevent the under seepage and potential soil liquefaction. The RCC section consists of an overflow spillway and gravity retaining wall at both sides to create flow channels and retain the earth dam at both sides (Figure 3).

Figure 1 Mae Suai Dam

Mae Suai Dam is an earth zone dam with RCC (Roller Compacted Concrete) section in the center of downstream slope located at Mae Suai district, Chiang Rai, Thailand, as shown in Figure 1. The differential settlement at the joint between RCC spillway and the earth-filled section caused leakage near the crest of the dam (Soralump et al., 2016). This unusual settlement is the result of a joint where materials of different stiffness are connected; the settlement pattern depends on the shape and interface shear strength of the contact area. The surface roughness is found to have a substantial effect on the interfacial shear strength and shear behavior, with the shear strength increasing with increased surface roughness level (Chen et al., 2015, Wang et al., 2020).

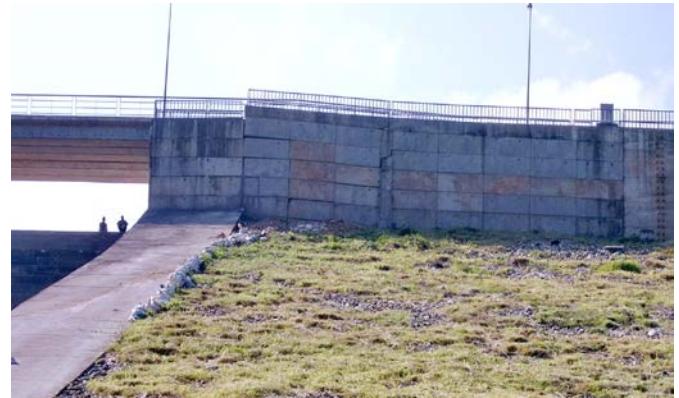
Figure 7 Elevation of RCC Block D and differential settlement at left bank (Photo by RID)

The differential settlement between RCC spillway and earth dam section can be observed prominently in the contact of two sections from the outside. The designer had the intention to deal with future differential settlement by making the crest elevation of earth dam section to be higher than the RCC spillway section, RCC Block D is, therefore higher than the spillway section, as shown in Figure 7. However, RCC Block D appeared to be raised over the adjacent RCC spillway with the passage of time, and therefore higher differential settlement is observed at this section (Figure 7 and Figure 8). The differential settlement of the dam had started after the first year of its operation in 2003.

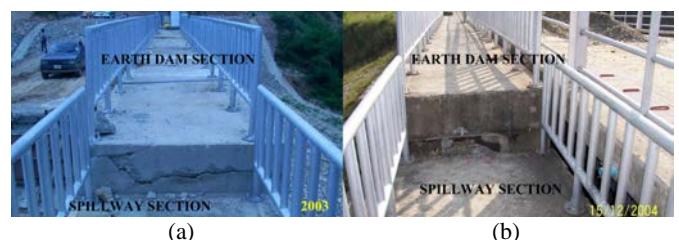
Figure 8 The settlement of the earth fill (Photo by RID: (a) 2003; (b) 2004)

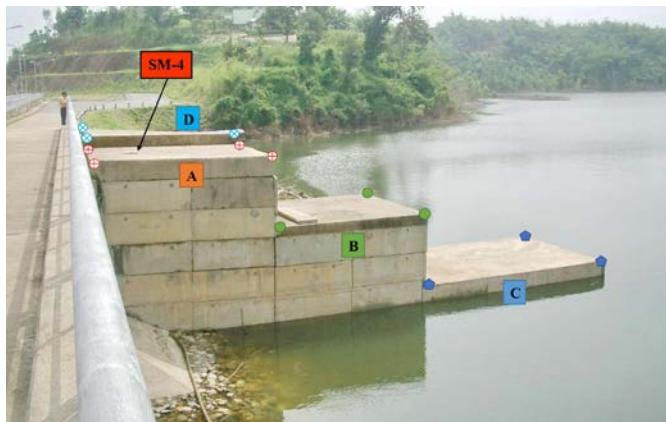
Figure 9 shows the location of observation points used to measure the settlement of RCC Block A, B, and C (Guide Wall). The vertical displacement of these RCC blocks on the right side of the dam is as shown in Figure 10. The maximum settlement was measured at the end of Block C, while Block A, that was adjacent to the spillway, had the lowest settlement. The location of block A represents the rotation of RCC block, and therefore the crack was observed at the contact between Block A, Block D, and RCC Spillway (Figure 11 and Figure 12). Since the leakage was also observed in the contact area, the repair work was done in 2005 by removing the precast concrete panels that covered RCC Block D and installing the impervious membrane over the surface of RCC blocks along with grouting in the cracks between RCC Block A, B, C and RCC spillway. The leakage flow was reduced after the repair work, but some leakage still persisted. Sub-drain system for filtering and collecting the leakage water was then installed at the downstream toe of RCC crest block and RCC block D to prevent unnecessary seepage. However, it was found that the crack expanded with the passage of time, and the rate of leakage increased significantly each year, indicating the risk of suffused flow that might lead to piping failure.

Figure 9 Reference point at surface of RCC block (Photo by RID)

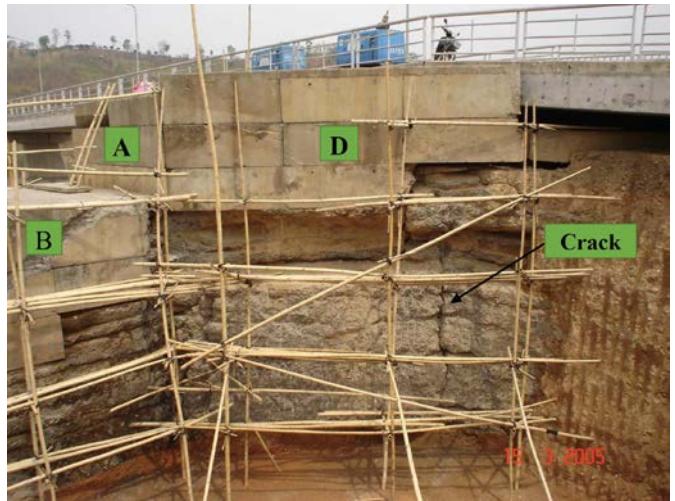
Figure 12 Crack in RCC Block D (Photo by RID, 2005)

decreases gradually as it moved near the abutment, causing block D to rotate, and the cracks were observed due to shear stress.

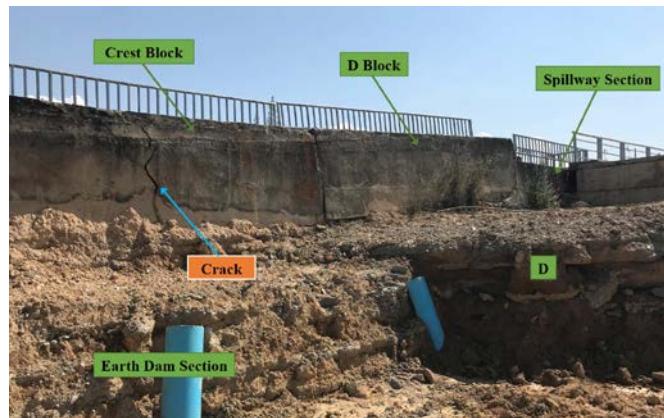
Furthermore, characteristics of settlement and tendency of the maximum shear stress were examined from physical observations and finite element analysis during the rehabilitation processes. The design of RCC crest block is as shown in Figure 22. It can be seen that the designer had an intention to deal with future differential settlement by making the crest elevation of earth dam section higher than the RCC section, in other words adding the camber. The results from finite element analysis showed that RCC block D had maximum shear stress and was greater than the shear strength of RCC (Figure 25). The characteristics of the settlement and occurrence of the crack in contact area between earth dam section and spillway section during the rehabilitation corresponded with the results of finite element analysis as shown in Figure 23 & Figure 24. The figure also shows the upward tilting of RCC block D due to shear cracking, i.e., the block was raised higher than the adjacent spillway section due to shear cracking (Figure 7 & Figure 8). The cracks observed at the RCC block D (Figure 24) are consistent with the results obtained from finite element analysis (Figure 25), causing leakage through RCC material to downstream section of the dam. The result from geodetic monitoring data and FEA shows the increase in settlement over time, especially during the first five years. After repairing the dam in 2004, the crack gradually expanded with the passage of time, leading to the significant increase in the rate of leakage.

Figure 23 Rehabilitation processes of Mae Suai Dam (2019)

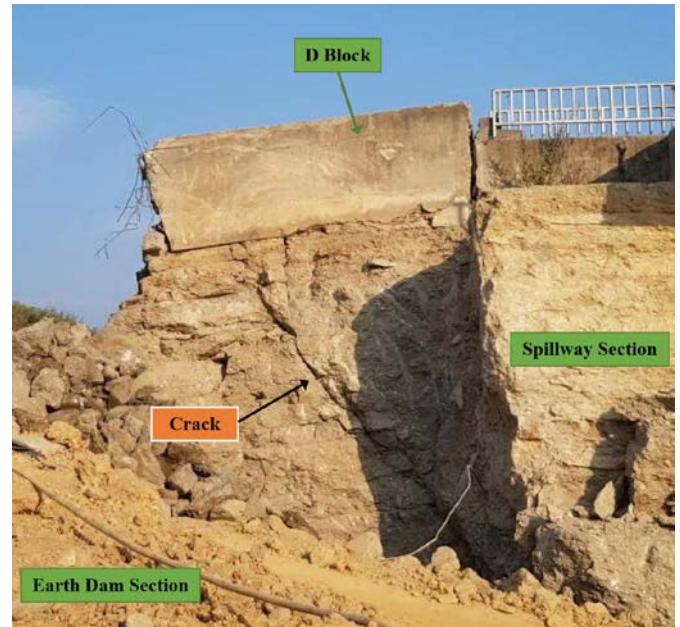
Figure 24 Crack appeared in the rehabilitation processes of Mae Suai Dam (2019)

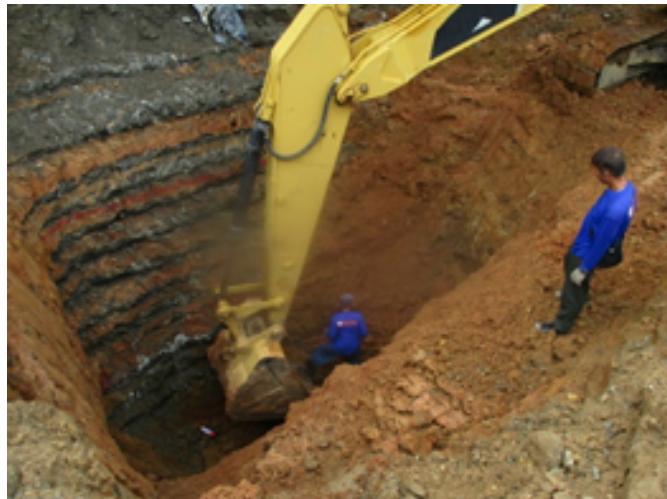
Figure 31 Roughness Surface in rehabilitation processes of Mae Suai Dam (2019)

This roughness was caused by the construction process by either compacting the RCC and each layer of clay together or using a material as a formwork with another material. However, the taper causes the clay at the contact to be compacted which leads to the increase in interface stiffness. Therefore, both roughness and taper have the effect on non-uniform settlement. The interaction between clay-concrete interface with roughness is useful for potential engineering applications, such as deep foundations or high composite dams. The shear resistance from roughness at interface used in the finite element analysis should be close to the strength of the clay ($R_{inter} = 1.00$) for determining the actual behavior of settlement. However, during the construction process, it is difficult to smoothen the RCC surface and allow the earth dam to slide down along the RCC inclination. The taper is also necessary to prevent the seepage through the contact between clay and RCC spillway.

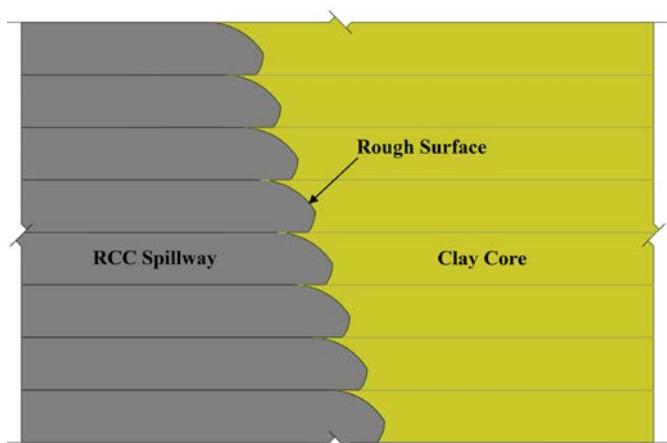
Figure 32 Rough surface between RCC spillway and clay core

If these types of dam structures are selected in other projects, the pattern of settlement should be considered in accordance with the guidelines for dam crest design to prevent damage and leakage caused by the non-uniform settlement of the dam. RCC block as the dam crest should be placed above the maximum water level of the dam to reduce the leakage at the downstream side. Additionally, to reduce the effect of roughness at the interface, CVC curb should be used instead of direct soil-to-RCC collision compaction.
