# Characteristics of Hardpan Calcrete of the Nyalau Formation and Impact on Design of Foundations

**ABSTRACT:** Nyalau Formation, found in Bintulu Division in Sarawak, Malaysia was formed by a thick array of shallow water marine and paralic sedimentary rocks. The formation is of predominantly sandstone origin and also the lesser known 'limestone' which is described as hardpan calcrete in this paper. Changes of sea levels during the mid-Pleistocene epoch resulting in the formation of raised terrace where marine deposits sedimented and subsequently followed by depositions of the coastal alluviums and inland peat swamps. The interaction of the depositions may have contributed to the formation of the hardpan calcrete. Laboratory tests such as petrographic thin section, X-Ray Diffraction (XRD), uniaxial compressive strength, point load tests, in-situ static load tests had been carried out on the hardpan calcrete to obtain the engineering design parameters to formulate a possible detailed design methodology on shallow foundation and its associated construction work progress. Several practical and effective solutions had also been proposed at locations where the hardpan calcrete layer wa

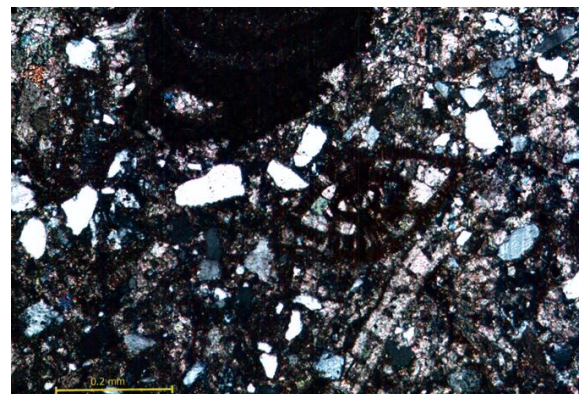
The petrographic thin section results shows that the sample is fine-grained and made out of fine calcite minerals, silt-sized quartz grains (5%) and some carbonaceous materials. Fossils of algae and skeletal remains of marine organisms (Figure 3) can also be observed in the matrix. The content of hardpan calcrete from the petrographic thin section is similar to the deposited materials during the Pleistocene Epoch as described by Koh (1968).

Figure 1 Petrographic thin section of hardpan calcrete

Hardpan calcrete samples were retrieved from Samalaju Industrial park and sent for Hand Specimen, petrographic thin section (Figure 1) and X-Ray Diffraction (XRD) test (Figure 2). Results of Hand specimen describes the sample as hard, fine-grained, dark grey in colour and reacts vigorously with 10% hydrochloric acid.

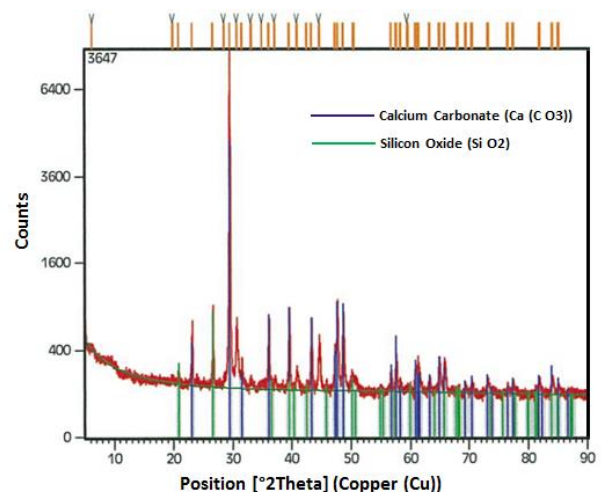
Figure 2 Mineral identification by XRD technique

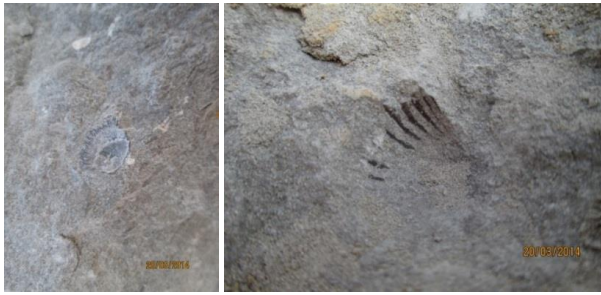
Figure 3 Marine fossils present on the hardpan calcrete

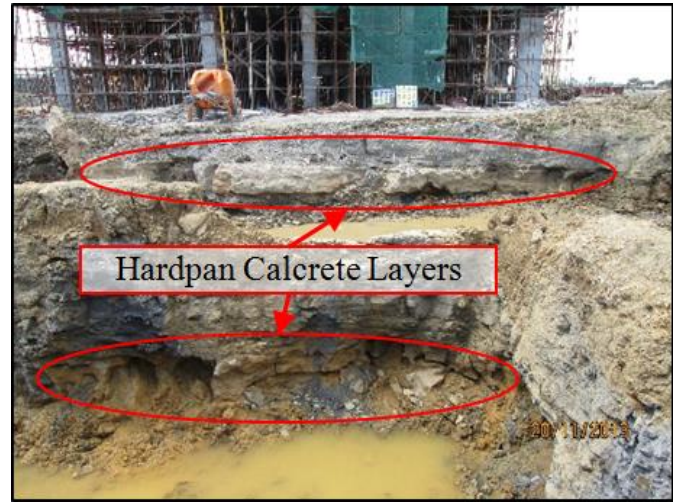
Figure 4 Hardpan calcrete layers

The hardpan calcrete found in Samalaju Industrial park has similar physical properties as both sandstone and limestone. This calcium carbonate cemented matrix is generally light-coloured, but can range from white to light pink to reddish-brown, depending on the amount of impurities present (Oklahoma Department of Mines, 2011). Hardpan calcrete layers can vary from a few centimeters to a few meters thick and multiple layers can exist in a single location as shown in Figure 4.

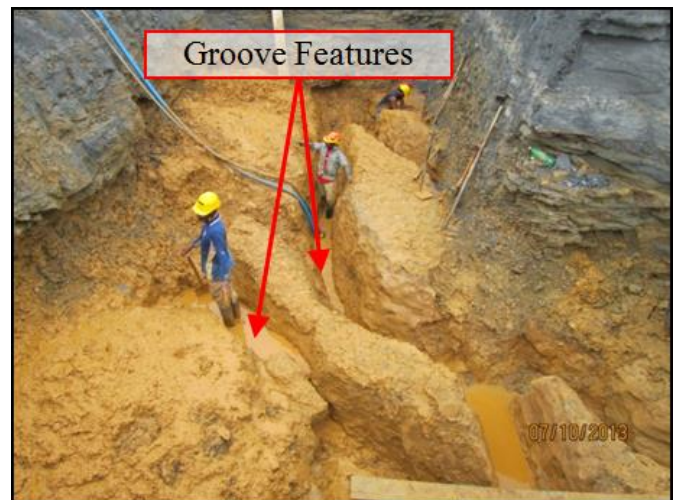
Figure 5 Features of hardpan calcrete

Hardpan calcrete layer has relatively low permeability, which leads to possible formation of perched water table. Groove line features are commonly found on the upper surface of hardpan calcrete as shown in Figure 5. The groove lines may be the result of reactions between the slightly acidic ground water or perched water table, eroding the hardpan calcrete. Clayey materials have been observed along the groove line features that derived from the erosion of mudstone, and trapped in the hardpan calcrete layers due to the impermeable mudstone below.

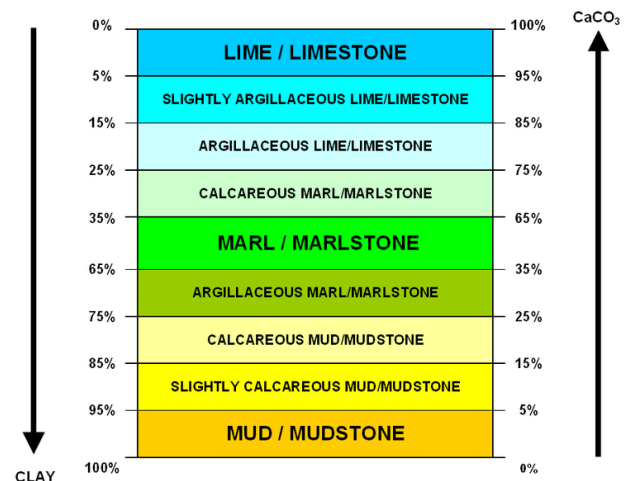
Figure 6 Clay and CaCO<sub>3</sub> content of different materials

Hardpan calcrete layers encountered were observed to be filled with a relatively soft, wet, very sticky and unusually plastic material known as marl as shown in Figure 6 (Moxham & Eckhart, 1956). According to Blatchley (1900), marl is a soft earthy material mainly consisting of clay and calcium carbonate or lime. The colour of marl ranges from milky-white to brownish yellow, dependant on the percentage of impurities the marl contains.

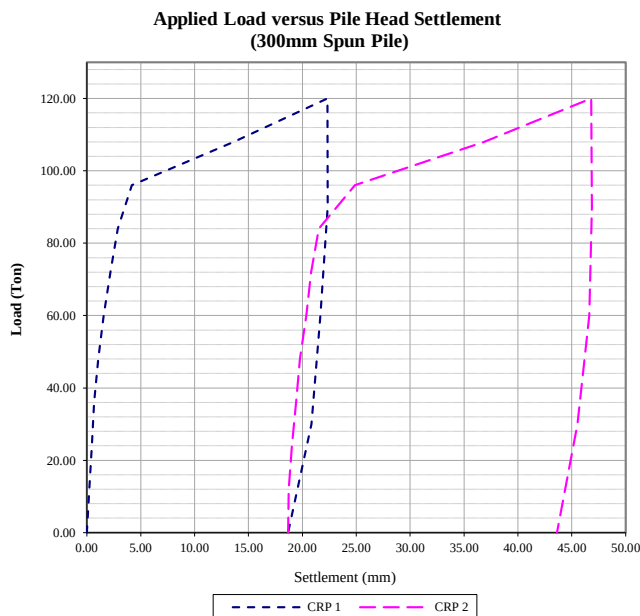
Figure 9 Load-settlement behaviour of 300mm spun pile

the limiting values specified by Jabatan Kerja Raya (JKR) Malaysia – 1988, where pile settlement at twice working load should not be more than 38.0mm or 10% of the pile diameter or width.

The cause of this phenomenon was not further investigated with additional exploratory boreholes or field tests due to time constrain. The possible presence of the hardpan calcrete (Figure 8) with marl infill at the end bearing layer for the pile may be a possible cause of the relatively large settlement. The load applied on the pile may have been transferred onto a thin layer of hardpan calcrete with soft marl infill underlying it, resulting in a large residual settlement after each load cycle. Laboratory results for hardpan calcrete specimens shown in Table 5 reveal that the complex matrix has very high compressive strength. The behaviour of a possibly thin brittle layer of calcrete with underlying soft marl deposits is unknown, which may be a possible reason of the 46.86mm settlement recorded at twice working load of the pile. As a solution, the design capacity of the 300mm spun pile was downgraded from 60 tons to half the capacity, 30 tons. Based on the plot in Figure 9, settlement recorded at 30 tons is relatively small and the settlement at twice working load of 30 tons, 60 tons, is within the limiting values specified by Jabatan Kerja Raya (JKR) Malaysia – 1988.

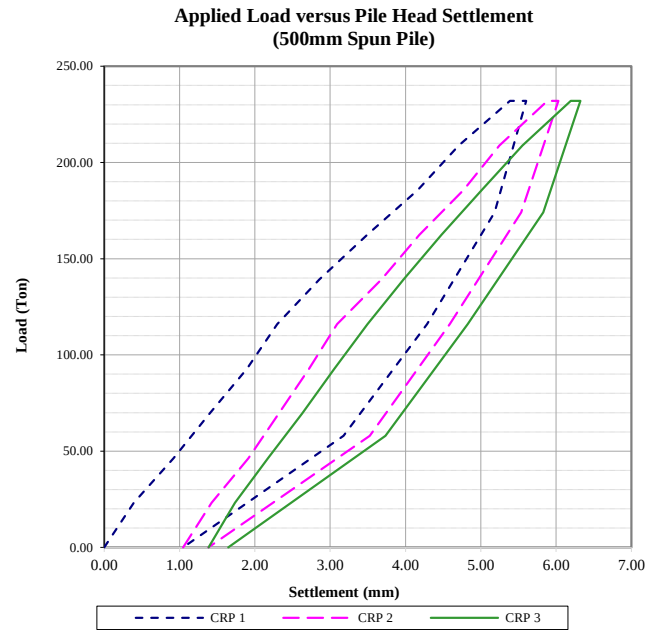
Figure 10 Load-settlement behaviour of 500mm spun pile

On the other hand, results for the 500mm pile CRP test (Figure 10) and 1.6m x 2.2m pad footing (Figure 11) fulfills the JKR specifications but shows very different settlement behavior when test load is applied.

The CRP Test for 500mm spun pile shows a relatively higher magnitude of pile head settlements with increasing load when load was initially applied to the pile. A gentler gradient of settlement was observed towards the end of the test showing that the skin friction may have been fully mobilised thus, load is transferred to the end bearing of the pile. The graph also indicates that the pile behaves elastically as the residual settlement decreases for every cycle, which is expected for a good pile foundation (Chin 1978).

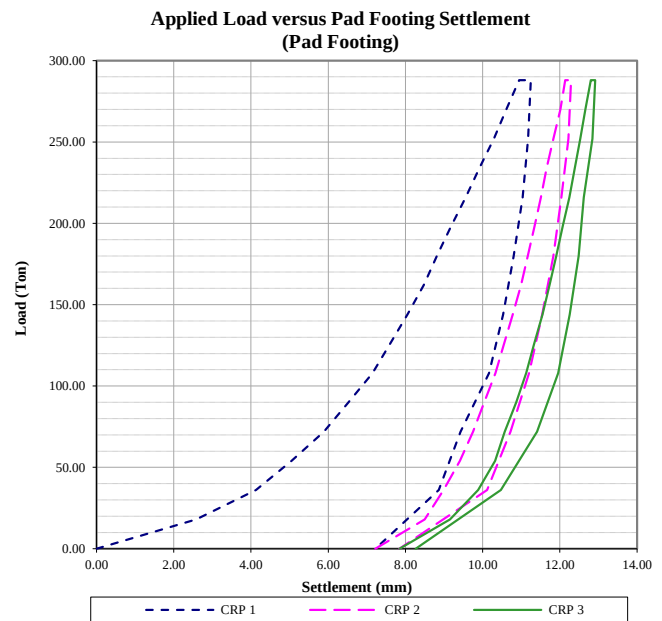
Figure 11 Load-settlement behaviour of pad footing

Dissimilar from the spun pile, the pad footing shows a different behavior of settlement during the CRP Test. As shown in Figure 11, larger magnitude of settlement was observed during the initial stage followed by lesser settlement towards the end of the test. The higher magnitude of settlement may be the result of immediate settlement from the uneven surface area or poor surface preparation of the pad footing.

Settlement was recorded to be smaller as compared to initial stage as the applied pressure may have caused mobilisation of bearing pressure of the ground after immediate settlement had taken place (Bengt 1999). This is further proven by subsequent CRP results mainly CRP2 and CRP3 which shows no indication of immediate settlement and almost full rebounds of the plate after load removal.

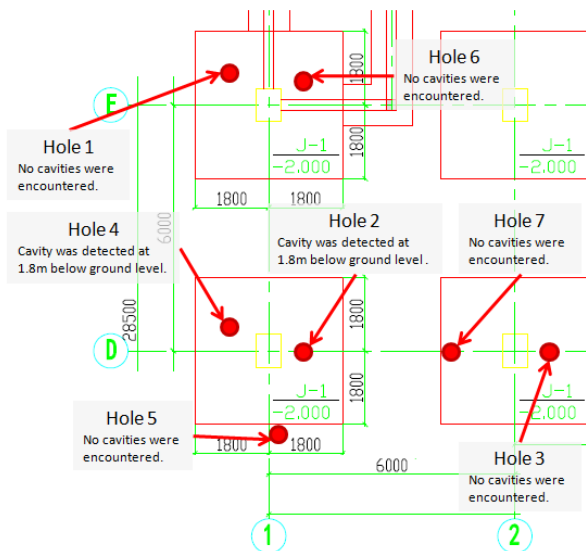
Figure 12 Investigation holes performed to verify presence of hardpan calcrete

One of the designed solutions was to combine three individual pad footings that are located on a hardpan calcrete layer. A site exploration for the three pad footings as shown in Figure 12 was carried out by drilling seven holes to investigate the probable thickness of hardpan layer and presence of marl infill beneath the uneven layer. The reason for carrying out this exercise is to explore possible solutions other than removing the relatively thick and solid layer of hardpan calcrete because it can be an expensive and time consuming process.

The investigation identified a soft marl layer that was 1.8 m beneath the footing at gridline 1/D. The findings were from the drilling results of hole nos. 2 and 4 as shown in Figure 12. The drilling probe was observed to have plunged into a soft layer with high moisture content after 1.8 m of drilling, causing soft marl to ooze out from the drilled holes and the probe jammed in the drilled hole. The other five holes were drilled up to 5.0m depth without encountering any cavities.

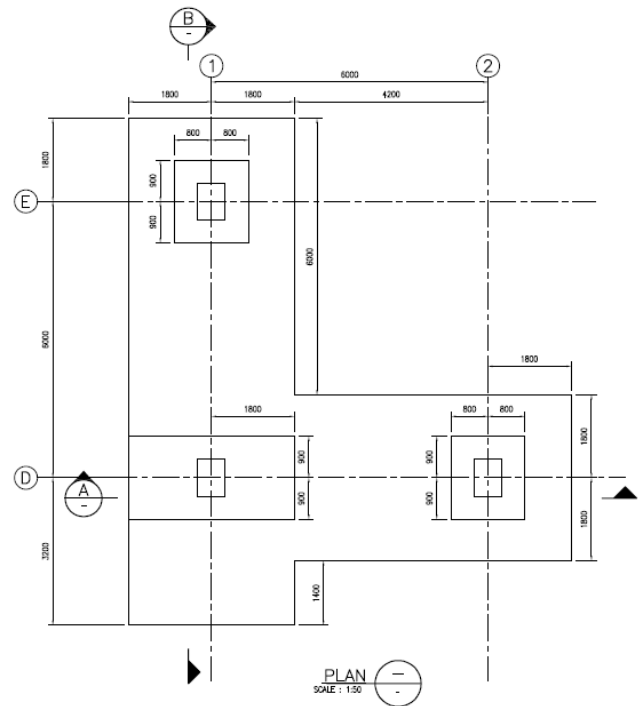
Figure 13 Re-designed combined pad footings

The hardpan layer was found to be approximately 2.8 m thick. This is confirmed by the observation of the drilled material/dust flushed out from the drilled hole after every 0.2 m to 0.3 m of drilling. In order to rectify this problem, a combined footing was designed to form a larger contact area to spread the designed load that was initially required for pad footing 1/D. The combined footing shown in Figure 13 also acts as a rigid pad to decrease any possible differential settlement. A finite element analysis was carried out across section B as shown in Figure 14. Figures 2 and 16 show the

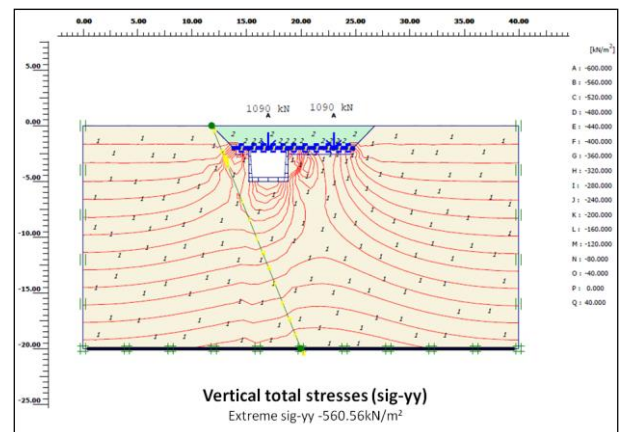
Figure 14 Finite element model with presence of cavity

The combined pad footing was modelled as a plate element, which sits directly above the soft marl infill. Another assumption made was that all the grooves or cavities present on the upper part of the hardpan calcrete layer will be cleaned thoroughly and backfilled with mass concrete before the combined pad footing was to be constructed over it. Thus, the calcrete layer with grooves backfilled with concrete is assumed as a layer with higher compressive strength that will experience minimal settlement, hence the applied load can be transferred underlying rock layer effectively. Conservatively, the cavity was modelled as void infilled with ground water.

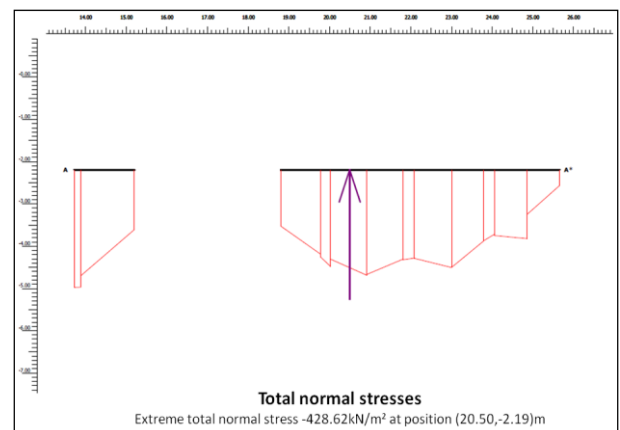
Figure 15 Analysed stresses acting on pad footing considering presence of cavity

analysed stresses acting on the pad footing and the settlement respectively for considering presence of cavity.

The total normal stress computed by the finite element analysis is  $428.62 \text{ kN/m}^2$  whereas the extreme vertical displacement is  $4.36 \text{ mm}$ . According to Bjerrum and Meyerhof's admissible and danger limits as shown in Table 6, a maximum of  $4.36 \text{ mm}$  settlement over  $6.0 \text{ m}$  span falls within the  $1/750$  angular distortion criteria ( $8 \text{ mm}$  over  $6 \text{ m}$ ) indicating that there will be minimal settlement to a structure and will not interrupt operation of sensitive machineries (Ricceri & Soranzo n.d.).

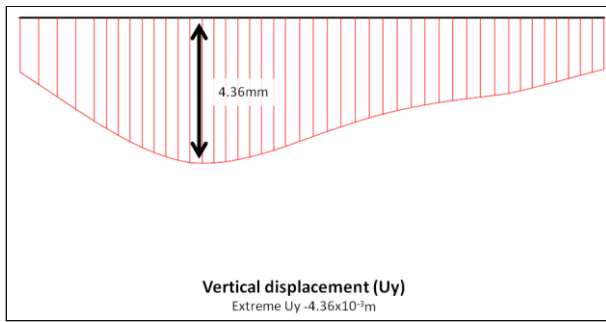
Figure 16 Analysed settlement considering presence of cavity

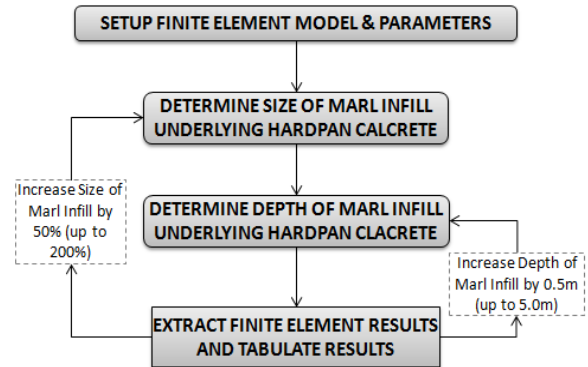
Figure 17 Procedure to analyse shallow foundation on hardpan calcrete with underlying marl infill

order to achieve the  $1/750$  angular distortion criteria in Table 6 (Ricceri & Soranzo n.d.). Anything thinner will require the excavation to remove the calcrete and the soft marl before backfilling it with mass concrete. The sequence of finite element is shown in Figure 17.

This method of investigation is necessary when pad footings are founded on mudstone layers where hardpan calcrete layers with marl infill were encountered while constructing surrounding pad footings. Several holes should be drilled with a percussion hand drill to investigate the presence or depth of marl infill beneath the mudstone layers where pad footing will be founded on.

The analysis was carried by assuming a marl infill is present with various sizes and depth within a homogeneous mudstone layer. Hardpan calcrete layers are not modelled as the relatively hard material beneath the marl infill should not impact the results greatly. Soil properties similar to a SPT-N 15 soil were utilized to model the marl infill within the mudstone layer. Properties of the mudstone layers were obtained from the laboratory test result carried out during the sub-surface investigation stage. An axis symmetry model with equivalent surface area as a  $2.2 \text{ m} \times 1.6 \text{ m}$  pad footing was used for the parametric study.

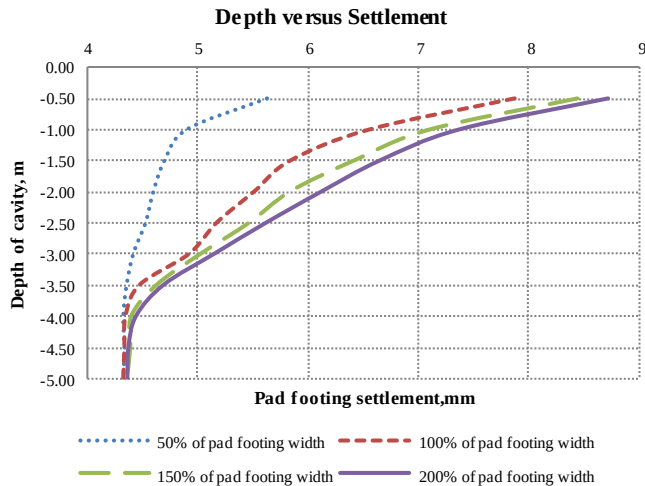
Figure 18 Analyzed relationships between depth of cavity and settlement of pad footing

Results of the analysis revealed that both depth factor and width factor of the marl infill affect the magnitude of settlement of the pad footing, as shown in Table 7 and Figure 18 respectively.

The magnitude of settlement was observed to be decreasing with depth for all the analysis with different width of marl infill. This finding also aligns with the concept of a pad footing where pressure applied is uniformly distributed from the pad footing. As a result, the magnitude of settlement for marl infill at a lower depth was observed to be smaller.

Therefore, the findings from this finite element analysis reveals that, a minimum thickness of 1.0m of mudstone is required above the hardpan calcrete layer in order to prevent differential settlement issues that may cause disruption to equipment that is sensitive to ground subsidence.

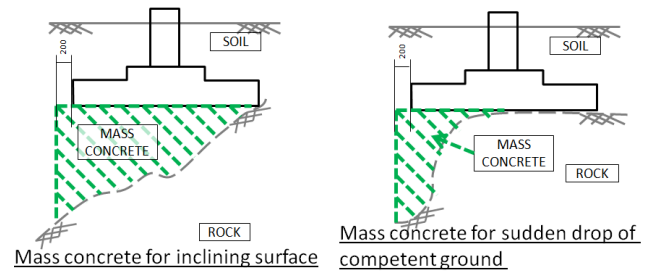
Figure 19 Schematic of mass concrete for pad footing supported on undulating rock profile

The utilization of mass concrete to even out steep slopes of competent ground surface was one of the solutions adopted to cater for the undulating ground as shown in Figure 19. The mass concrete method will be utilized when bedrock/suitable ground is located less than 3.5m deep from the proposed soffit level of the pad footing.

Mass concrete is a preferred replacement material compared to compacted suitable soil as the compaction effort as well as the compatibility of the soil stiffness may be an issue due to the poor weather condition. Mass concrete is also a faster solution that will have minimal water ponding issues that may deteriorate the easily weathered rock before a replacement material is placed.

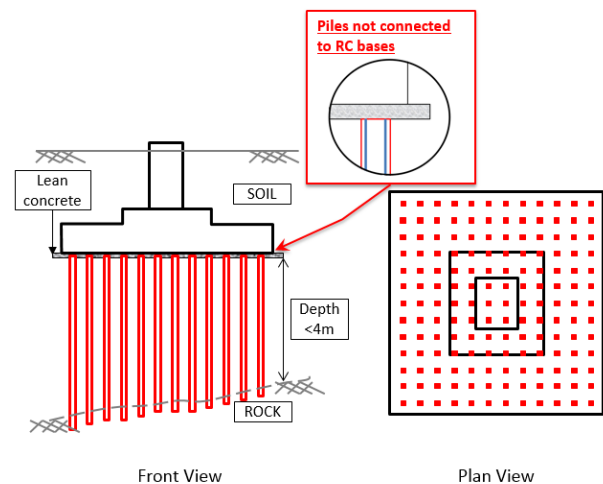
Figure 20 Schematic of 'pile-supported' pad footing for ground with overburden less than 4m

In conditions where competent ground is more than 3.5 m deep from the pad footing soffit level, a pile supported pad foundation system shown in Figure 20 will be adopted. The driven piles in a mat pattern act as ground improvement method that provides similar bearing capacity required by the pad footing design. Pile capacity for the driven piles were designed as short piles where the governing capacity for the pile is the end bearing capacity with minimal or no contribution from the skin friction. The spacing of the piles can be determined by equation below.

The reinforcement of the driven piles are not joint to the pad footings, instead, the pile heads are flushed against the soffit and tied together by the 100mm thick lean concrete. The reason for this design is to allow the pad footing to behave like surrounding pad footings where the load from the pad foundations are evenly transferred to the underlying hard stratum by the closely knitted mat piled system.
