# Engineering and Applied Science Research

## Urbanization and initial groundwater quality investigation in Malabe, Sri Lanka

Anjula Rajapakshe and Upaka Rathnayake\*

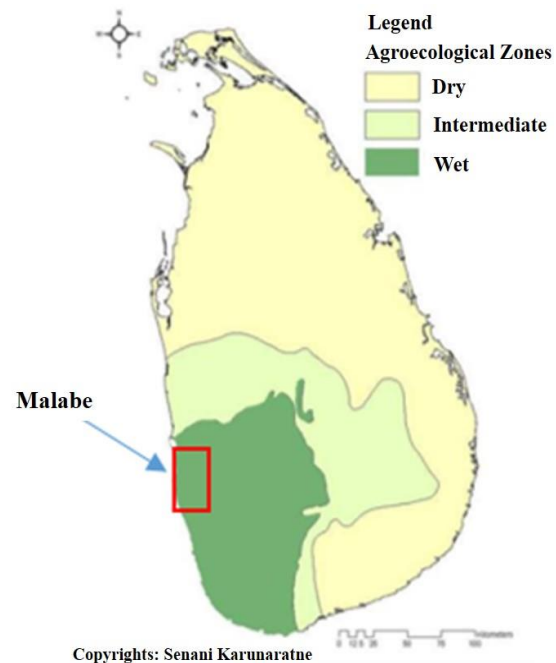
**Figure 1** Three climatic zones in Sri Lanka and Malabe [39]

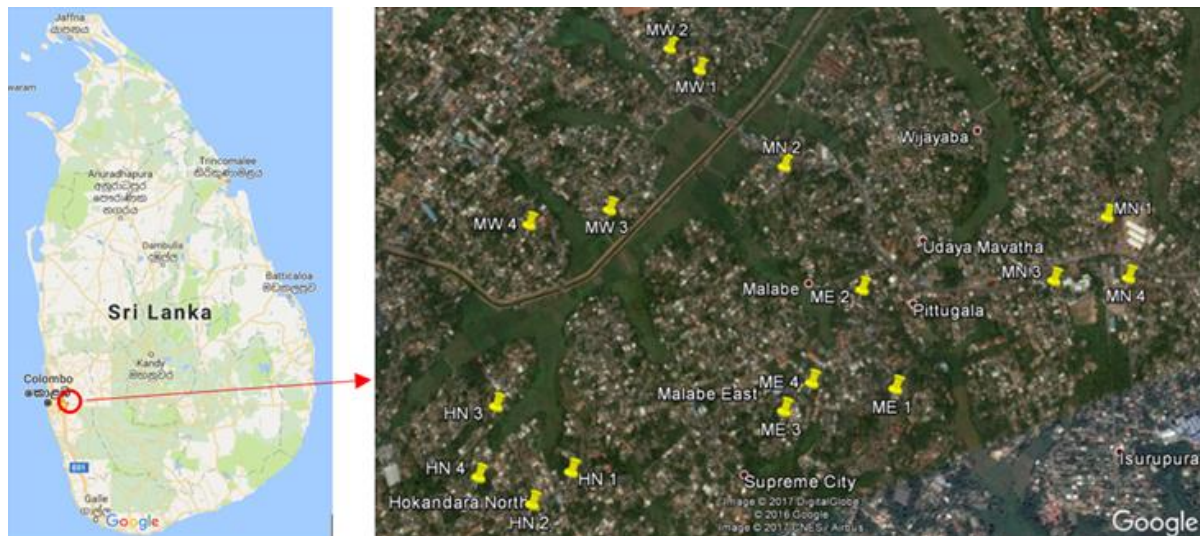
**Figure 2** Sample locations (obtained from Google Earth)

samples were collected from 16 wells and then, their water quality tested at the Water and Environmental Engineering Laboratory, SLIIT. Table 2 and Figure 2 show spatial information about these 16 sampled wells. The wells were chosen so that they were evenly spread over Malabe. Since Malabe is in the wet zone, the groundwater table is not that deep. Therefore, the wells in this area are shallow with the average depth of 3-6 m.

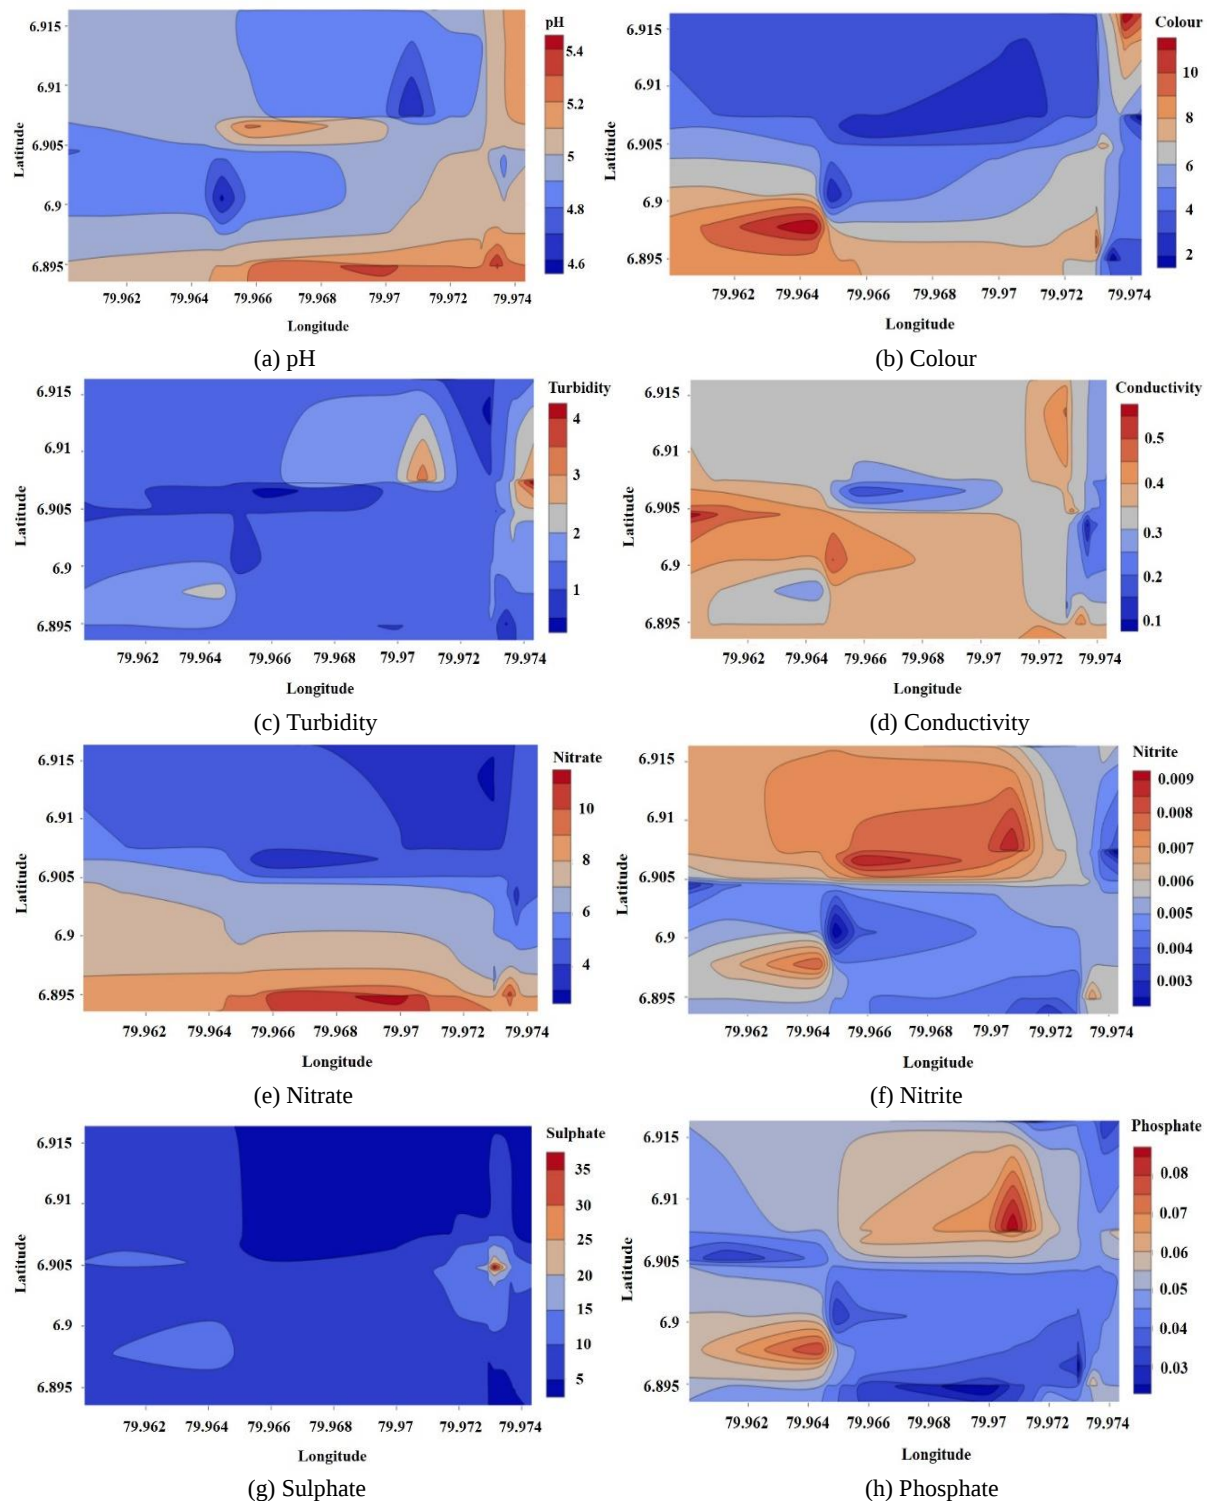
**Figure 3** Water quality contours of eight physicochemical parameters

Groundwater quality contours were developed and are presented in Figure 3a-3h. Figure 3a shows pH contours in the area. The blue patches depict areas with low pH values in well water. Therefore, this contour map can be used as an initial guide for suitability of future groundwater wells and in addition to providing focus to investigations of the reasons for acidic groundwater. Low drinking water pH values may result in several health issues including redness of skin and eye irritation [42].

Colour and turbidity can adversely impact the aesthetic features of water. Most of these groundwater wells are neither covered nor walled. This can influence the turbidity and colour of the groundwater. Electrical conductivity indicates the presence of various ions in the groundwater. This is primarily due to human activities. The contours of the physicochemical parameters of the groundwater of the Malabe area demonstrate spatial variations. Waste materials are a major source of anthropogenic nitrate contamination of groundwater. Disposal of human and animal sewage, industrial food waste and polyresins can cause nitrate contamination [43]. The selected research area has several sources of these pollutants in the form of uncontrolled septic tanks that contaminate groundwater. Additionally, phosphorous from various sources can promote algal growth, increasing turbidity. Fertilizers used in agriculture can raise the nitrate and phosphate concentrations of groundwater.
