Advance in Geogrid Reinforced Slopes in Malaysia

T.A. Ooi¹ and C.H. Tee²

Keywords: Soft Ground; Geo-synthetics; Slope failure; Slope rehabilitation

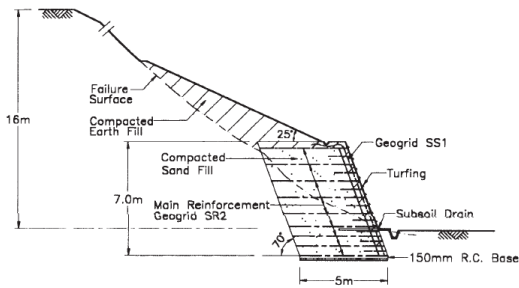
Figure 2b Scheme of rehabilitation using geogrid reinforced slope

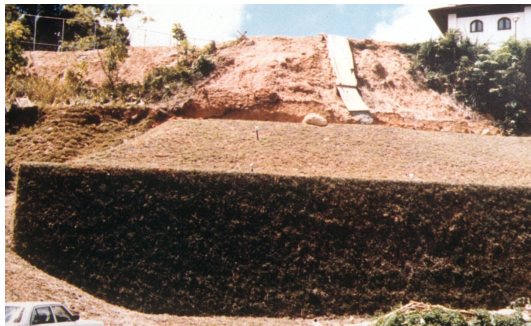
Figure 2d Rehabilitation in progress with upper slope, 1987

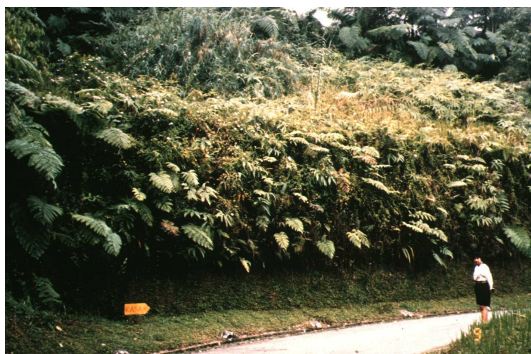
Figure 2f View of Petronas bungalow slope in 1989
by courtesy of Mike Dobie

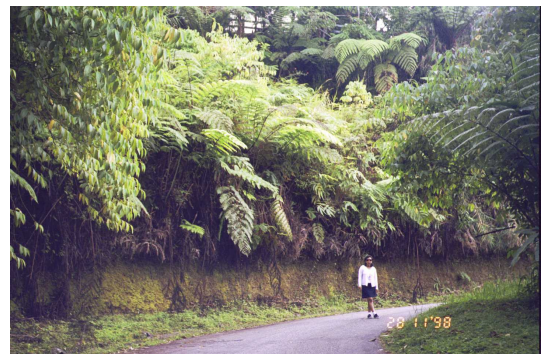
Figure 2g View of Petronas bungalow slope in 1998
by courtesy of Mike Dobie

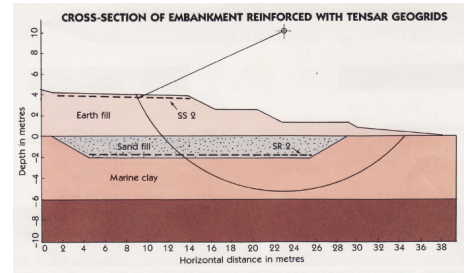
Figure 4c Embankment slip circle analysis

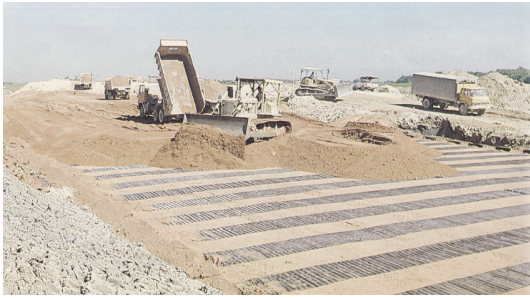
Figure 4d Laying of SR2 uniaxial geogrid

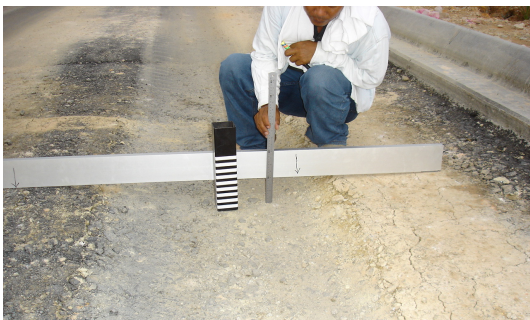
Figure 5c 100mm rut depth @ 120 passes Missing Link unpaved section

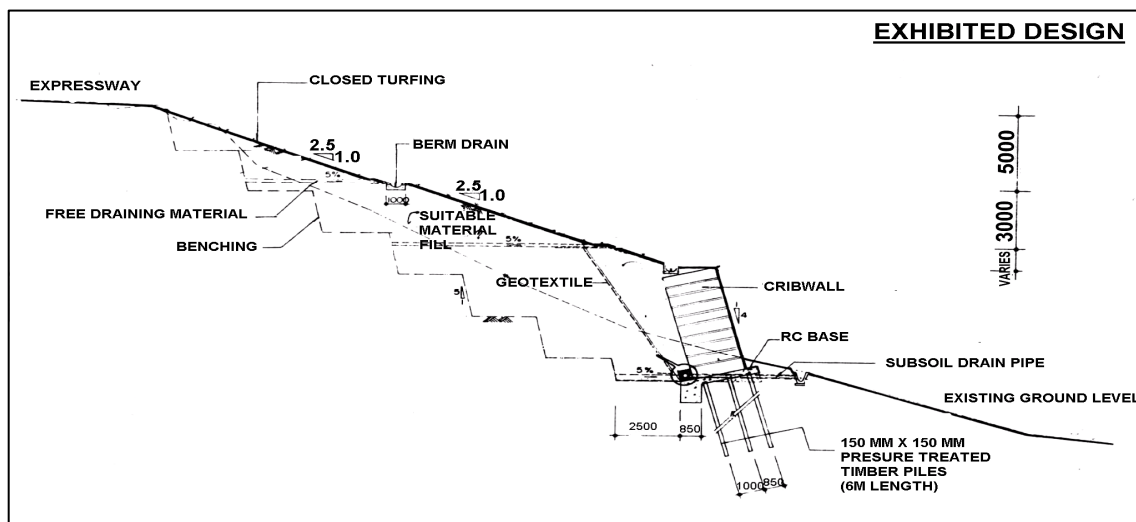
The Senawang – Air Keroh road embankment slope failure happened as a result of not cutting back the loose overfill on slope which has moved down the slope with passage of time. Figure 10a shows picture of the failure. Figure 10b & 10c show typical sections of the schemes for slope rehabilitation. The geogrid alternative was selected by the client in preference to the exhibited design using crib wall supported on precast reinforced concrete (RC) piles. The geogrid solution is more cost and time effective and blends in well with the existing green environment. This method of rehabilitation was often preferred by the client.

Figure 10b Exhibited design

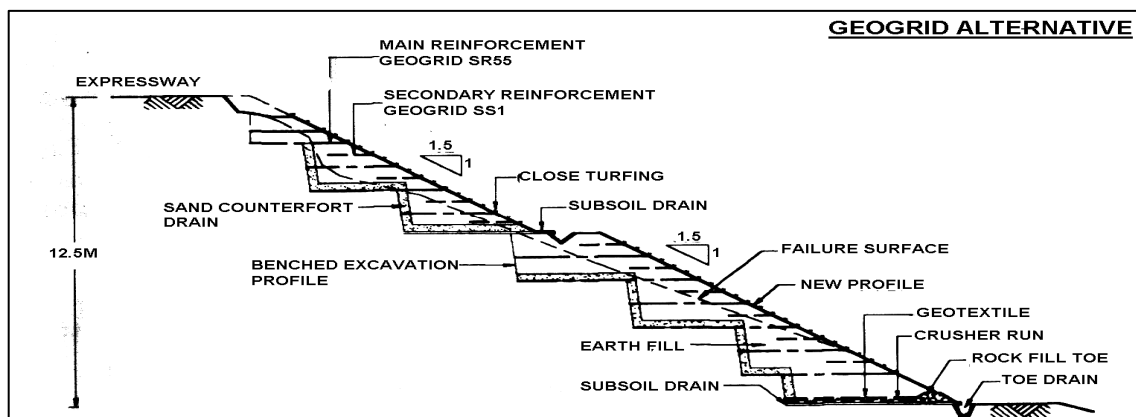
Figure 10c Alternative design

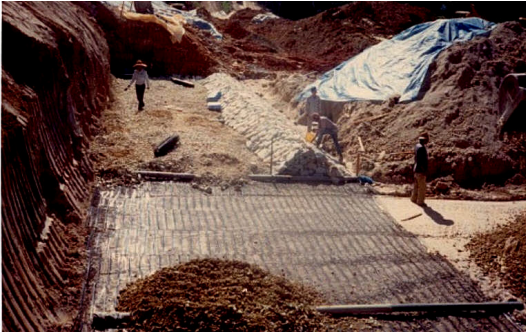
centres. A rock fill toe and toe drain was also provided to avoid toe softening due to poor drainage. Figure 10d shows rehabilitation in progress. Figure 10e shows picture of rehabilitated slope.

Figure 10d Rehabilitation in progress, 1989

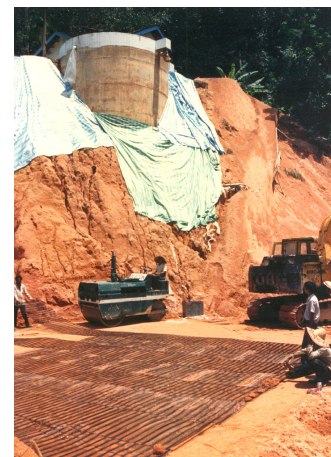
Figure 12b Construction at safe height

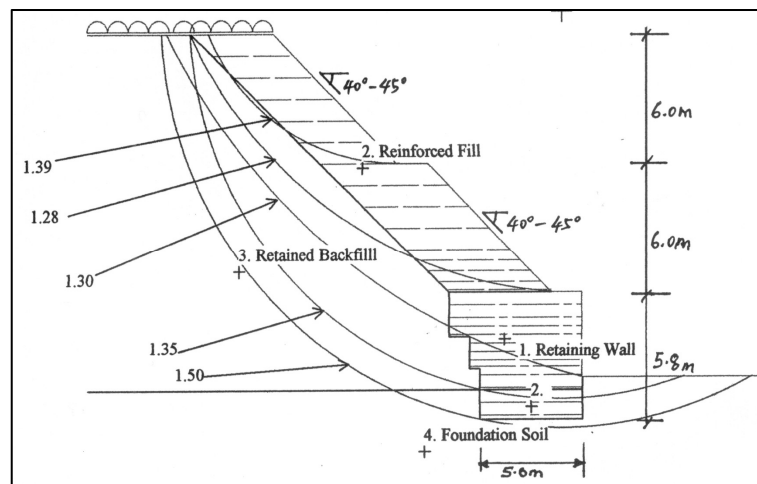
Figure17c Stability analysis of the rehabilitation scheme.

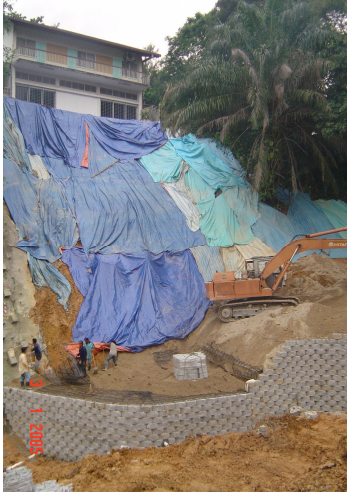
Figure 17d Construction of Modular Block wall with geogrid.

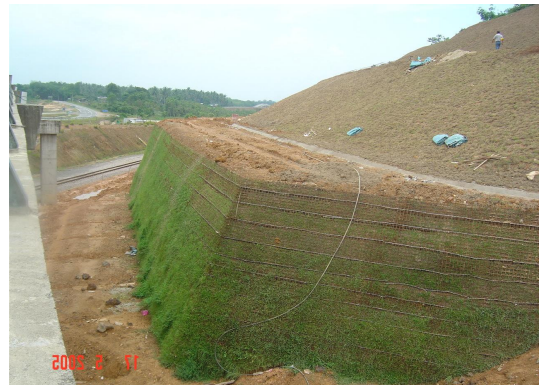
Figure 18e Turfing of geogrid block

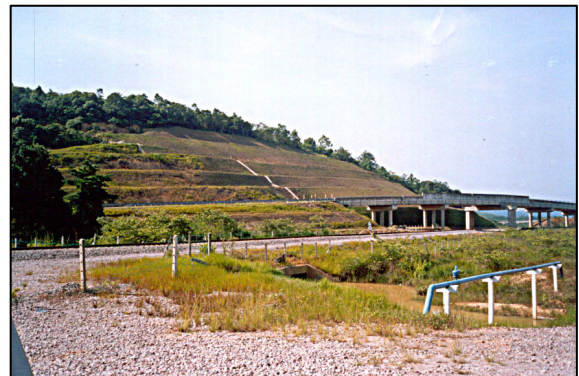
Figure 18g Overall view of rehabilitated slope

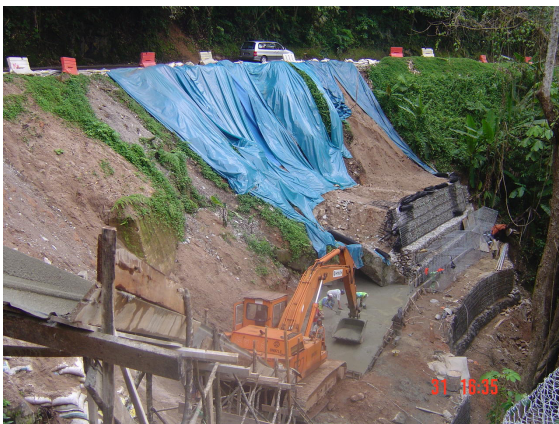
Figure 19c View of slope on rehabilitation

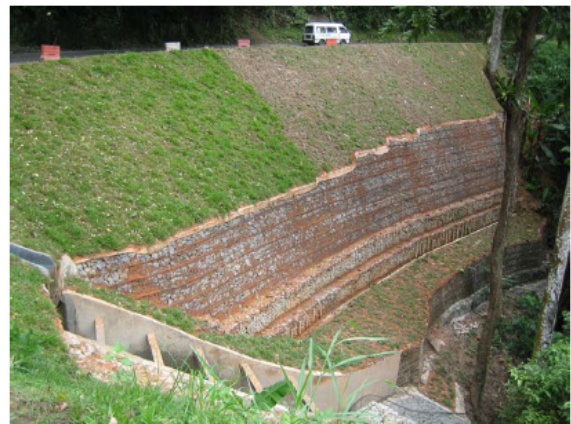
Figure 19d view of slope on rehabilitation

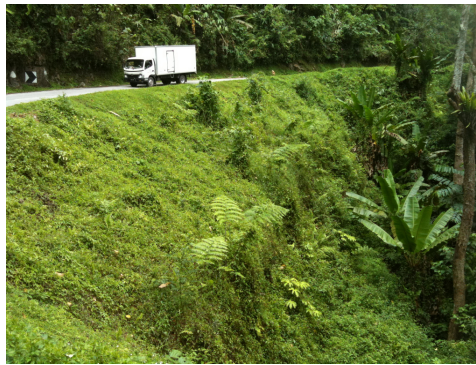
Figure 19e Recent view of rehabilitated slope

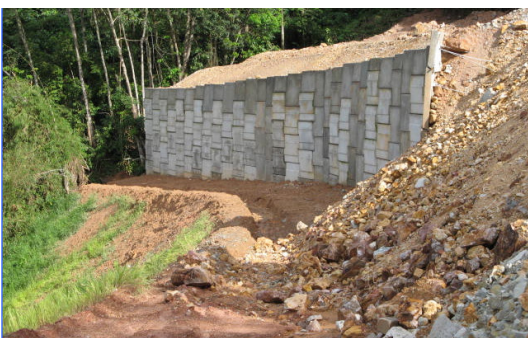
Figure 20b Anchored soil wall completed on 21st May 2006

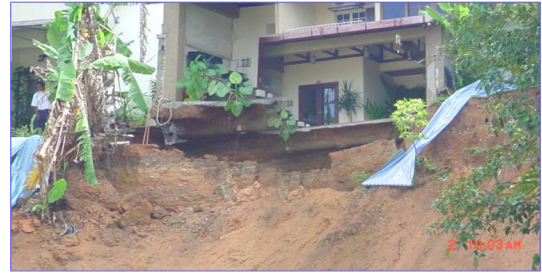
Figure 20d shows the collapse of the anchored reinforced soil wall 10 days after completion during the May 2006 monsoon season. Figure 20e shows a distant view of the landslide area covered in plastic sheets. Figure 20f shows the condition of the slope behind the plastic sheets. Figure 20g shows the schematic of rehabilitation of failed slope. Figure 20h and 20i show the respective picture of lower rock fill and upper geogrid embankment. Figure 20j and 20k shows the earthworks at formation level of the backyard. Figure 20l shows the spacious back garden. Figure 20m shows the devastated condition of the back yard before rehabilitation. Figure 20n shows the rehabilitated slope on completion. Figure 20p shows the rehabilitated slope with turf established.

Figure 20f View behind the plastic sheets

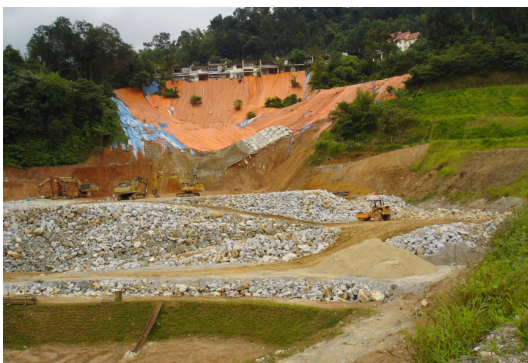
Figure 20h Construction of lower rock fill embankment

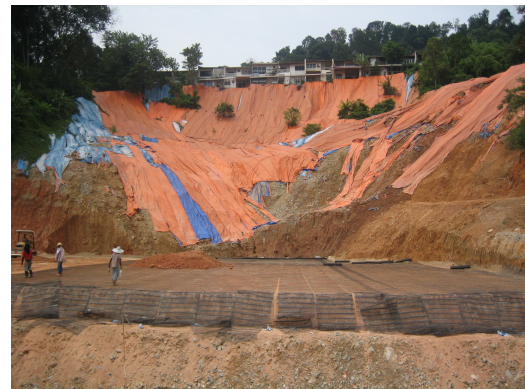
Figure 20i Construction of upper geogrid embankment

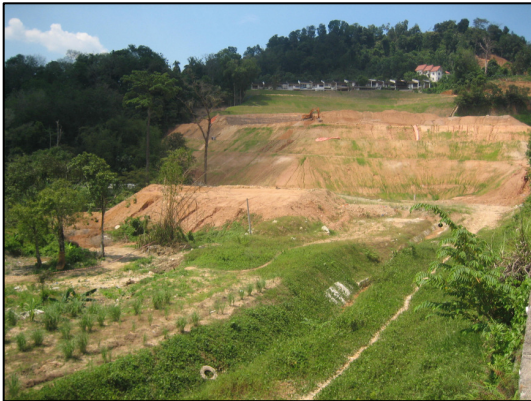
Figure 20n Rehabilitated slope on completion.

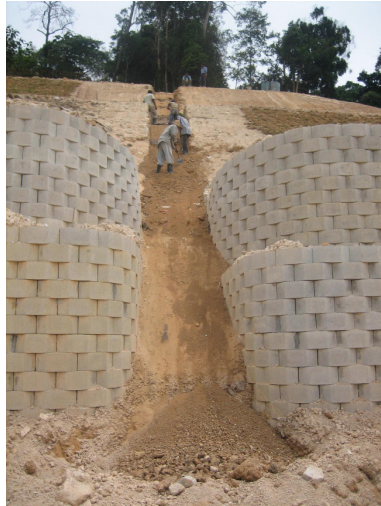
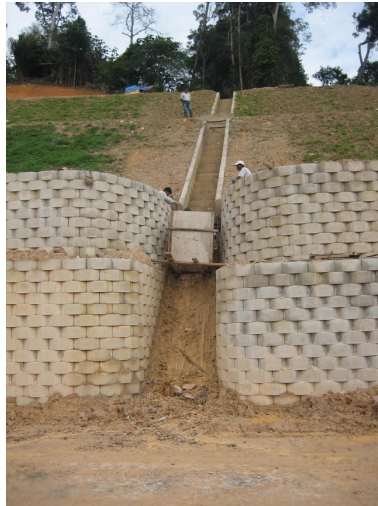
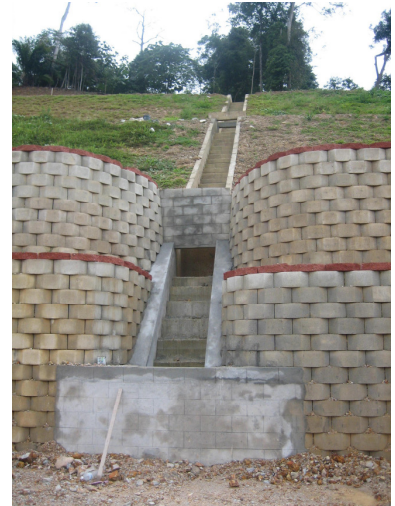
Figure 21h shows the commencement of rehabilitation works in November 2007. It can be seen that the landslide has encroached into the housing development site. Figure 21i shows the construction of slope drainage and Modular Block wall in progress. The rehabilitation work was completed with turfing in July 2008. The exposed fissures of the boulders were patched with cement mortars and formed part of the landscape features of the upper turfed slope. Figure 21j shows the view of completed slope rehabilitation with Modular Block wall and construction of houses in September 2008. Figure 21k shows the picture of the completed slope rehabilitation, Modular Block wall and houses in April 2009. The construction of houses were completed in October 2008. Modular Block wall, geogrid reinforced slopes complete with drainage and turfing were completed in December 2008. By April/June 2009 all houses were constructed, sold and occupied. This is a project where the purchasers are comfortable with the idea of living near a slope. Throughout the design and construction of slope rehabilitation, public safety and drainage were both amongst the top most priority of the client.

Figure 21i Constructions of slope drainage structures and Modular Block walls in progress.

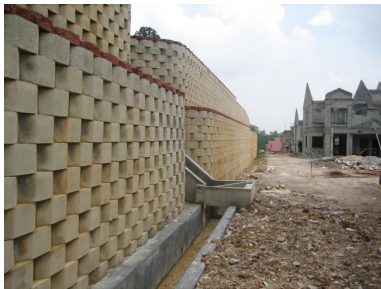
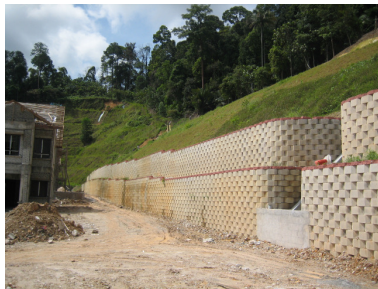
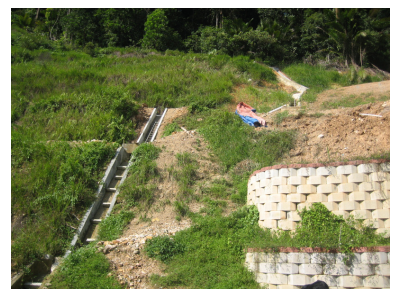
Figure 21j View of completed slope rehabilitation of Modular Block walls and slopes.

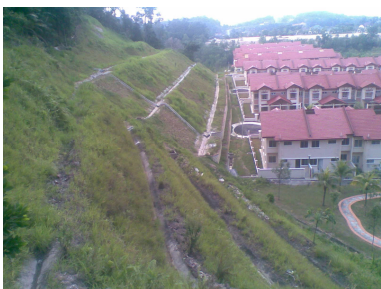
Figure 21k (i) June 2010 showing slope and houses

Figure 21k View of completed slope rehabilitation and houses, April 2009 & June 2010

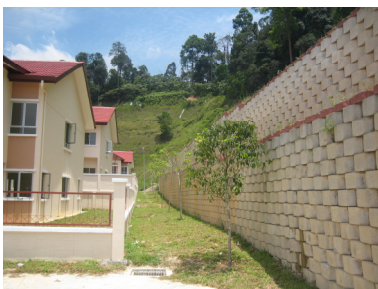
Figure 21k (ii) April 2009 showing houses and walls

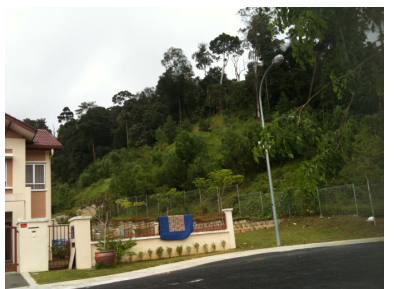
Figure 21k (iii) April 2009 showing houses and slope with trees
